Askøy municipality. Environmental status and assessment of municipal waste water with regard to the requirement of secondary treatment in the EU Urban Waste Water Directive

Title Askøy municipality. Environmental status and assessment of municipal waste water with regard to the requirement of secondary treatment in the EU Urban Waste Water Directive.	Report No.. 6108-2011	Date 28.01.2011
	Project No. 29247	Pages Price 34
Author(s) Torbjørn M. Johnsen	Topic group Marine ecology	Distribution Free
	Geographical area Hordaland	Printed NIVA

**Environmental status and assessment of municipal
waste water with regard to the requirement of
secondary treatment in the EU Urban Waste Water
Directive**

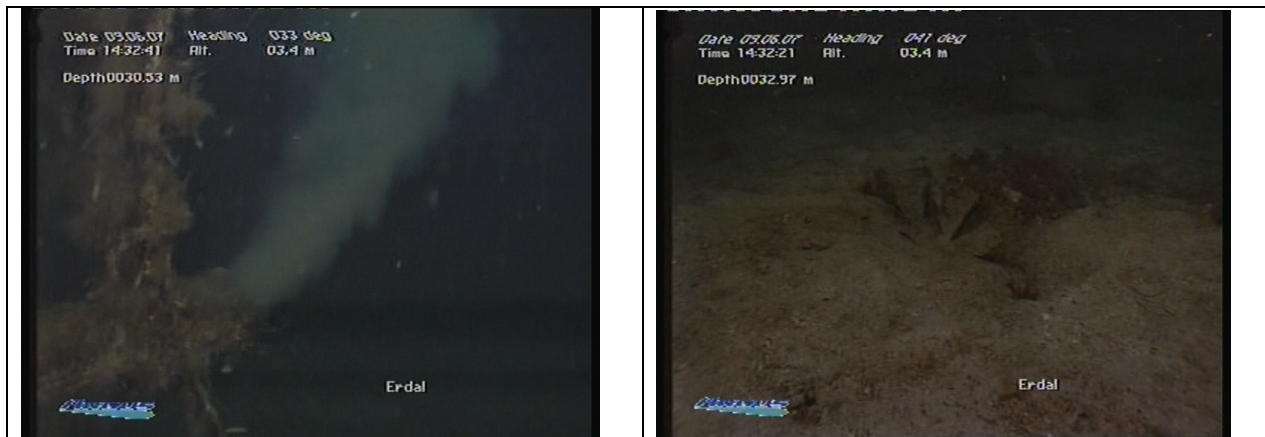
Figure 7. Plume and pipe end area at Erdal.

ROV (Remotely operated underwater vehicle) inspections around the pipe ends at Erdal and at Florvåg showed no visual debris or surface pollution (Molvær et al. 2007) (**Figure 7**, **Figure 8**). The positions and depths for the pipe end at Erdal and Florvåg is given in **Table 5**.

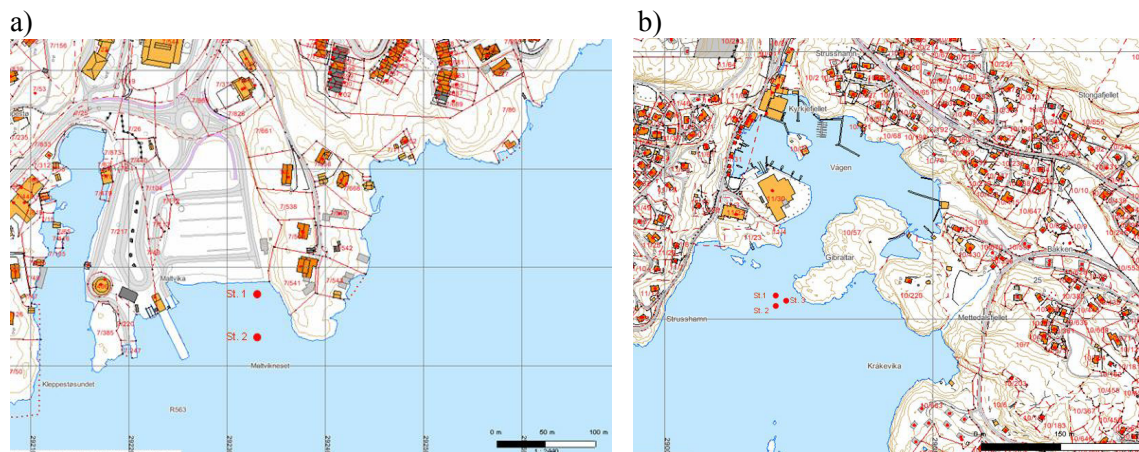
Figure 11. Sampling stations for sediments and benthic fauna at a) Kleppestø and b) Strusshamn.

Close to the outlet of waste water at Kleppestø (St.1) (**Figure 11a**), the TOC-content in the sediment was high (“Poor” condition), but the benthic fauna species diversity was high giving “High” classification (**Table 7**). The level of TBT was high (“Bad”, most likely due to antifouling paint used on vessels (ferry and fast-running boat traffic close to the sampling station)), and the sediments were also to some extent polluted with some heavy metals (Hg – “Poor”, Cu – “Moderate”, Pb – “Good”) (**Table 8**).

Attempts to take sediment samples approximately 50 m outside the waste water discharge at Kleppestø (St.2) failed due to rocky bottom.

Sediments from three stations at Strusshamn (**Figure 11b**) showed varying contents of TOC (“Good”-“Poor”) (**Table 7**). Benthic fauna analyses showed “Good” conditions at all three stations. Station 2 and 3 had slightly elevated concentrations of lead (“Good”), and station 3 had elevated concentration of mercury (“Good”) (**Table 8**). TBT varied at the 3 stations between “Good” to “Poor”.

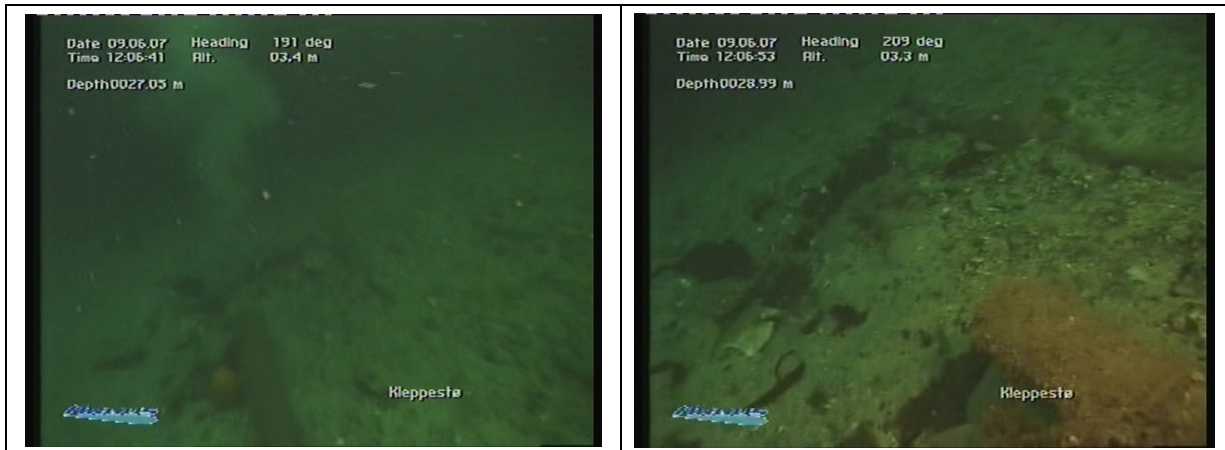
Figure 12. Plume and pipe end area at Kleppestø.

The end of the pipe at Kleppestø was found at 30 m depth (**Table 9**). No surface pollution or visual debris was observed at the pipe end (**Figure 12**). At Strusshamn several pipes were observed, but the end of the main pipe was found at 26 m depth (**Table 9**). At the main pipe end there was practically no debris and limited surface pollution (**Figure 13**).

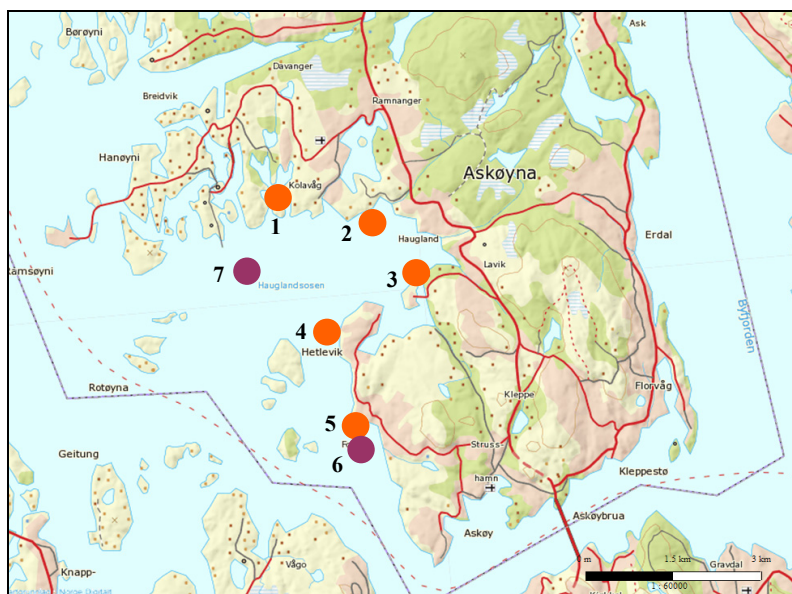
Figure 17. Map of soft-bottom sampling. 1 = Kollevåg, 2 = Hauglandshella, 3 = Juvik, 4 = Eide (Hetlevik), 5 = Haugadalen (Follese), 6 = reference station A24, 7 = reference station Ha10.

At Askøy west sediments were only investigated for soft-bottom fauna and parameters necessary for classification (organic carbon, grain size). Soft-bottom investigations were performed following the Norwegian standard of investigation of soft-bottom fauna ISO 16665:2005 at all waste water discharges west of Askøy and at 2 references stations (**Figure 17**). The benthic fauna showed good environmental

condition for the majority of the discharges. At Kollevåg, Hauglandshella, Eide (Hetlevik), and Haugadalen (Follese) the benthic conditions were excellent, corresponding to class I “High” in the Norwegian classification system (cf. **Table A1**). The benthic fauna at the reference stations showed, as earlier, good conditions and belongs to class I “High”. At Juvik (**Figure 17**, st.3) untreated waste water had been discharged during a period of 1-2 months, caused by a clogged discharge pipe. The discharges of untreated waste water lead to bad conditions corresponding to class V “Very poor” (**Table 14**). When discovered, the discharge of untreated waste water was immediately stopped.

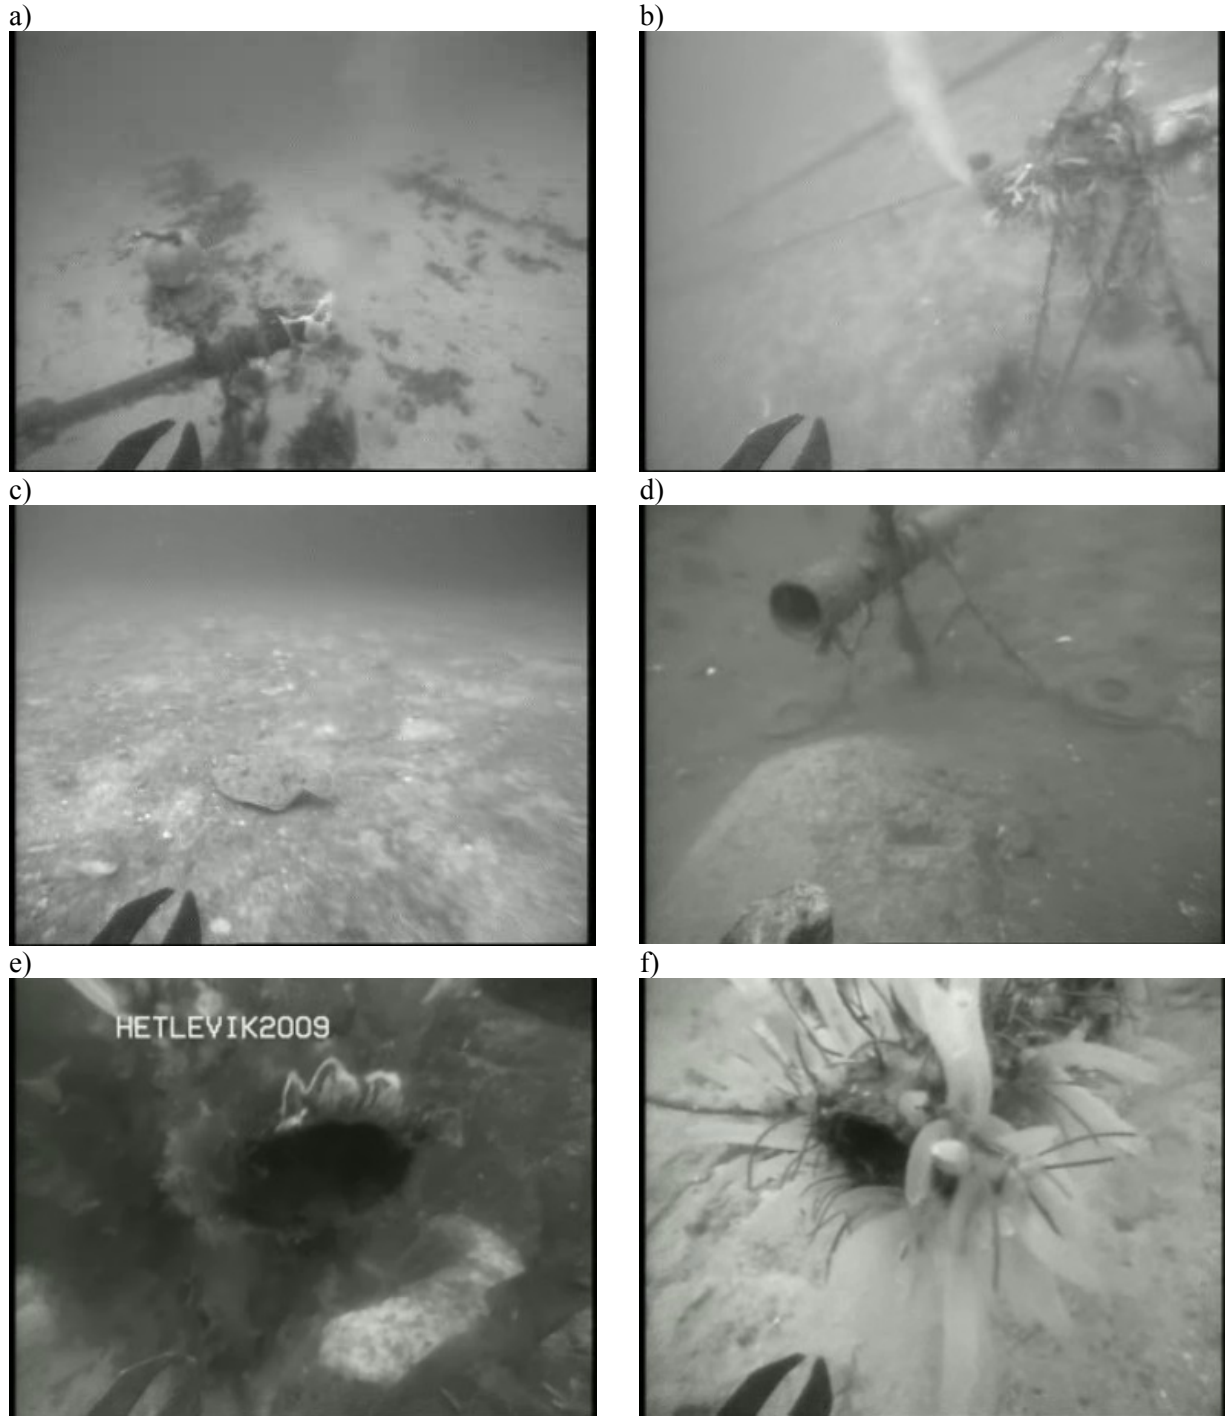
Figure 18. Plume and pipe end area at a) Kollevåg, b) and c) Hauglandshella, d) Juvik, e) Eide (Hetlevik), and f) Haugadalen (Follese).

At all stations ROV was used to find position and depth for the pipe ends (**Table 15**). Videos were recorded to document the environmental condition at the pipe ends and for visual inspections of the pipeline. At all stations, except Juvik, there were no sign of debris or surface pollution at the pipe ends. At Juvik the ROV inspection revealed that untreated waste water was pumped out into the inner part of Juvik caused by a clogged discharge pipe. At the pipe end some debris were observed.
