Askøy municipality. Environmental status and assessment of municipal waste water with regard to the requirement of secondary treatment in the EU Urban Waste Water Directive

Title Askøy municipality. Environmental status and assessment of municipal waste water with regard to the requirement of secondary treatment in the EU Urban Waste Water Directive.	Report No.. 6108-2011	Date 28.01.2011
	Project No. 29247	Pages Price 34
Author(s) Torbjørn M. Johnsen	Topic group Marine ecology	Distribution Free
	Geographical area Hordaland	Printed NIVA

Client(s) Askøy municipality, 5323 Kleppestø, Norway	Client ref.
---	-------------

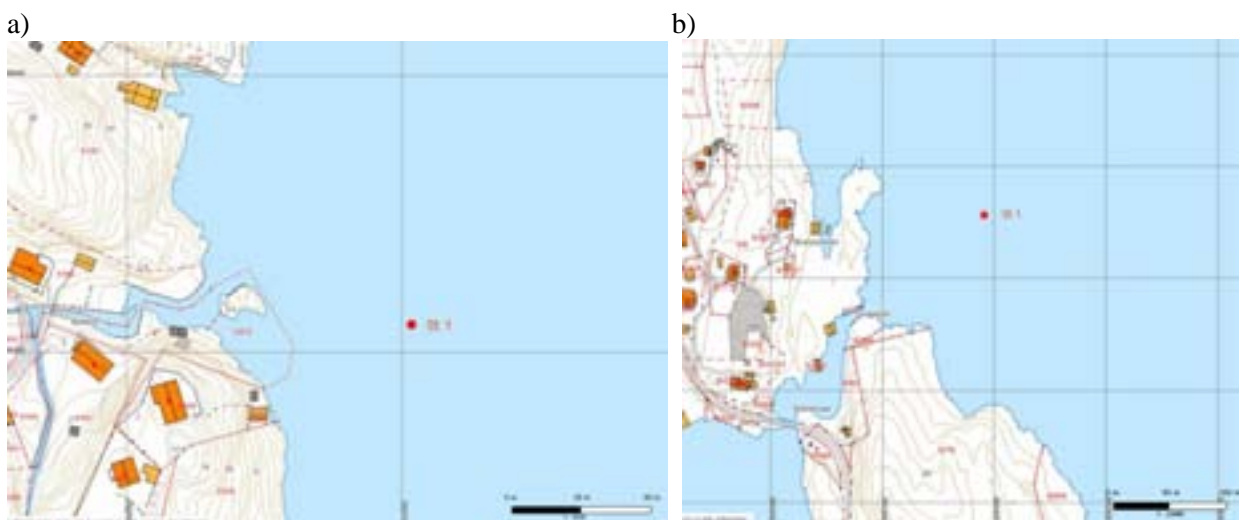
Figure 6. Sampling stations for sediments and benthic fauna at a) Erdal and b) Florvåg.

At Erdal and Florvåg (**Figure 6**) the sampling conditions were bad due to rocky bottom, resulting in chemical analyses of sediments only from Erdal. The sediments at Erdal (depth = 37 m) had relatively low contents of organic material (TOC) (**Table 3**) giving “Good” condition” according to the Norwegian Climate and Pollution Agency’s (Klif) environmental quality classification system (Molvær et al. 2007) (cf. **Table A1**). Semi-quantitative analyses of benthic fauna from both stations showed natural species diversity and composition without unusual numbers of pollution-tolerant species. At Erdal, TBT was slightly elevated (“Good”), while the generally low contents of heavy metals and contaminants gave “High” condition (cf. **Table A2**). At Florvåg the sediments consisted of shell-sand with no visual organic loads at the surface, or smell of H₂S, indicating normal conditions with aerobic breakdown of organic material (Dahl-Hansen et al. 2007).

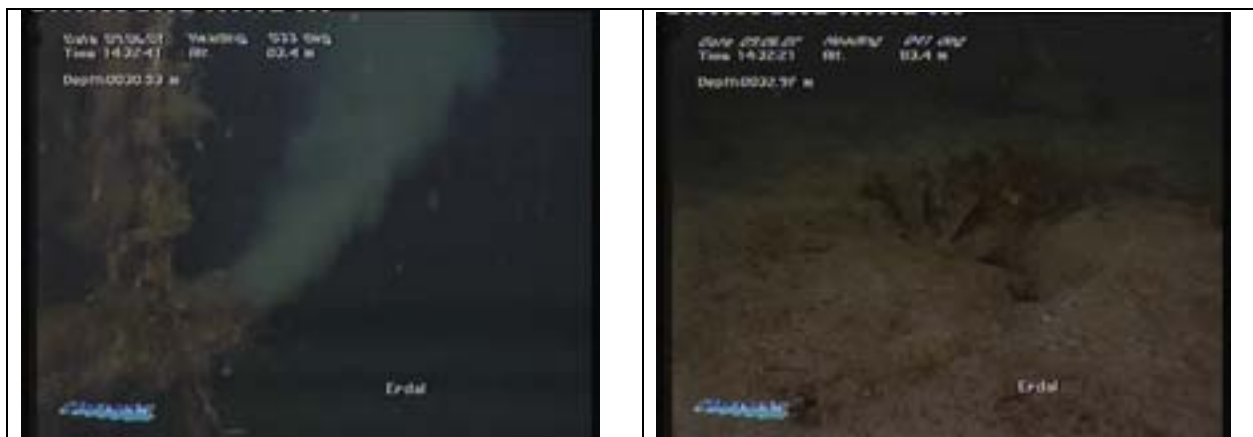
Figure 7. Plume and pipe end area at Erdal.

ROV (Remotely operated underwater vehicle) inspections around the pipe ends at Erdal and at Florvåg showed no visual debris or surface pollution (Molvær et al. 2007) (**Figure 7**, **Figure 8**). The positions and depths for the pipe end at Erdal and Florvåg is given in **Table 5**.

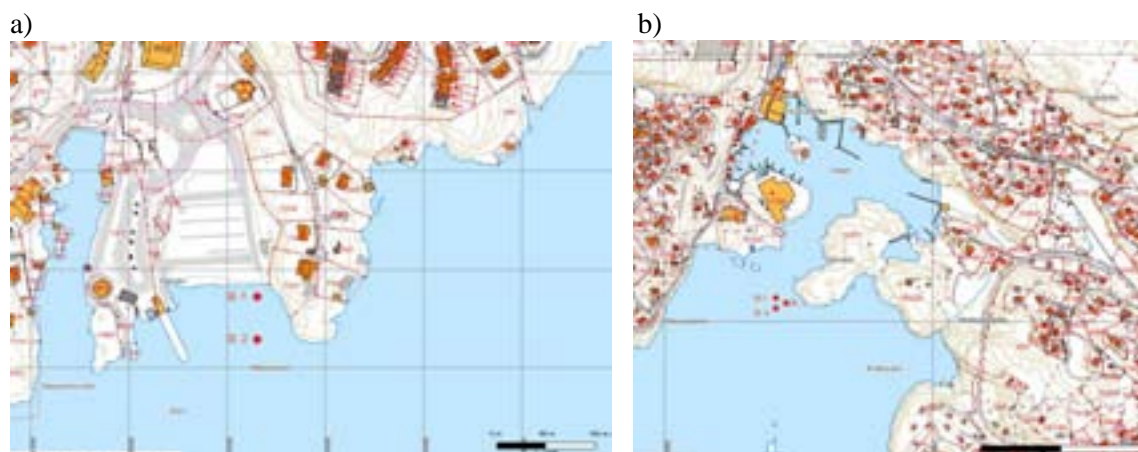
Figure 11. Sampling stations for sediments and benthic fauna at a) Kleppestø and b) Strusshamn.

Close to the outlet of waste water at Kleppestø (St.1) (**Figure 11a**), the TOC-content in the sediment was high (“Poor” condition), but the benthic fauna species diversity was high giving “High” classification (**Table 7**). The level of TBT was high (“Bad”, most likely due to antifouling paint used on vessels (ferry and fast-running boat traffic close to the sampling station)), and the sediments were also to some extent polluted with some heavy metals (Hg – “Poor”, Cu – “Moderate”, Pb – “Good”) (**Table 8**).

Sediments from three stations at Strusshamn (**Figure 11b**) showed varying contents of TOC (“Good”-“Poor”) (**Table 7**). Benthic fauna analyses showed “Good” conditions at all three stations. Station 2 and 3 had slightly elevated concentrations of lead (“Good”), and station 3 had elevated concentration of mercury (“Good”) (**Table 8**). TBT varied at the 3 stations between “Good” to “Poor”.

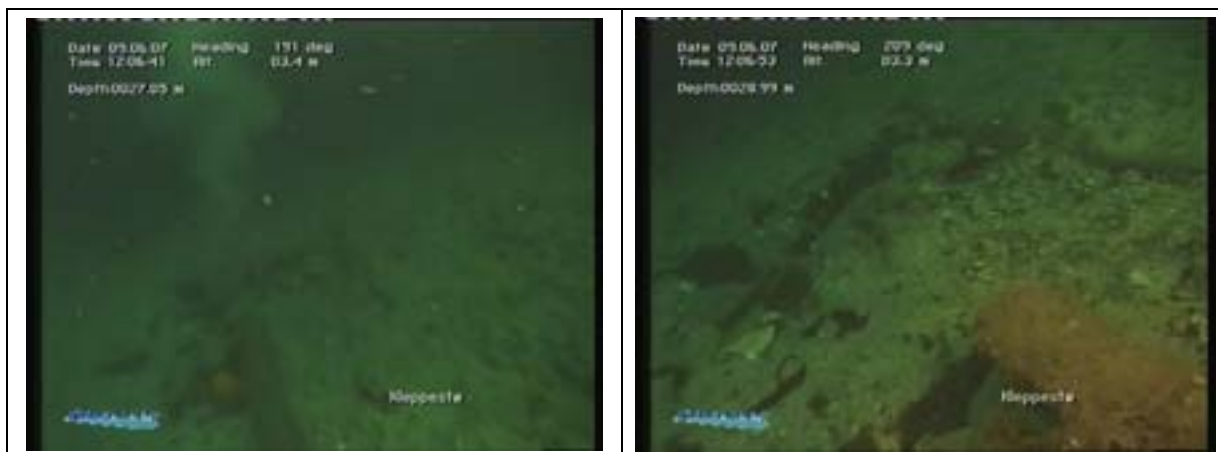
Figure 12. Plume and pipe end area at Kleppestø.

The end of the pipe at Kleppestø was found at 30 m depth (**Table 9**). No surface pollution or visual debris was observed at the pipe end (**Figure 12**). At Strusshamn several pipes were observed, but the end of the main pipe was found at 26 m depth (**Table 9**). At the main pipe end there was practically no debris and limited surface pollution (**Figure 13**).

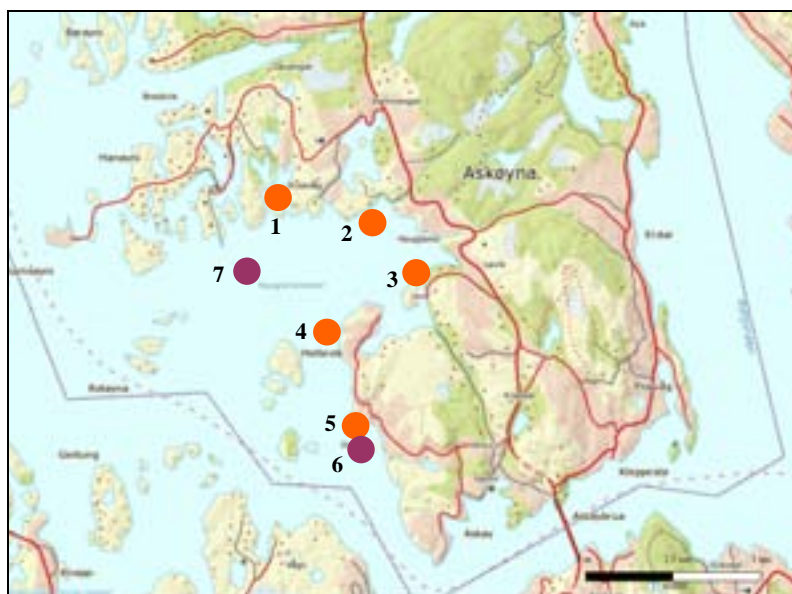
Figure 17. Map of soft-bottom sampling. 1 = Kollevåg, 2 = Hauglandshella, 3 = Juvik, 4 = Eide (Hetlevik), 5 = Haugadalen (Follese), 6 = reference station A24, 7 = reference station Ha10.

At Askøy west sediments were only investigated for soft-bottom fauna and parameters necessary for classification (organic carbon, grain size). Soft-bottom investigations were performed following the Norwegian standard of investigation of soft-bottom fauna ISO 16665:2005 at all waste water discharges west of Askøy and at 2 references stations (**Figure 17**). The benthic fauna showed good environmental

condition for the majority of the discharges. At Kollevåg, Hauglandshella, Eide (Hetlevik), and Haugadalen (Follese) the benthic conditions were excellent, corresponding to class I “High” in the Norwegian classification system (cf. **Table A1**). The benthic fauna at the reference stations showed, as earlier, good conditions and belongs to class I “High”. At Juvik (**Figure 17**, st.3) untreated waste water had been discharged during a period of 1-2 months, caused by a clogged discharge pipe. The discharges of untreated waste water lead to bad conditions corresponding to class V “Very poor” (**Table 14**). When discovered, the discharge of untreated waste water was immediately stopped.

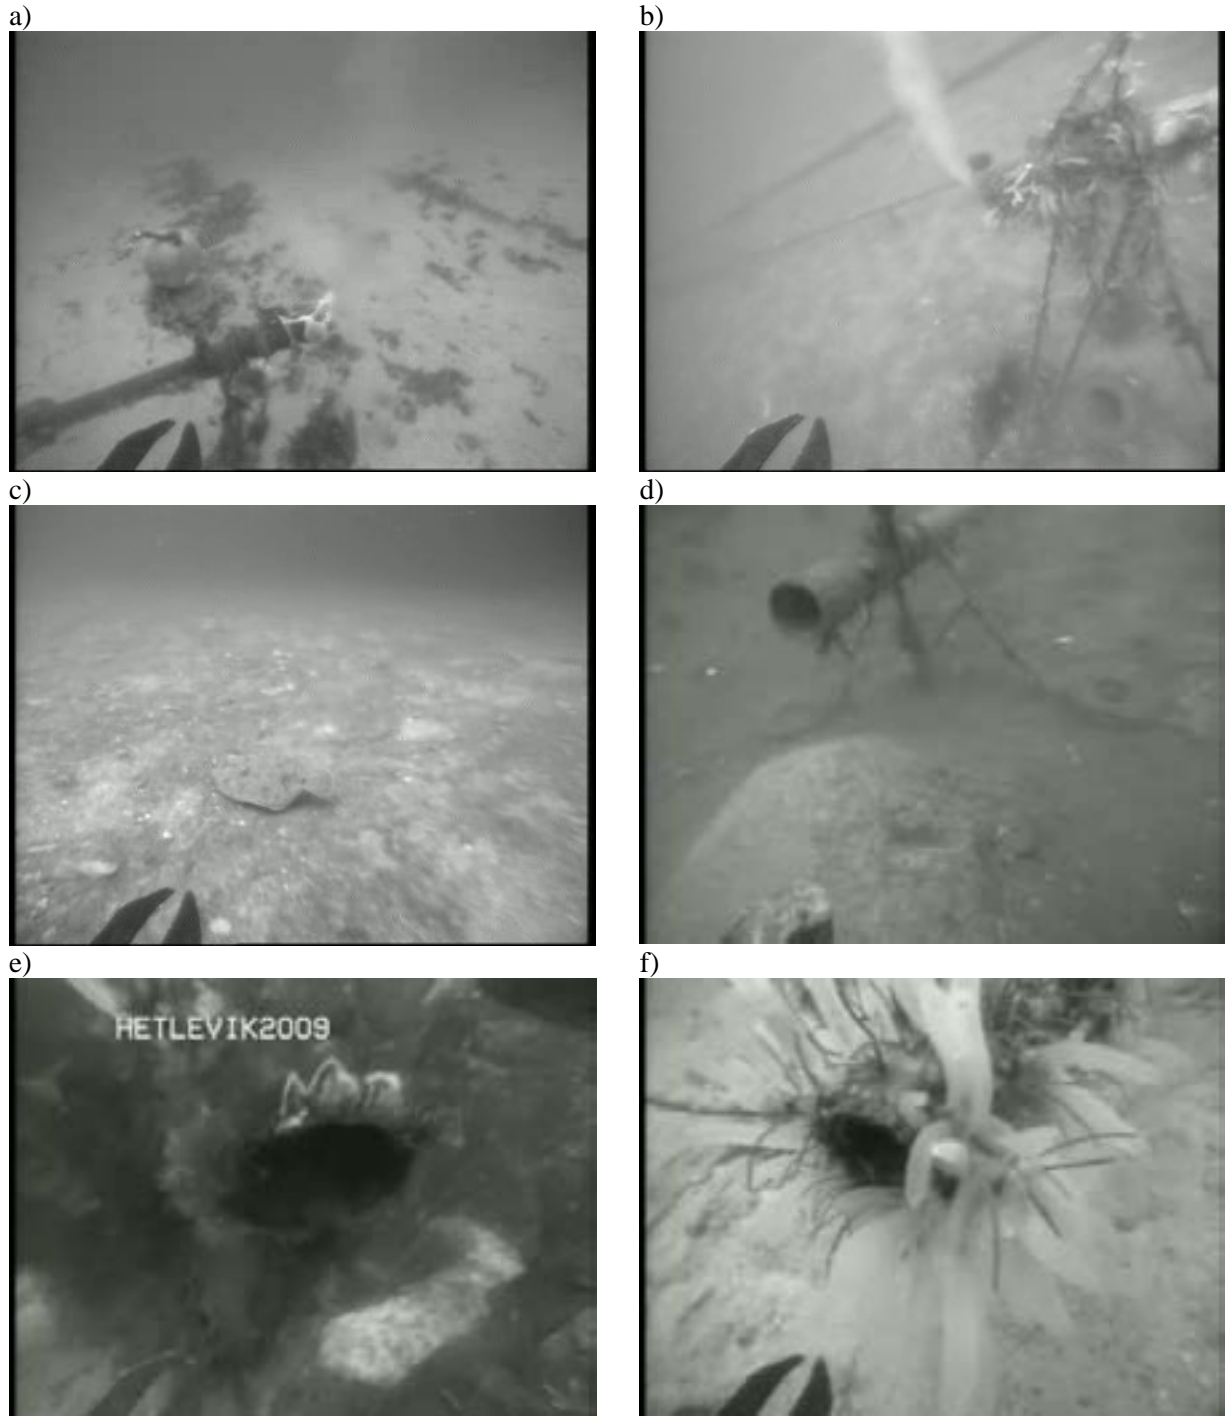
Figure 18. Plume and pipe end area at a) Kollevåg, b) and c) Hauglandshella, d) Juvik, e) Eide (Hetlevik), and f) Haugadalen (Follese).

At all stations ROV was used to find position and depth for the pipe ends (**Table 15**). Videos were recorded to document the environmental condition at the pipe ends and for visual inspections of the pipeline. At all stations, except Juvik, there were no sign of debris or surface pollution at the pipe ends. At Juvik the ROV inspection revealed that untreated waste water was pumped out into the inner part of Juvik caused by a clogged discharge pipe. At the pipe end some debris were observed.
