REPORT SNO 3943-1998

Mangdechu Hydroelectric Project

Environmental and Socio-economic Impact
Assessment Study:

**Water Quality and Sanitation,
Aquatic Flora and Fauna**

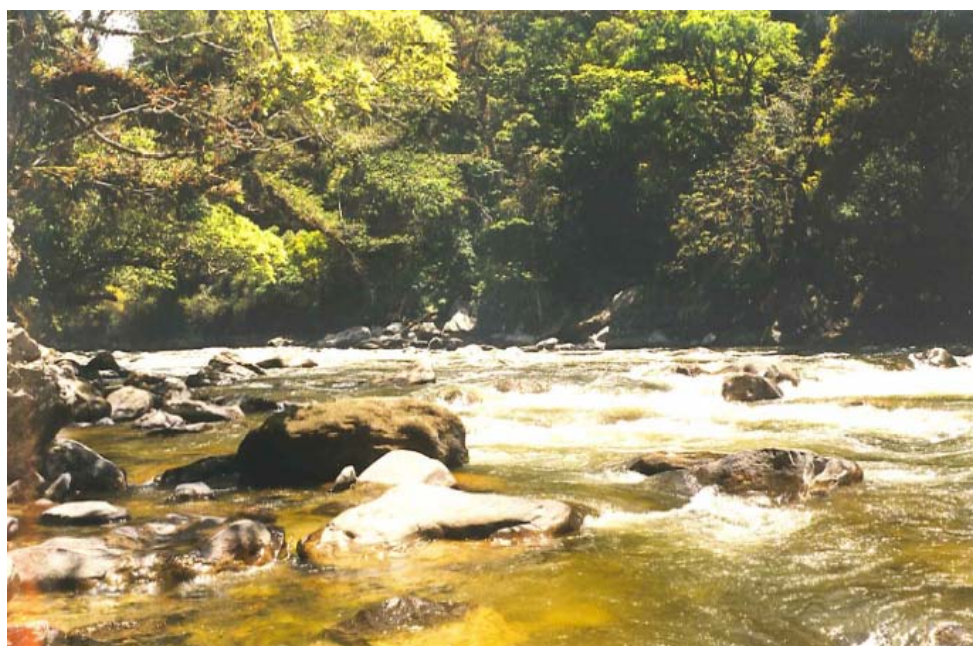
Figure 2.1 Mangdechu river and the location of the project area.

Upper Mangdechu River is situated mostly in Trongsa district of Central Bhutan. The main river originates from a big outlet glacier coming down from the ice-fields around Gangkar Phunsum mountain range in the Northern Bhutan. The river flows south and passes the Trongsa town area at about 1750 m above sea level. It then traverses in south-westerly direction for a total of approximately 9.5 km where it confluences with Chendebji river in between the project dam site and tailrace location. Then it traverses in south-east direction receiving other small tributaries. The river flows into Southern Bhutan where it reaches Manas River and the combined rivers flows as Manas River into the Indian State of Assam to eventually join the Bramaputra river. The total catchment area of Mangdechu River is 4444 km², where as the upper part that is going to be utilised for hydropower production is 1523 km². The river in the project area is shown in Figure 2.1.

The intake dam will be situated just downstream of Trongsa Town. Being approximately 50 m high, it will fill up a small reservoir of about 86000 m³. The water will be diverted via a 12.5 km long tunnel to a power station at Langthel.

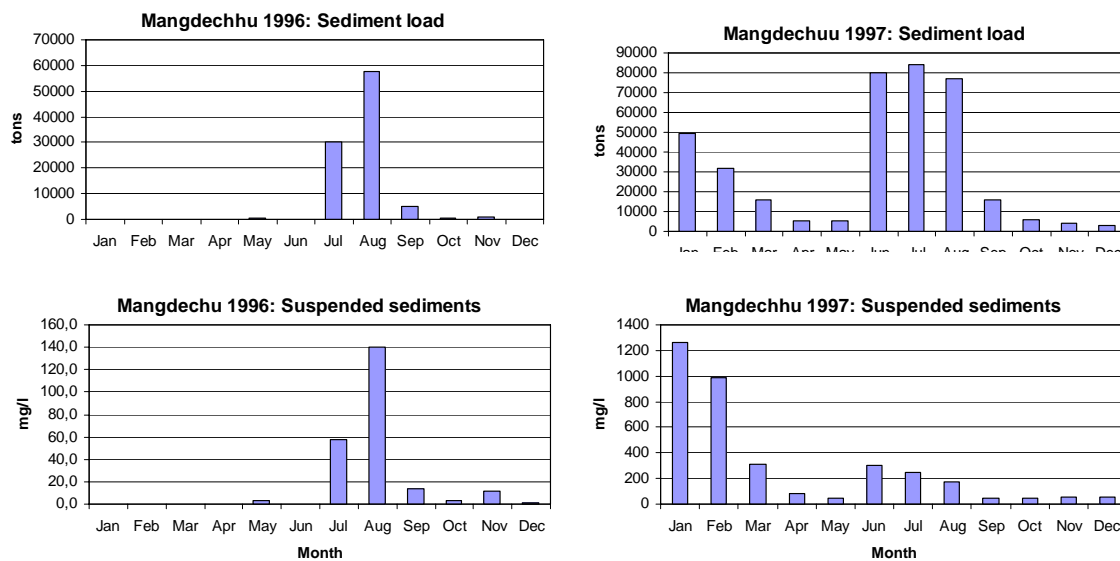
Figure 6.2 Suspended sediments in Mangdechu at Jeezam Bridge (the road crossing just upstream Trongsa) 1996 and 1997. The upper panel shows monthly transport values, the lower panel shows monthly mean concentrations. Data from DOP’s monitoring, month without column = lack of data.

Mangdechu River is periodically heavily impacted by erosion material. Visually the water can appear perfectly clear in the dry season and look completely grey at other occasions due to heavy sediment load. Periods of rainfall and snow-melt upstream results in immediate increase in sediment load. The hillsides along the river are steep and contain thick layers of easily erodible soil. Every year several landslides occur along the valley. The summer 1998 was particularly wet and many slides took place. Figure 6.2 shows the monthly load and the mean monthly concentration of particulate matter in the river water for 1996 and 1997.

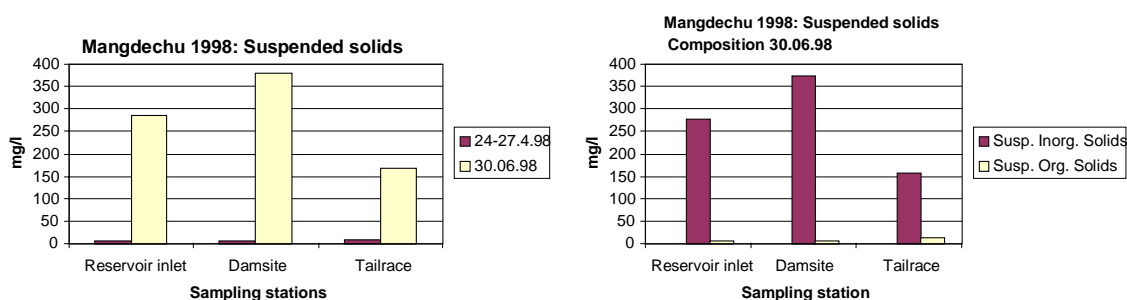
Figure 6.3 Concentration of suspended solids in Mangdechu River observed during the water quality sampling. Left panel shows the difference between wet and dry season, while the right panel shows the inorganic and organic fraction of the suspended solids in the river water in June 30-98 (wet season).

Figure 6.3 shows the concentration of suspended solids measured during the field work of the EIA study. In the left panel is shown the total suspended solids during dry and wet season, while in the right panel the total content is split into organic and inorganic fractions.

The concentration was only 6 mg/l in April in a low flow period, and increased to 380 mg/l in late June during high flow conditions.

From the right panel it becomes clear that nearly all the suspended material consist of inorganic particles, i.e. erosion products.

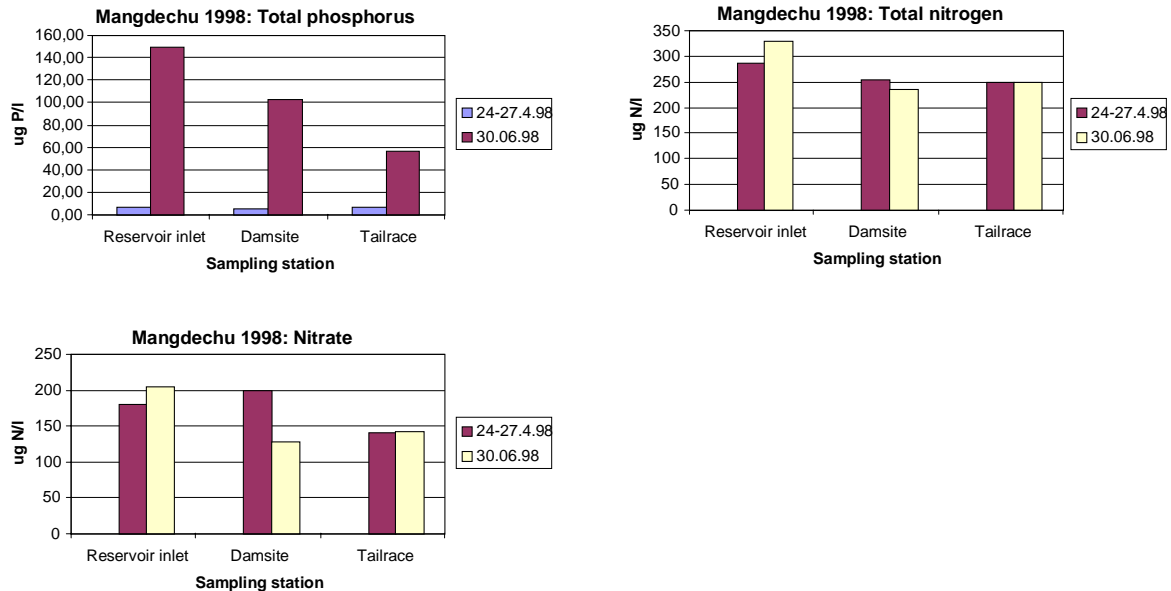
Figure 6.4 Mangdechu 1998. Observed concentrations of the plant nutrients phosphorus and nitrogen. The April values represent the dry season, while the June values represent the rainy season.

Figure 6.4 shows the concentration of the nutrients phosphorus and nitrogen. The concentration of total phosphorus in this river is completely determined by the content of erosion material, and is quite insignificantly impacted by anthropogenic effluents. In the dry, low flow season the concentration of total phosphorus was only 5-6 $\mu\text{g P/l}$, while in the wet season it increased up to as high value as 150 $\mu\text{g P/l}$. This high concentration of erosion derived total-P is firmly bound to soil particles and is only to a minor extent available to aquatic plants. High turbidity during erosion periods of high P-concentrations also reduces the plants possibility to utilise the high total-P concentrations during the wet season.

As well as the low total-P concentration during low flow periods, the low values of total nitrogen and nitrate clearly show the nutrient poor status (oligotrophic) of Mangdechu. Nitrogen is not attracted to particles, and is therefore not increasing due to erosion activity. For that reason there is not a significant difference between values from the wet and the dry season. Almost all the nitrogen is in the form of nitrate, which indicate low uptake by algae and other aquatic plants.

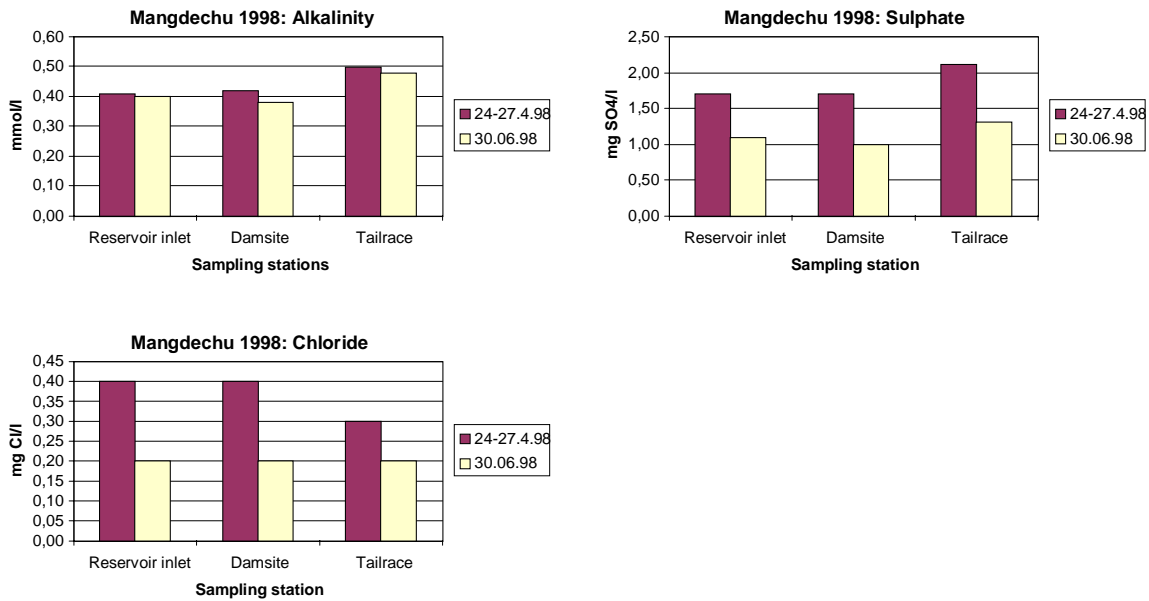
Figure 6.6 Main anions in Mangdechu during the water quality sampling (April data represent the dry season, while June data represent the wet season).

Sulphate and chloride is extremely low. The content indicates that there is not much gypsum rocks in the catchment, neither boggy landscapes of any extent, nor deposition of acid rain or sea salt components.

The slightly higher content of chloride at the two uppermost stations indicates impact from discharges from Trongsa Town. Chloride is extremely mobile through soils so the consumption of salt in households is easily observed in the receiving waters. Chloride is, however, harmless to the environment in the concentrations observed in Mangdechu.

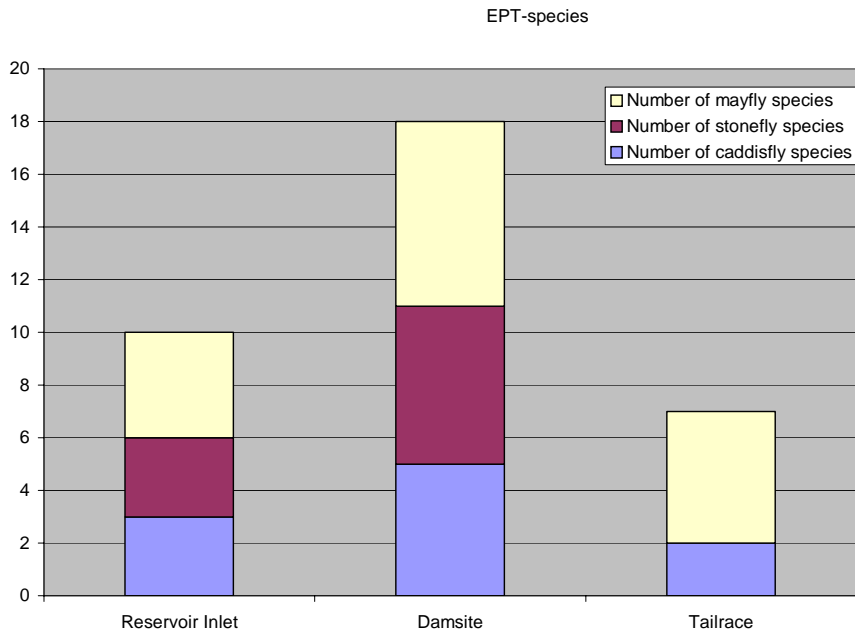
Figure 8.3 The number of species of mayflies, stoneflies and caddisflies (EPT; Ephemeroptera, Plecoptera, Trichoptera) observed at each site in the river Mangdechu 25.04.1998.

The diversity expressed as the total number of EPT-species (Ephemeroptera, Plecoptera, Trichoptera) were 18 at the damsite, and only 10 at the reservoir inlet and 7 at the tailrace, see Figure 8.3. The most common mayfly species were a *Baetidae*- species, whereas the most common stoneflies were *Isoperla spp.* and *Amphinemura spp.*. An *Agapetus* species were the most common caddisfly. Besides these species large specimen of *Dinocras* stoneflies were observed at the damsite and the reservoir inlet, as well as large specimen of a *Philopotamidae* caddisfly at Damside.

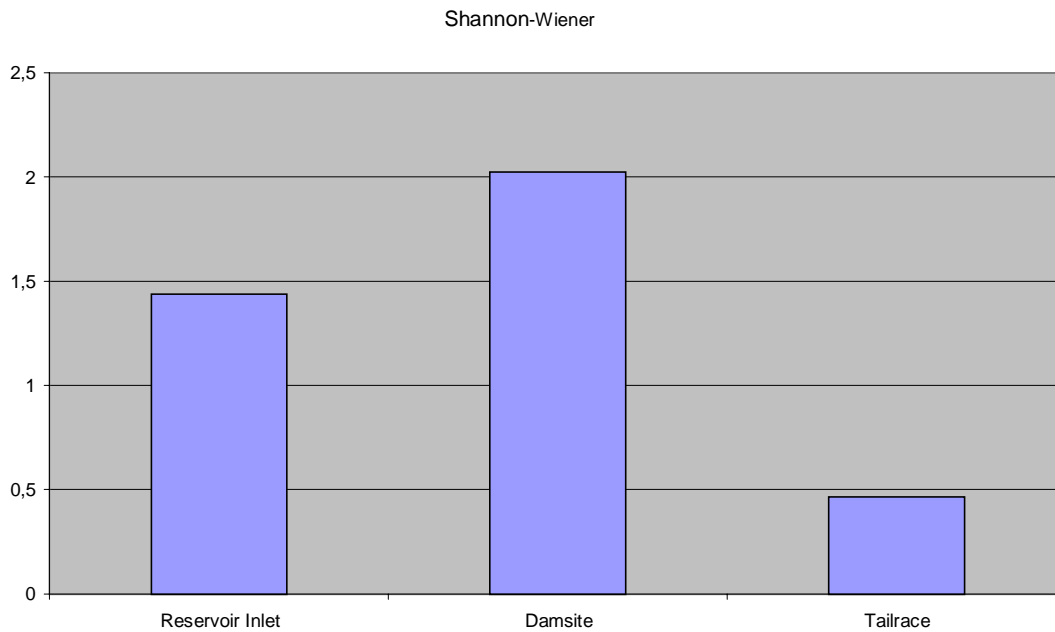
Figure 8.4 The diversity of mayflies+stoneflies+caddisflies expressed as Shannon-Wiener diversity index at each site in the river Mangdechu 25.04.1998.

The diversity within the EPT groups as calculated by Shannon-Wiener diversity index, Figure 8.4, showed about the same relative differences between the sites as for the EPT index. The values were about 1.5, 2.0 and 0.5 at the reservoir inlet, damsite and tailrace respectively.
