Highway E18 Grimstad-Kristiansand; effects and quantification of acid runoff from deposits of sulphide-bearing rock

Title Highway E18 Grimstad-Kristiansand; effects and quantification of acid runoff from deposits of sulphide-bearing rock.	Report No.. 5947-2010	Date 2011-07-6
	Project No. 29277	Pages Price 39
Author(s) Atle Hindar	Topic group	Distribution Free
	Geographical area Aust-Agder	Printed NIVA

**Highway E18 Grimstad-Kristiansand; effects
and quantification of acid runoff from deposits
of sulphide-bearing rock**

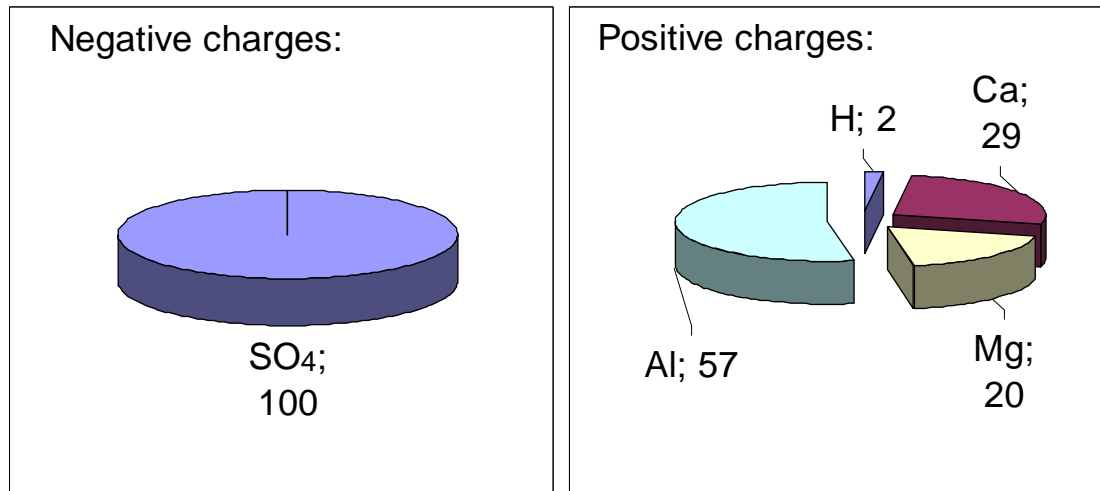
Figure 1. Charge balance (relative numbers; minor contributors to the balance not shown) for untreated runoff at Storemyr, Lillesand. Negatively charged sulphate is partly balanced and thereby partly buffered by calcium and magnesium from the rock itself, but aluminium is the dominating counter-ion. This water was very acid (significant concentration of H⁺) and extremely toxic to fish. Data from Hindar and Iversen (2006).

We suggest a critical Al concentration for brown trout in Lake Lomtjenn of about 0.1 mg/l, as labile Al (LAl). This is the target Al concentration, which may be reached at a relatively high pH. Before the construction period, pH could be down to 4.8 and LAl close to this target. The change in Al vs pH relation, as seen in Figure 19, is due to the change in sulphate concentrations from 4-5 mg/l in 2006 to 100-400 mg/l in 2008-2011, see also paragraph 1.2 and Figure 1.

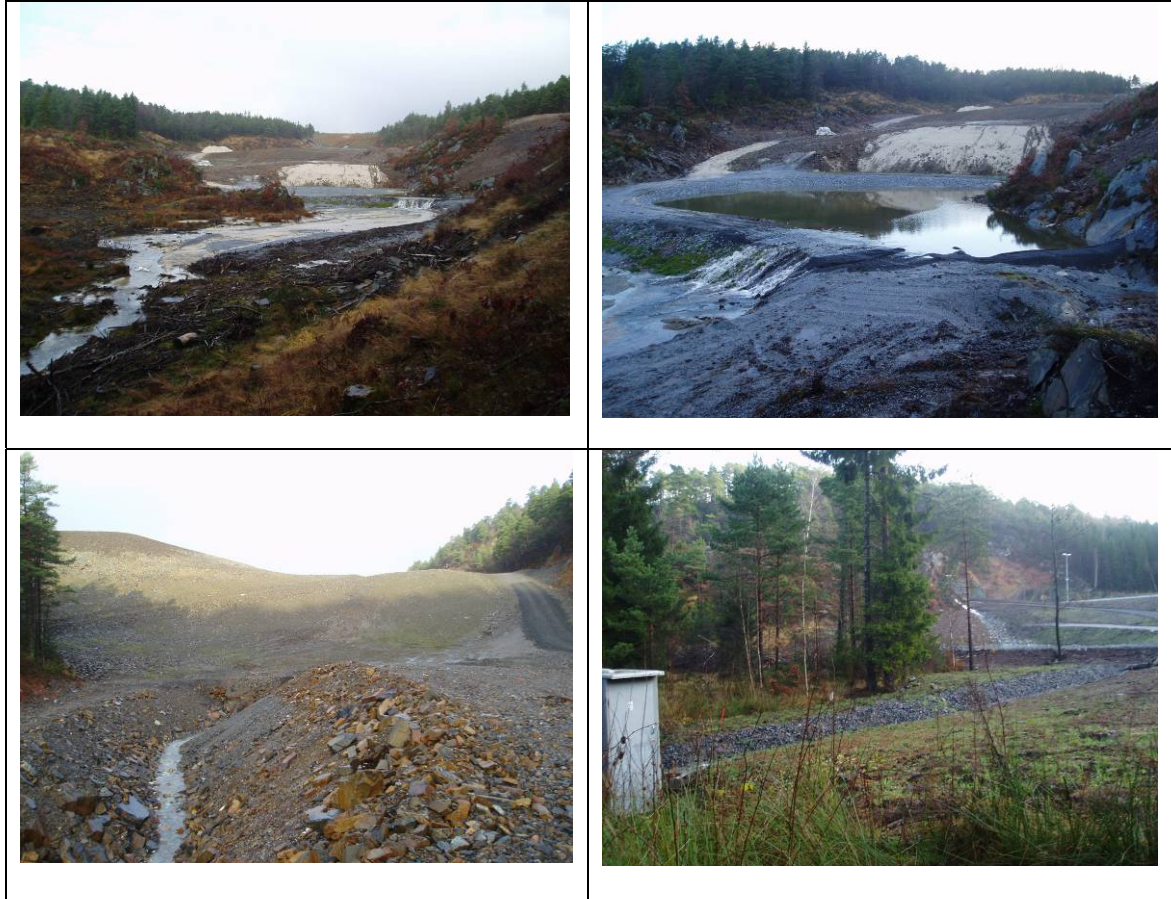
Figure 2. Deposit M17 (upper panel) with fill area, lower dam and downstream area with shell sand and gravel on November 17, 2009. Sampling point was at the dam outlet and 200 m downstream, at the base of the picture to the left. Deposit M20 (lower panel) with fill area, and outlet stream on November 17, 2009. The yellow-brown colour of the sulphide-bearing rock is clearly seen. Picture to the right shows the pH-measuring and sampling point 200 m downstream.

The two deposits M17 and M20 have been built over time and also changed their appearance over time. Both are built on relatively dry land and M17 is mostly unsaturated hydrologically. Part of M20 is soaked into a former swamp area. The pictures from the deposits in Figure 2 were taken in November 2009.

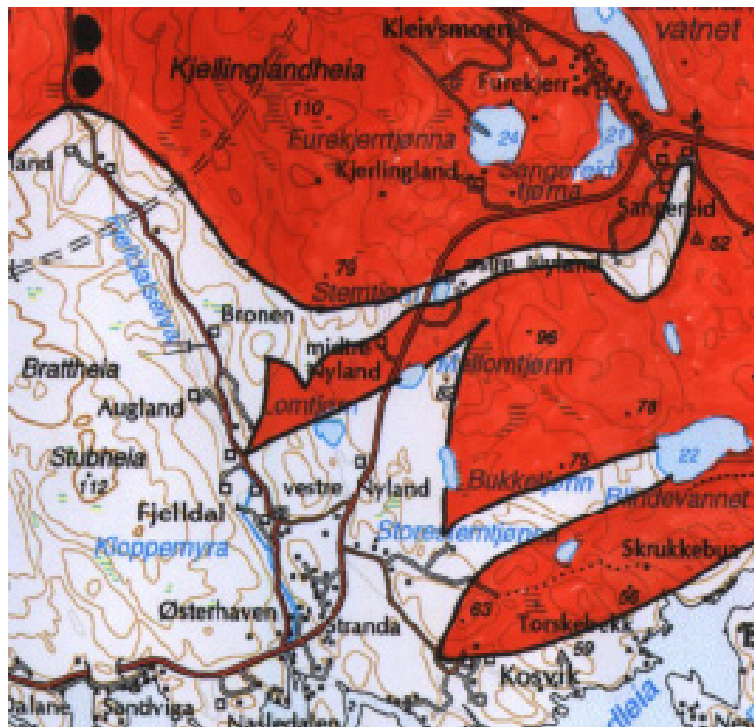
Figure 4. Geological map of the Lomtjenn/M17 area. Red colour indicates area with high risk of sulphuric bedrock. Black dots are areas with documented high concentrations of sulphur-containing bedrock. From Frigstad (2009).

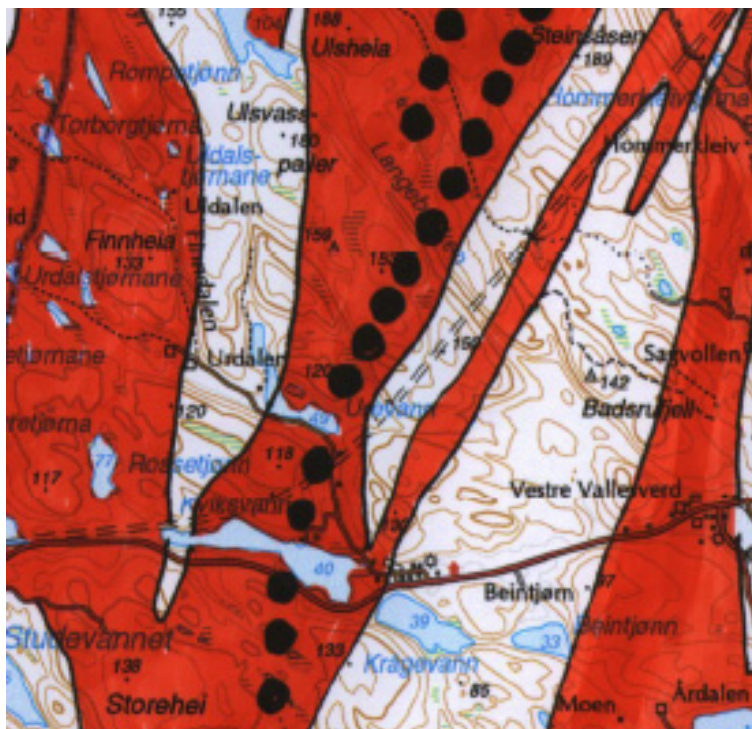
Figure 6. Geological map of the Urevatn/M20 area. Red colour indicates area with high risk of sulphuric bedrock. Black dots are areas with documented high concentrations of sulphide-bearing bedrock. From Frigstad (2009).

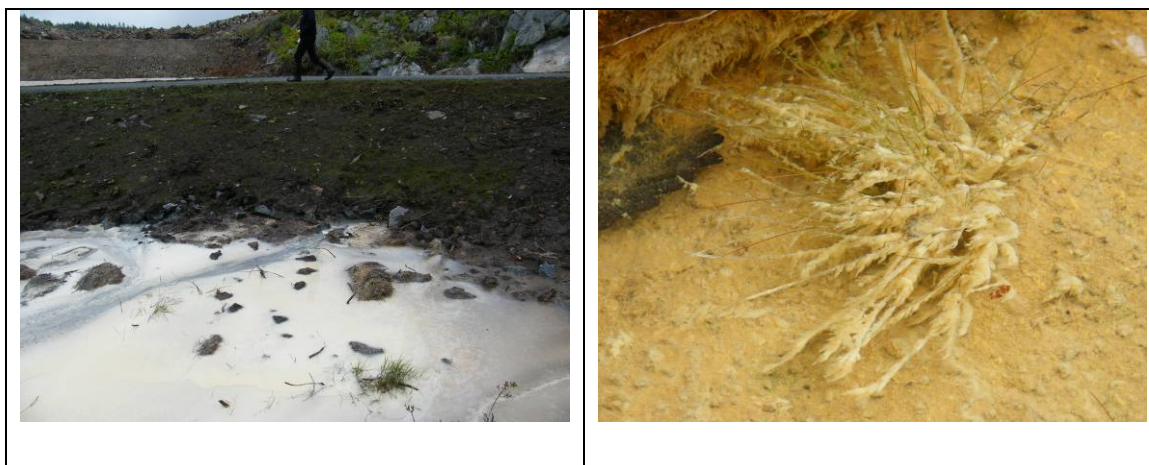
Figure 7. White precipitate at the dam barrier of M17, and attached to submerged plants and stream bed about 200 m downstream (May 18, 2009).

The fluffy, white material that was formed immediately downstream of M17 and its sedimentation basins, was observed during a trip on April 23, 2009. Examination at NIVA showed no bacteria, and thus the material was analysed for the most likely chemical constituents. The material (see Figure 7 for pictures) was grabbed with a clean plastic bottle on May 18, 2009, and sent to the NIVA laboratory. At the lab, about 10 ml of the precipitate including water was freeze dried, dissolved in acid (HNO_3) and then measured by ICP-AES (Perkin-Elmer Optima 4300 DV ICP-AES spectrometer, Perkin-Elmer Autosampler AS 93 plus, Hewlett Packard LaserJet 100). Data are given as μg per gram dry weight of the material.

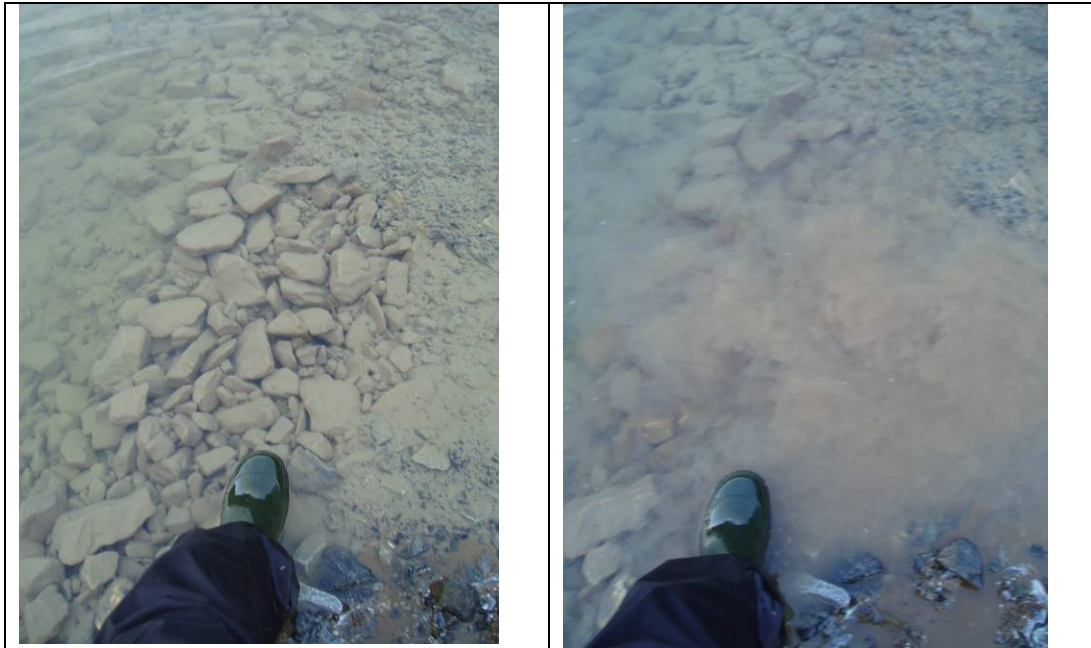
Figure 8. Fluffy, grey precipitates in lower dam at M17 before (left) and after careful disturbance of the limestone gravel.

On November 17, 2009, after the closing of the dam outlet at M17, a grey and very fluffy precipitate had formed on the surfaces of the coarse gravel in the lower dam. This precipitate

was sampled after careful disturbance of the gravel (see pictures in Figure 8), and concentrated by repeated sampling and sedimentation of water. At the lab, the particles were filtered through 0.45 µm Millipore filter and rinsed with distilled water, then dried and analysed as outlined above.

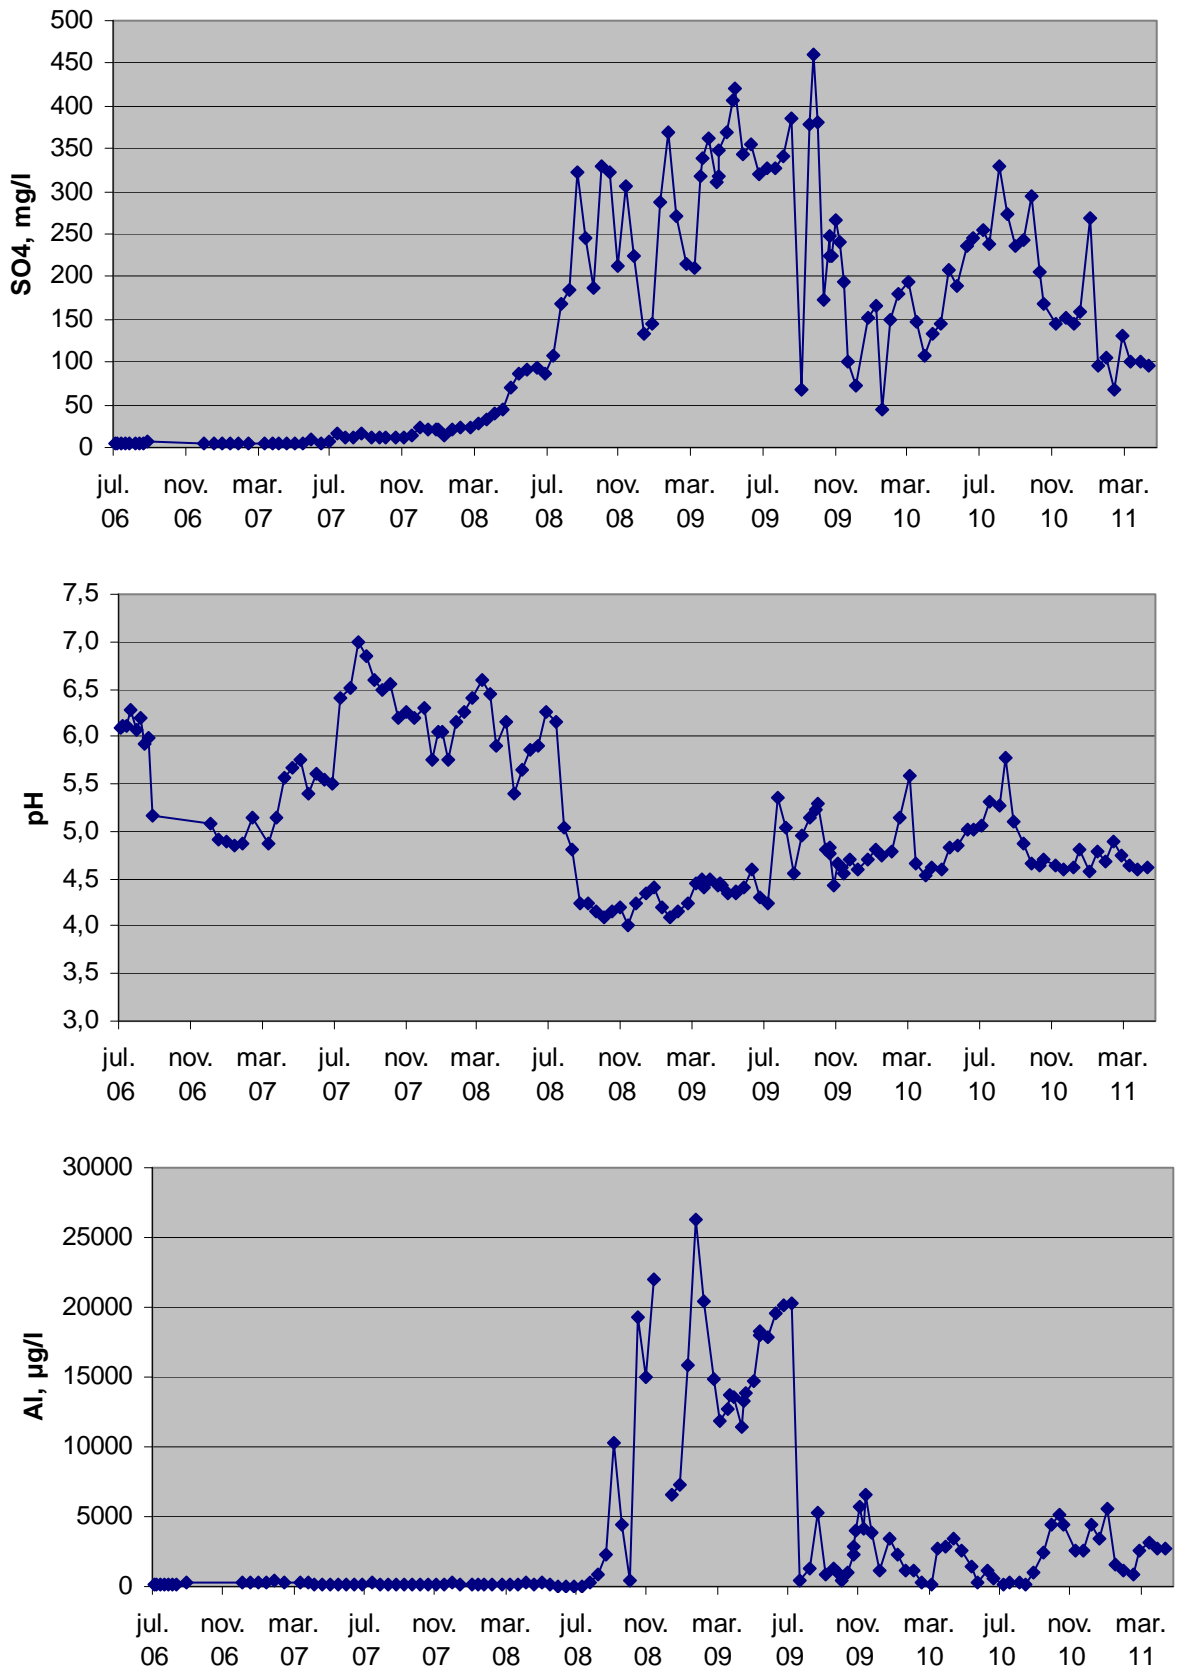
Figure 9. Outlet of Lomtjenn downstream of M17; sulphate, pH and reactive (at low concentrations) or total (at high concentrations) aluminium.

Data from the monitoring programme 2006-2011 show a remarkable increase in sulphate concentrations downstream of both M17 (outlet of Lake Lomtjenn) and M20 (inlet of Lake Urevatn) over time (Figure 9 and Figure 11).

At the outlet of Lomtjenn sulphate started to increase in July 2007, but stayed below 100 mg/l until August 2008. Following the rapid increase in August, pH decreased from background concentrations of 4.8-7.0 down to 4.0-4.6. At this time the aluminium concentration increased to very high levels, but data for the period September 2008 – February 2009 show large temporal variation.

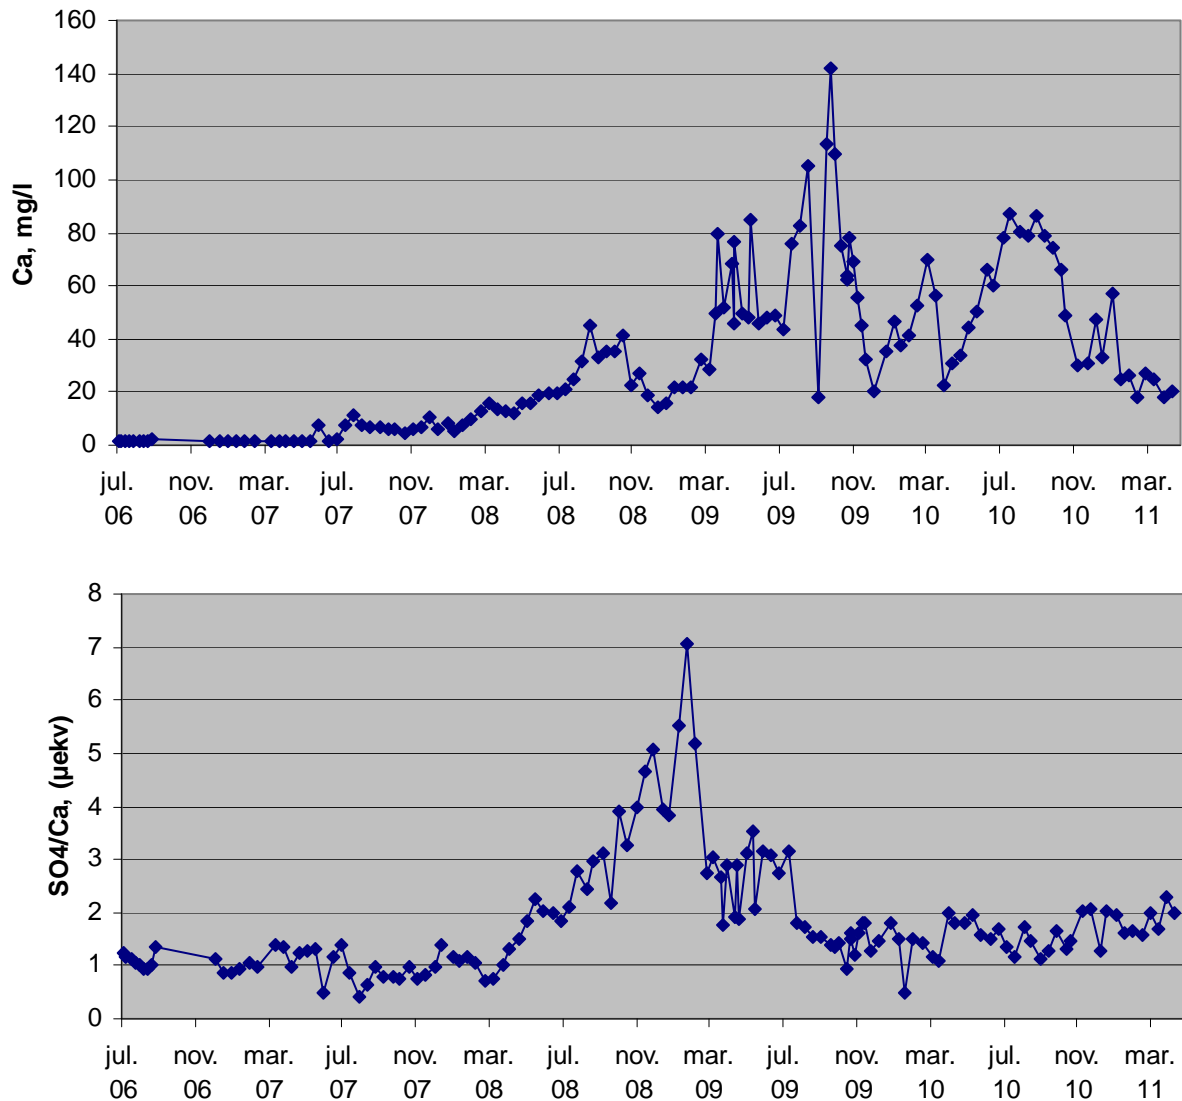
Figure 10. Outlet of Lomtjenn downstream of M17; calcium and the ratio sulphate/calcium on charge basis. A ratio close to one after the onset of the construction works indicates that sulphate is balanced by calcium due to addition of shell sand or other liming material.

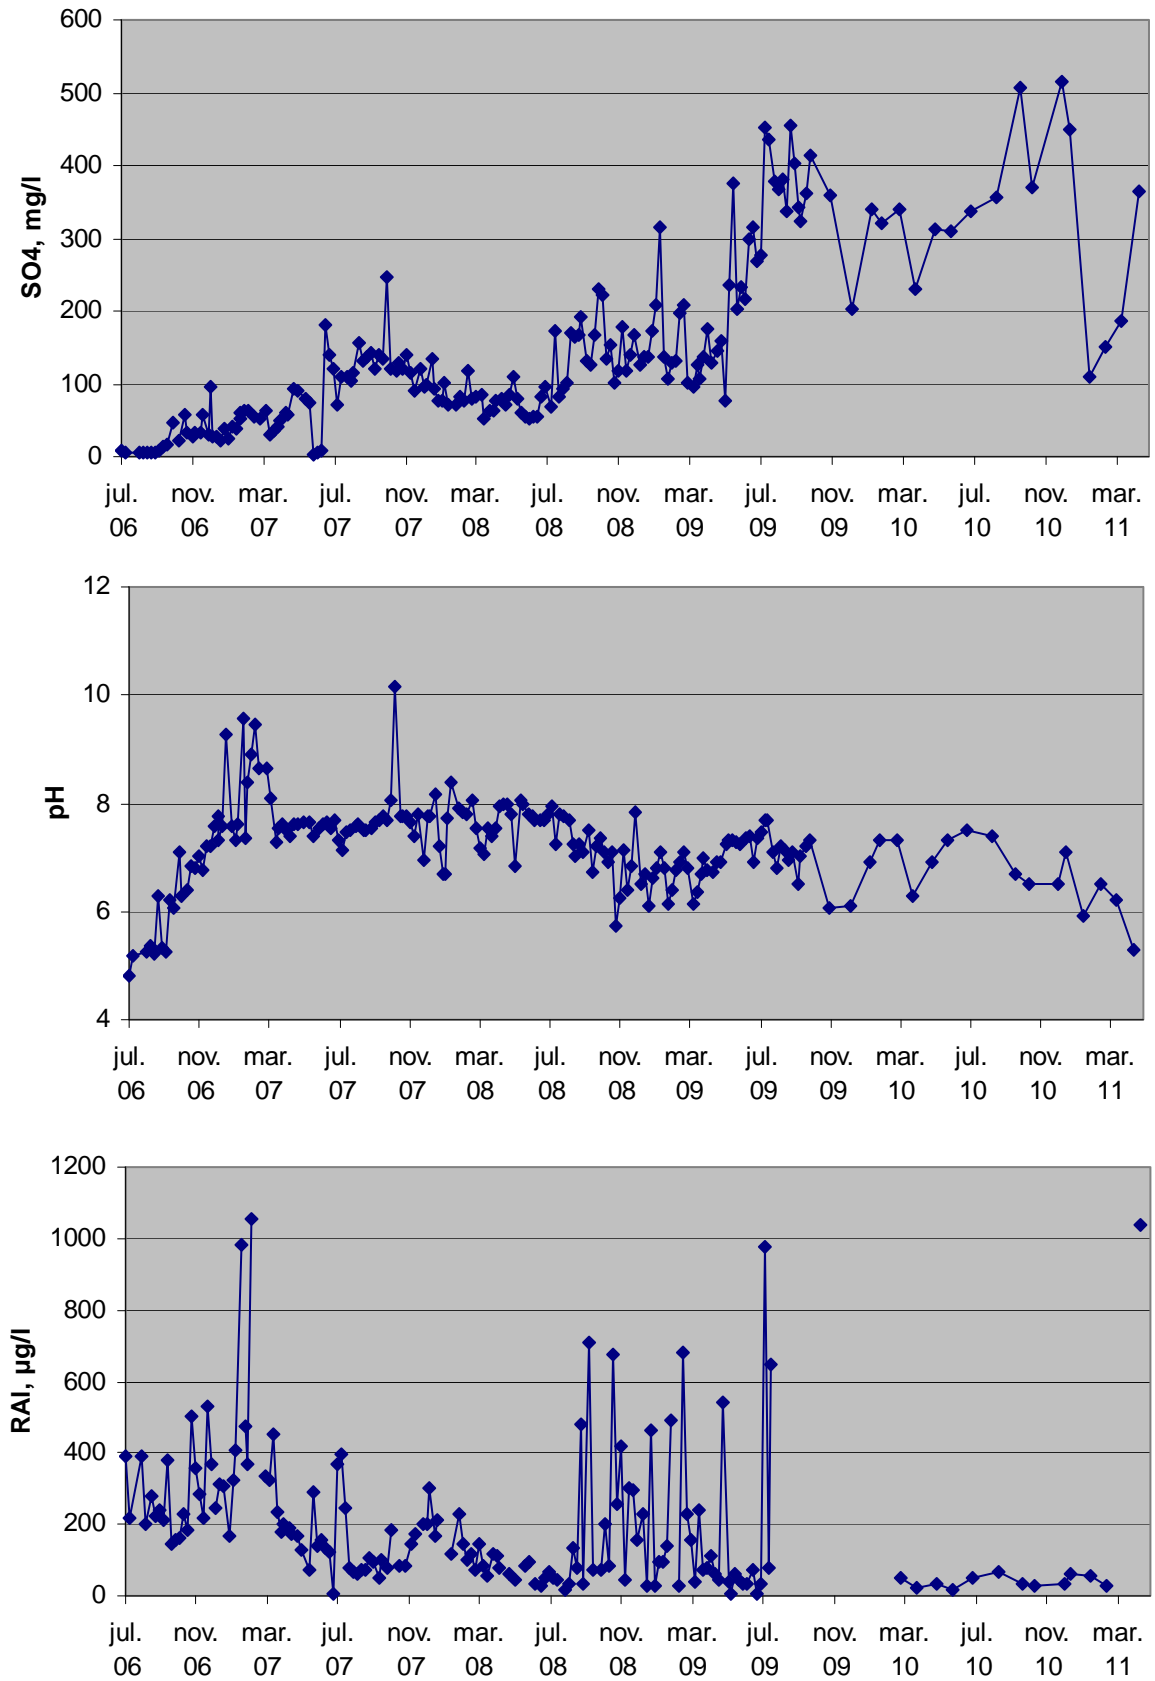
Figure 11. Inlet of Urevatn downstream of M20; Sulphate, pH and reactive aluminium.

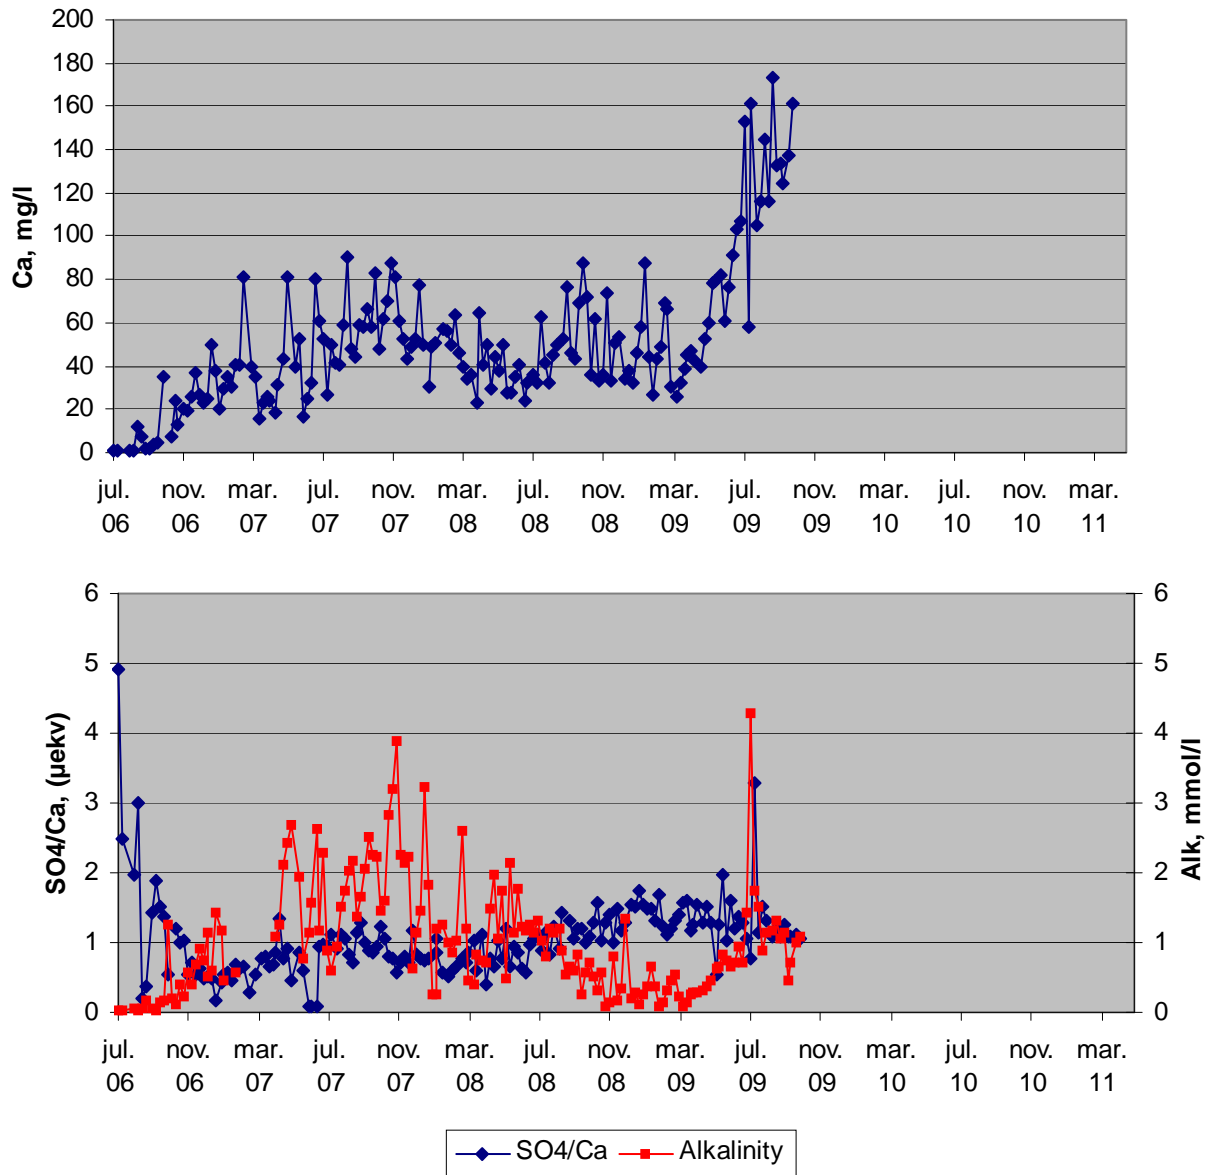
Figure 12. Inlet of Urevatn downstream of M20; Calcium and the ratio sulphate/calcium on charge basis. A ratio close to one after the onset of the construction works indicates that sulphate is balanced by calcium due to addition of shell sand or other liming material. Ca and alkalinity was excluded from the monitoring programme in October 2009.

At Urevatn the SO_4/Ca ratio started at 2-5 before the construction period, and the water was acid at the time. Then the ration decreased to below two in early autumn 2006 due to the addition of liming material at the deposit. From summer 2008 until the end of the calcium monitoring period the ratio stayed at 1-2. In the same time the alkalinity was high and pH acceptable.

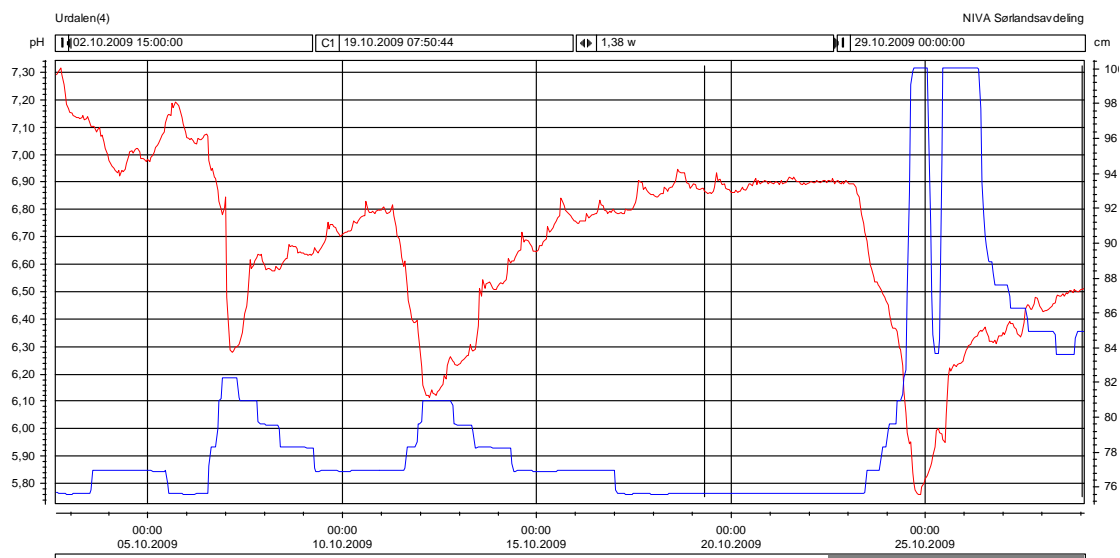
Figure 13. Continuous pH-readings (red line) and water level (step-wise changes) at the NIVA monitoring station in the inlet stream of Lake Urevatn in October 2009. The pH scale is from 5.8 to 7.3. pH drops when the water level, and thereby the water flow, of the stream increases.

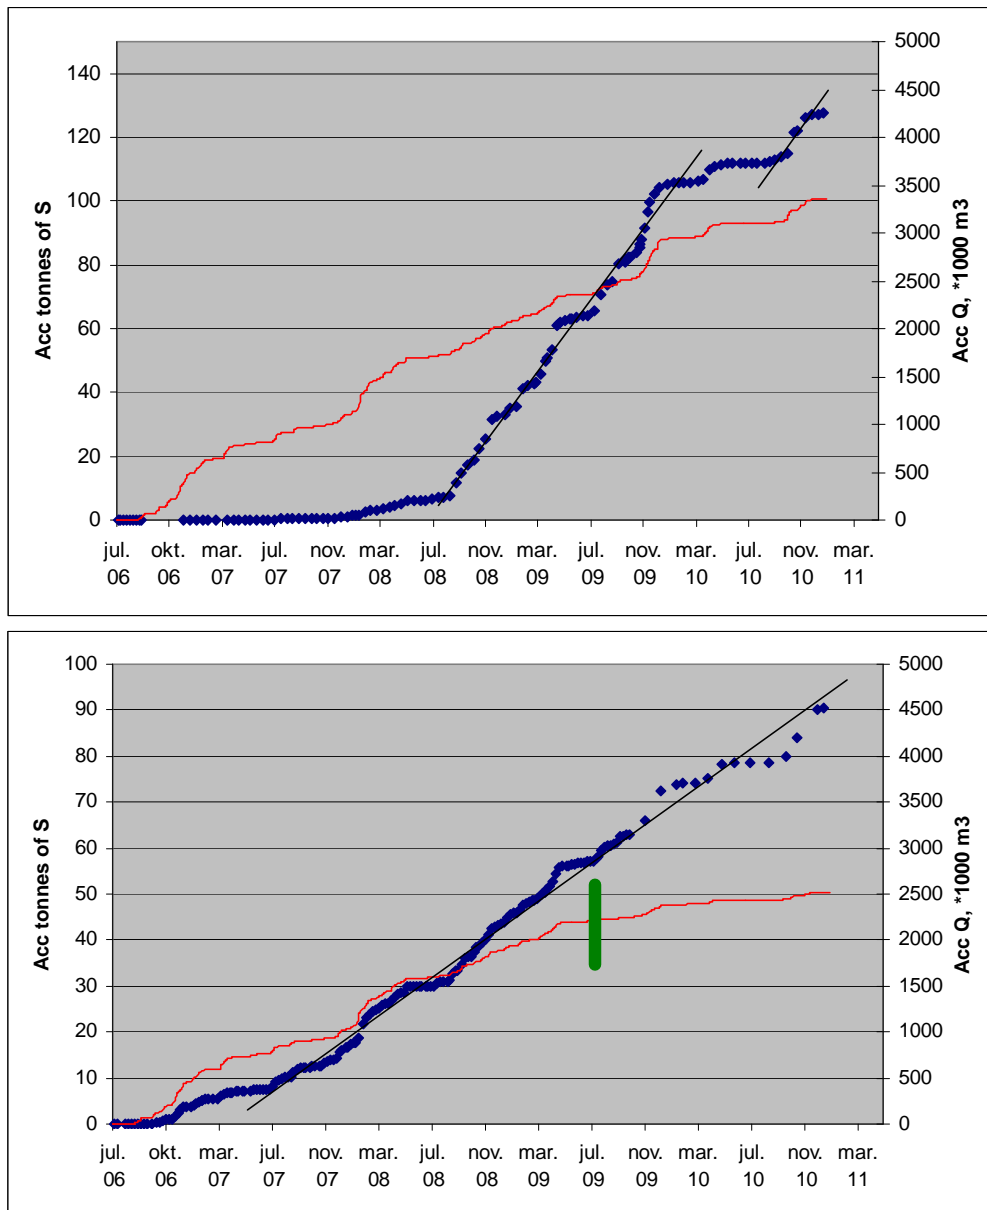
Figure 14. Accumulated net S-transport from M17 (upper) and M20 (lower). Lines are drawn for stable periods. Mean daily S-transport is calculated from the slope of these lines. Accumulated runoff for the catchments of the monitoring sites is also shown. The redirection of water from the upper catchment of M20 in summer 2009 is indicated with the green bar. The result is seen as a decrease in estimated runoff, but not in S-transport.

S-transport in terms of percent of S in the masses per year is about four times higher at M17 than at M20. There is no reason to believe that the masses of M17 are especially rich in sulphide content, and none of the deposits are covered as recommended by Fröberg and Höglund (2004), which make them open for incoming water and air. Relatively more shell sand has been used at M17 according to the figures in Table 1. About half of the shell sand at M17 was used in the dam construction, however, so the actual neutralising capacity of the rock pile itself has been as for M20. The reason for this large difference may therefore be due to other features, as suggested below.

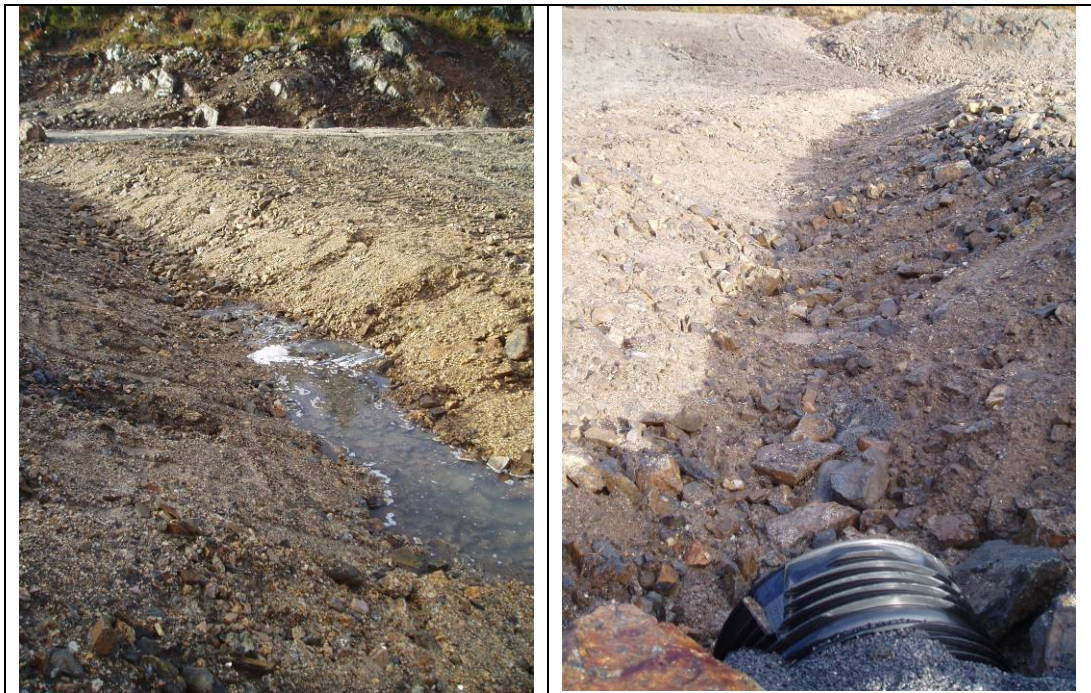
Figure 15. Open ditch across M17 on November 17, 2009. The stream in the picture to the left was supposed to cross the fill and enter the pipe in the picture to the right. Instead, it runs into the fill halfway over.

Third, although draining of water from the surrounding terrain was not very well carried out at either of the two deposits, draining at M20 is probably the most successful. Re-direction of 2/3 of the flow through the fill in summer 2009 had no apparent influence on the S-transport, however. At M17, all runoff that should go in open ditches on the sides and in an open ditch across the fill infiltrated back to

the fill (Figure 15). This resulted in good conditions for transport of weathering products to the stream water. Also at M20 a little stream that was supposed to run from a 0.1 km² side-catchment in east across the fill in an open ditch found its way down in the open fill halfway over the fill area.

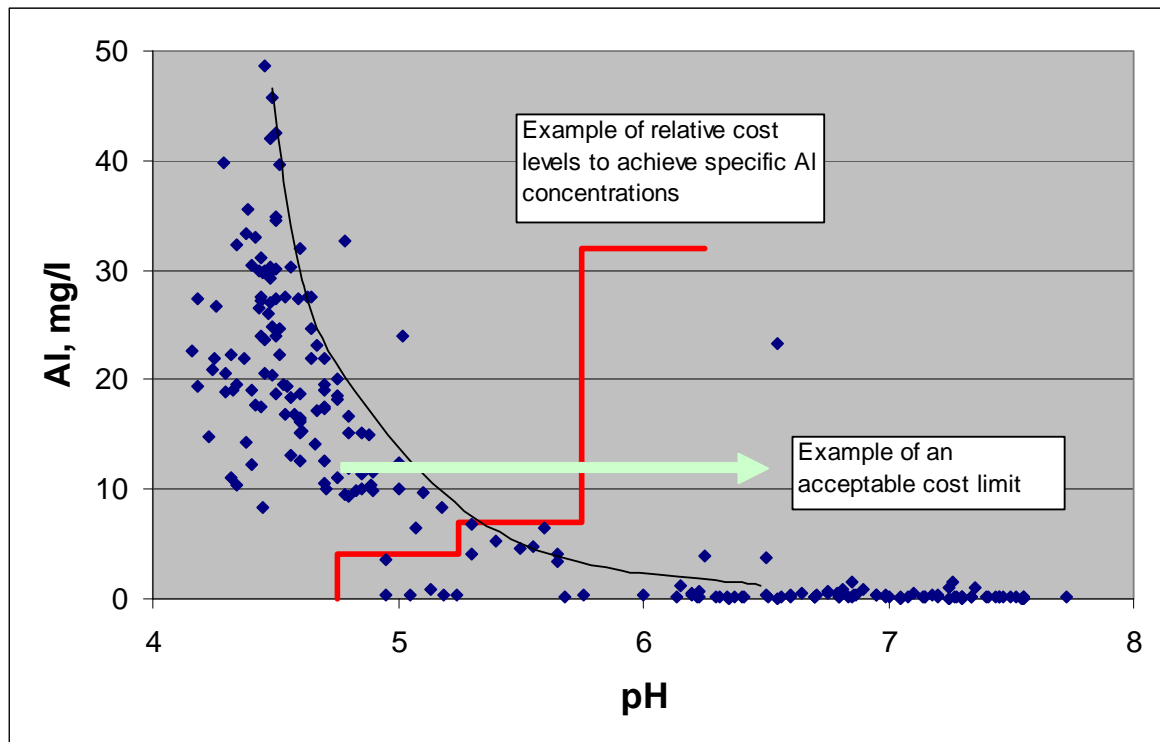
Figure 16. Principal sketch showing the relation between measured pH and aluminium concentrations (data not from M17/Lomtjenn). The black line, drawn by hand, is the operational Al-pH relationship, which will be the basis for cost evaluation. The red line is an example of relative cost levels for reducing pH, and thereby Al to specific concentrations. An acceptable cost limit should be established.

The sketch shows the effect on Al of increasing pH. The target Al-concentration could be the critical concentration for e.g. the sensitive brown trout (*Salmo trutta*), which is at 0.05-0.1 mg/l for the labile Al fraction (LAI). It could also be the Al-concentration which allows measures directly in the recipient. Lake Langedalstjenn is a good example here. NIVA did not recommend liming directly in the lake in 1992 (Hindar et al. 1992) due to very high Al-levels (several milligrams per liter), and fear for a green lake after substantial Al-precipitation. As the Al-concentrations decreased significantly over 15 years and down to about 0.5 mg/l, NIVA suggested liming. Successful liming was carried out. In this case Al at 0.5-1 mg/l represented a target concentration, which made it possible to take the last step towards the critical Al concentration for brown trout.

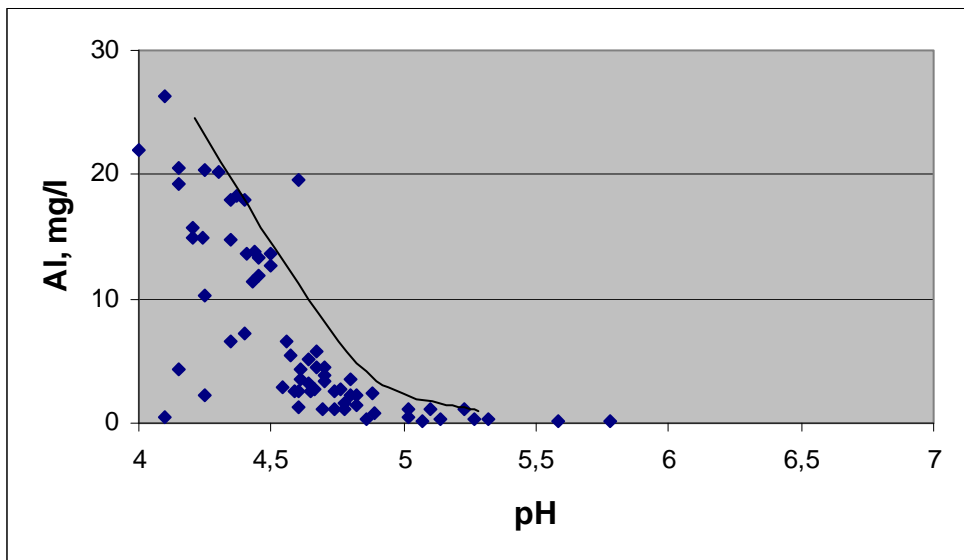
Figure 19. The Al-pH relationship at the outlet of Lake Lomtjenn during and after the construction period. The black line is drawn by hand, and indicates an operational Al-pH relationship. If a certain pH is reached, Al will probably not be higher than indicated by the line.

According to Figure 19, pH below 4.5 may result in Al higher than 15 mg/l. This is not sustainable. At the present accept limit of pH 4.7 from the discharge permit, Al may still be up to 6 mg/l. 1 mg Al/l has been measured for water with pH 5.2.
