# Repeated environmental baseline survey at AF Miljøbase Vats in conjugation with the Ekofisk cessation EPRD project

**Repeated environmental baseline survey at AF  
Miljøbase Vats in conjugation with the Ekofisk  
cessation EPRD project**

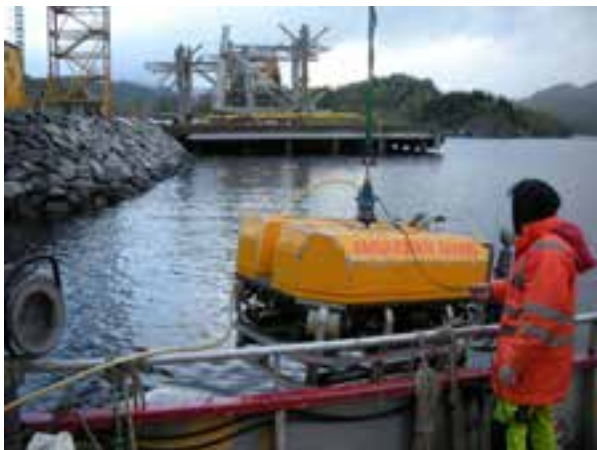
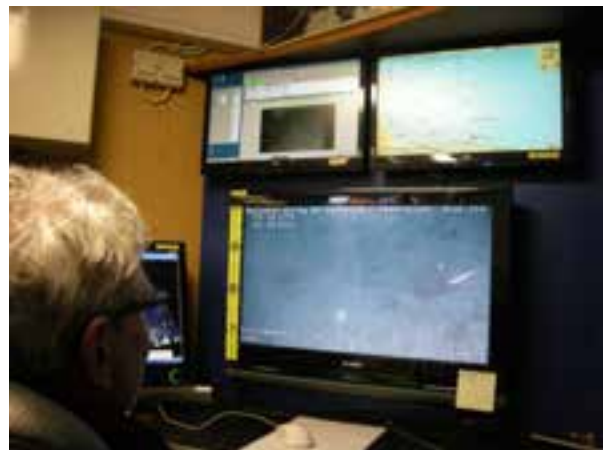
Figure 4: Left: The ROV from Amundsen which was used during the registrations 26.-27. May 2015. Right: The control room of parent vessel MS Scuba where the ROV pilot sits and where the recordings and records were made.

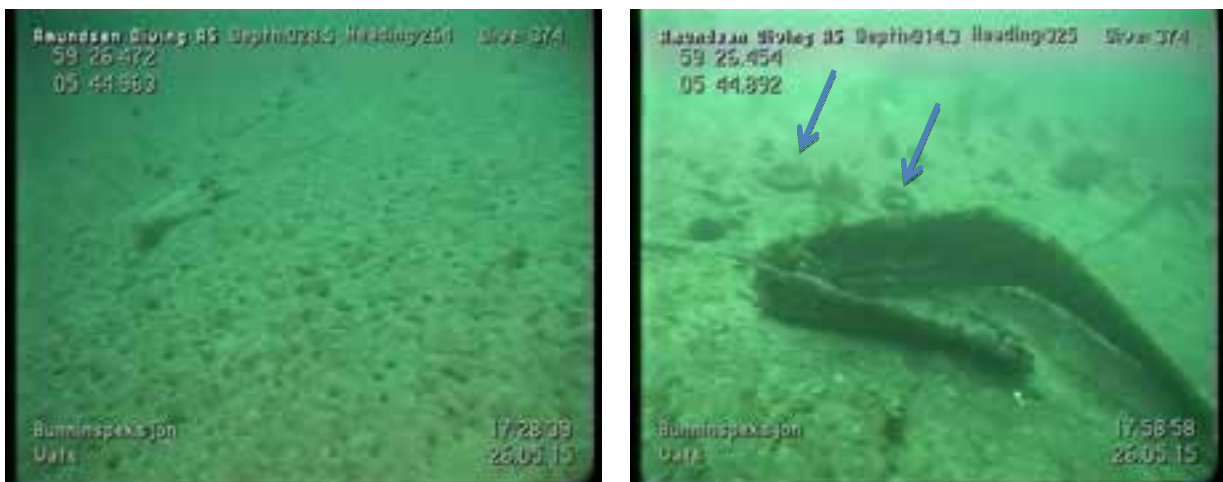
Generally in both areas, the seabed was in a 'living bottom' condition status. In both areas, we encountered holes and traces of benthic animals on the sediment surface (Figure 5).

Figure 5: Left: Many holes and grooves in the bottom indicate a live bottom. Here at ca. 30 m depth in the area north of the main quay. Right: A piece of corrugated iron and in the background tires (arrow) can be seen. The picture is taken from ca. 15 m depth in the area north of the main quay. Relatively many tires were observed at approximately 10-15m depth in this area.

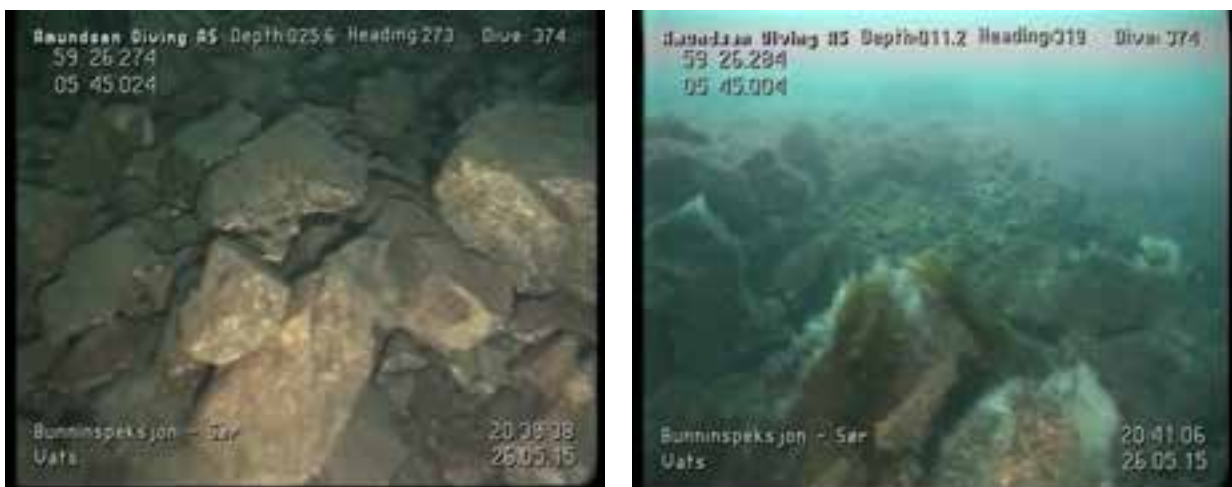
However, there was relatively little degree of fouling to be found on the rocks and boulders on the seabed. This was especially the case in the slightly deeper areas of Grønavika south of the quay where the seafloor was filled with a lot of rocks (Figure 6). In the upper 10-12 m we found scattered occurrences of sugar kelp and commonly occurring threadlike brown algae (Figure 6). A few places, dense occurrences of large hydroids were observed. And in the shallow part of this area, quite a lot of small wrasse fish were observed along the shoreline. We also saw a number of gadoid fish individuals, these were most probably saithe. It is a general challenge to estimate the actual density of fish at a location as based on ROV filming since it is likely that the same fish will be recorded several times during the filming.

Figure 6: The pictures show the area south of the main quay which was scattered with large rocks and boulders. Left picture show rocks at 26 m depth with only little algal fouling. Right picture: at approx. 11 m depth there was with significantly more fouling present, in particular sugar kelp and hydroids as can be seen on the rocks in the foreground.

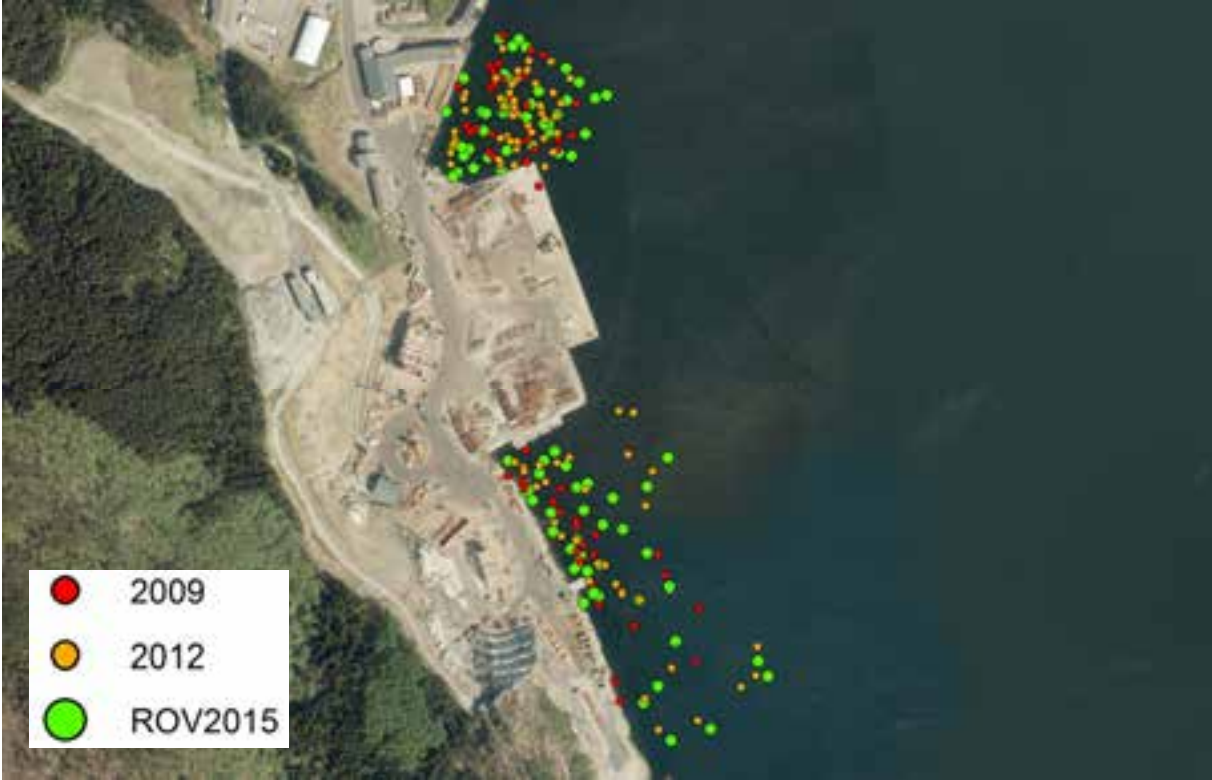
Figure 7: This overview picture shows the positions of all anthropogenic materials that have been registered and positioned during the ROV surveys conducted in 2009, 2012 and 2015.

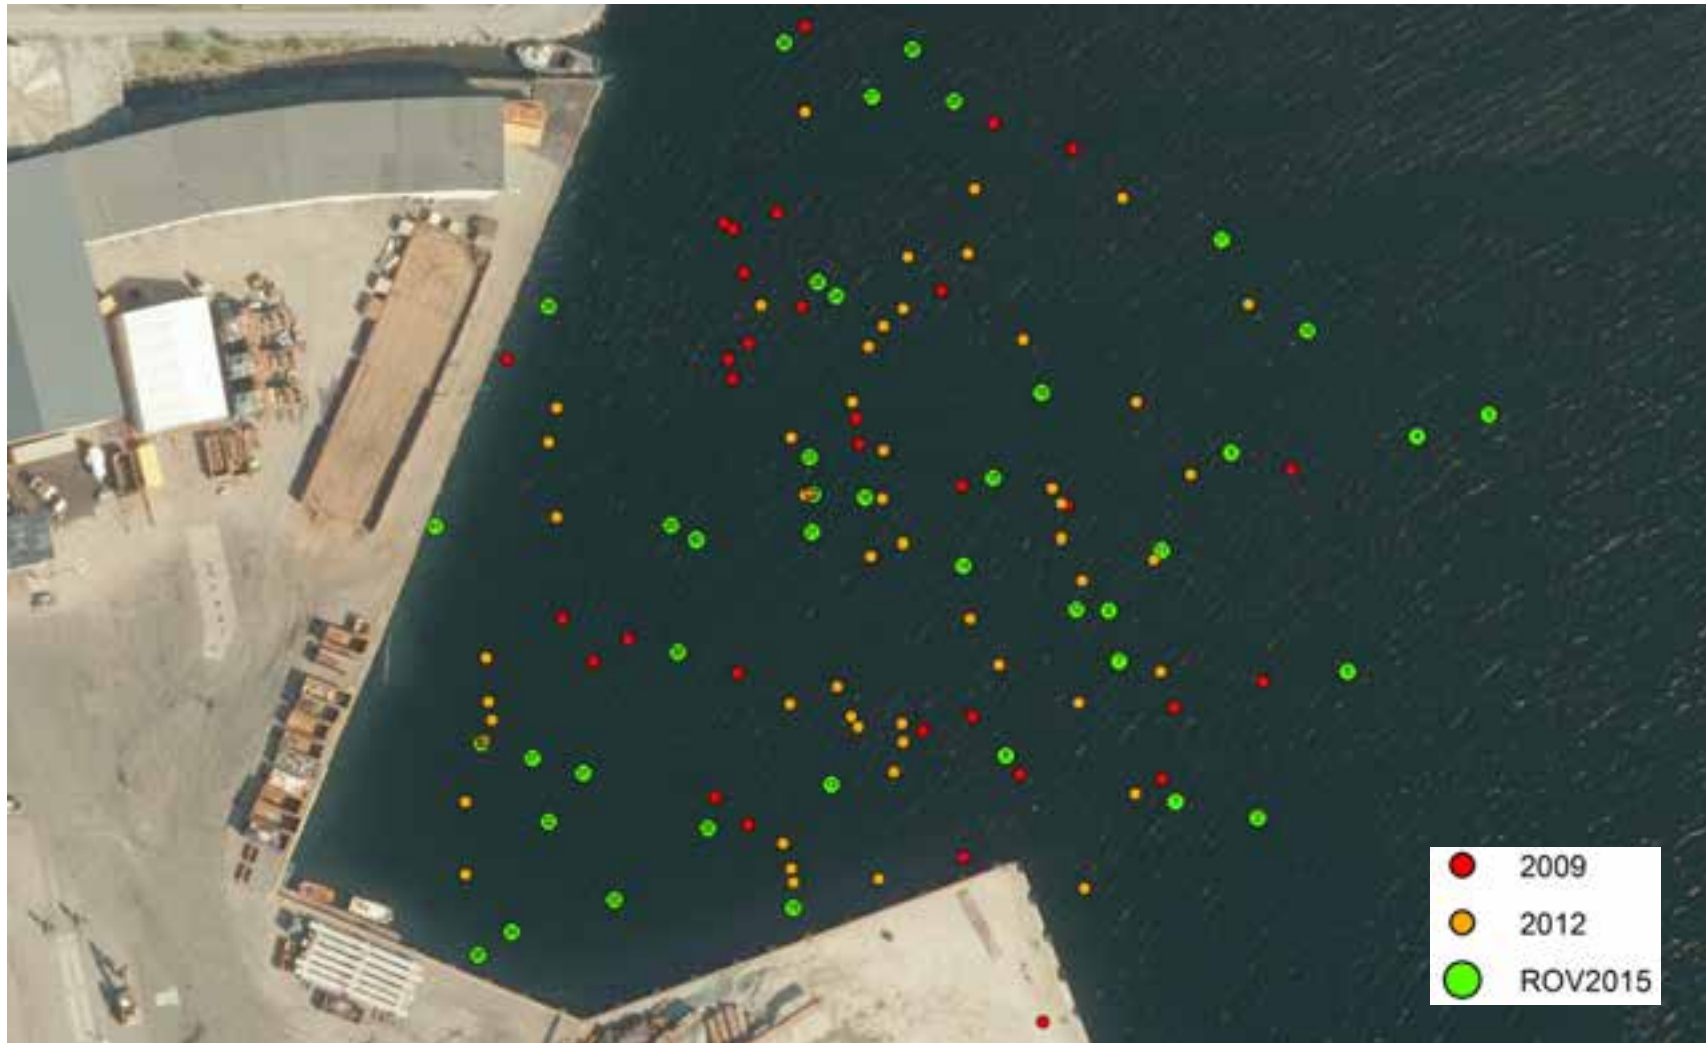
Figure 8: This picture shows the positions of all anthropogenic materials that have been registered and positioned in the area Raunesvika (north of the main quay) during the ROV surveys conducted in 2009, 2012 and 2015. For data registered in 2015, each individual debris object is given a ID number which also is referring to the observations summarised in Table 2.

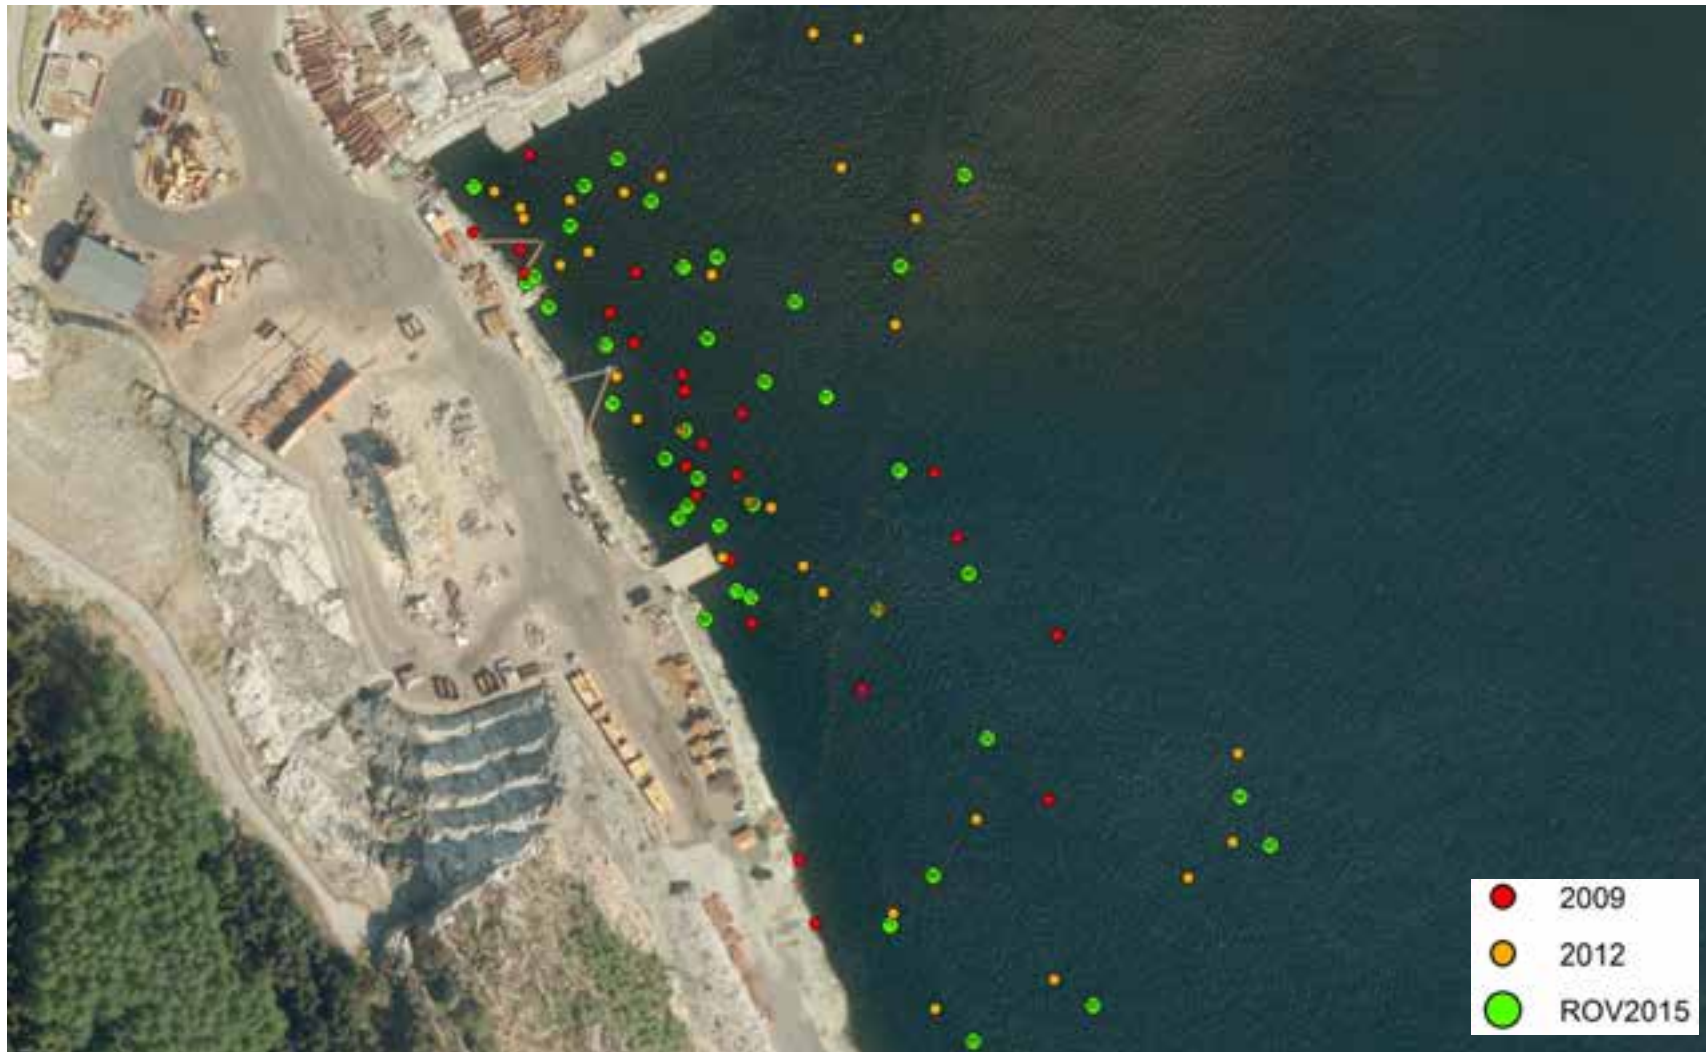
Figure 9: This picture shows the positions of all anthropogenic materials that have been registered and positioned in the area Grønnavika (south of the main quay) during the ROV surveys conducted in 2009, 2012 and 2015. For data registered in 2015, each individual debris object is given a ID number which also is referring to the observations summarised in Table 2.

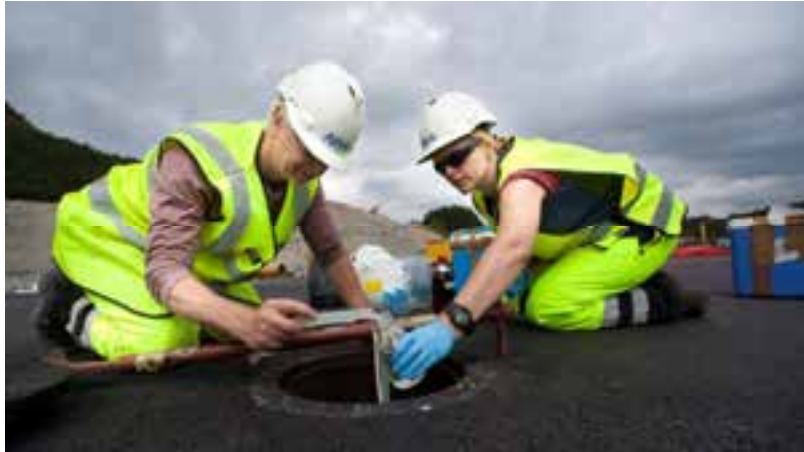
Figure 10: Groundwater samples from four wells in the quay deck are collected for analysis of contaminant levels.

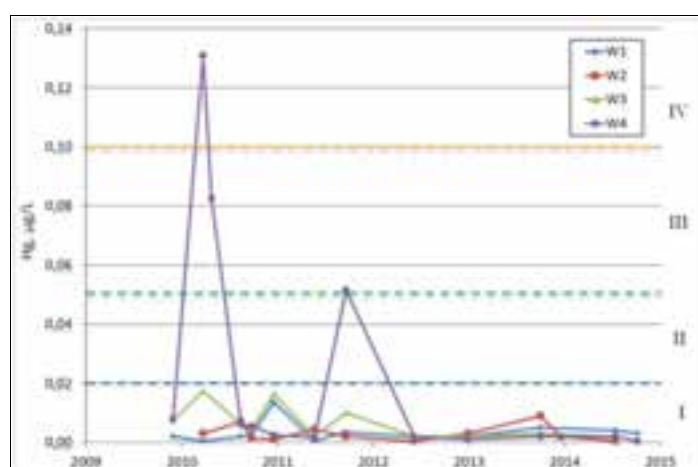
Water samples from the four wells at AFEV have also been analyzed twice a year throughout the period 2009 – 2014, in connection with the environmental monitoring program of the facility. A relevant finding from those analyses was a few observations of temporarily increased contamination level early in the monitoring program, e.g. for mercury (Figure 12). These results indicated that there were occasional leakages of contamination into the well water early in the monitoring program, and this was explained as most likely being caused by with improper sealing at the wells where the contamination was found. For example, some insulating plates from the lids of the wells were observed to have fallen into the wells. After better sealing of the wells was implemented, only low levels have been found after 2012, as can be seen in Figure 12.

Figure 12: Time trend of Hg levels in water samples from the groundwater wells at AFEV during the period 2010 – 2014 (data from the environmental monitoring program at AFEV).

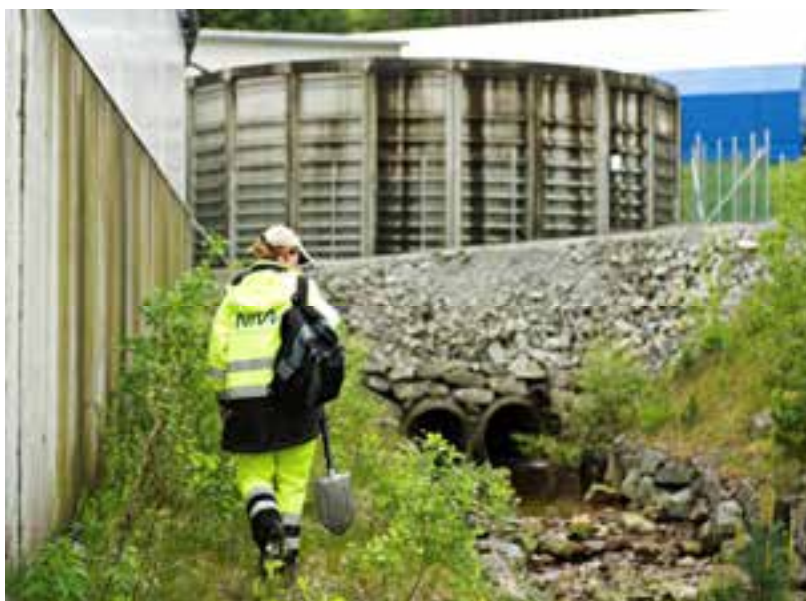
Figure 13: Collection of soil samples was done from two positions within the narrow brim located between the Raunes River and the wall at the north end of the AFEVBV area.

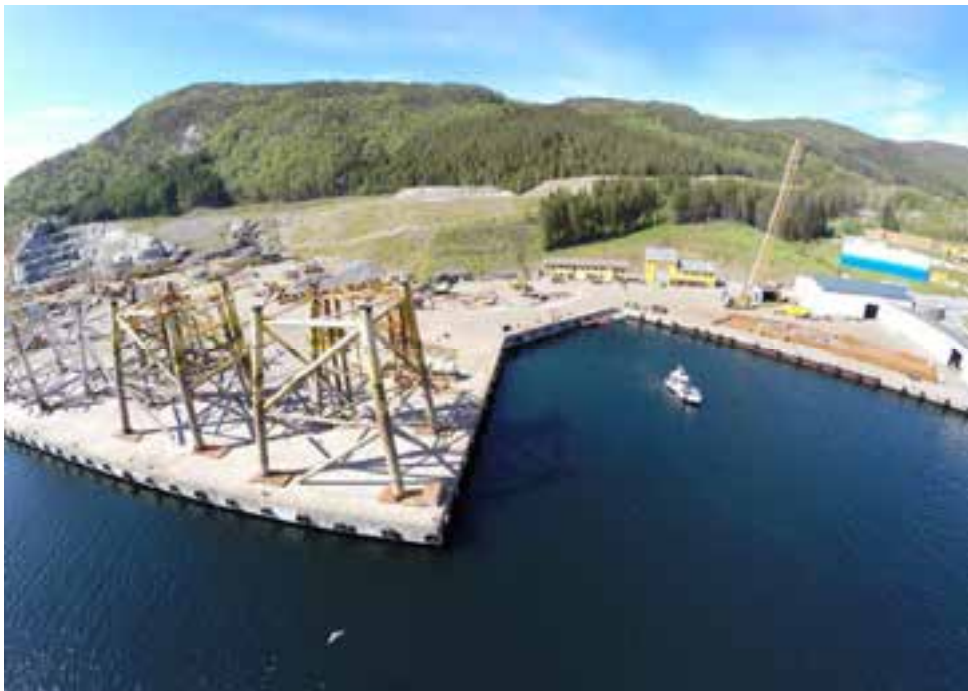
Figure 14: Drone picture from the sediment collection in Raunesvika in 2015, with the boat located approximately over the Raunes 2 sediment station.
