Integrated Water Resources Management in Myanmar Ecological Status of Rivers, Lakes, and Reservoirs

Title Integrated Water Resources Management in Myanmar Ecology of Rivers, Lakes, and Reservoirs	Serial number 7855-2023	Date 20.04.2023
Author(s) Andreas Ballot Marit Mjelde	Topic group Freshwater biology	Distribution Open
Tor Erik Eriksen Johnny Håll Cathrine Brecke Gundersen Hans Fredrik Veiteberg Braaten	Geographical area Myanmar	Pages 33 + attachments

Ecology of Rivers, Lakes, and Reservoirs

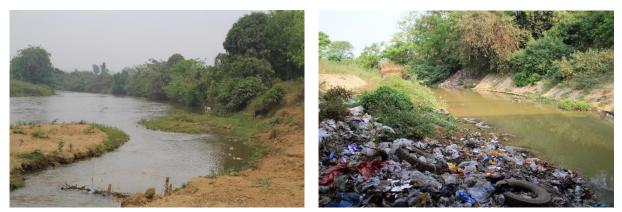
Figure 2. Tributary to Bago River (left) and Mazin Chaung in Bago centre (right). Photos: T.E. Eriksen.

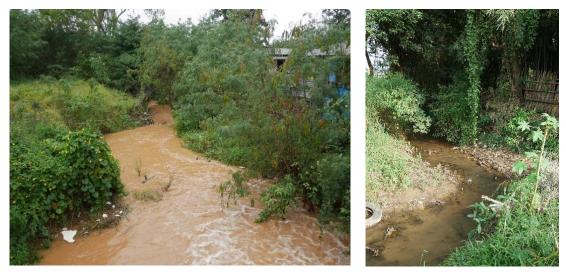
Figure 4. Two nameless tributaries to Inlay Lake. Photos: T. E. Eriksen.

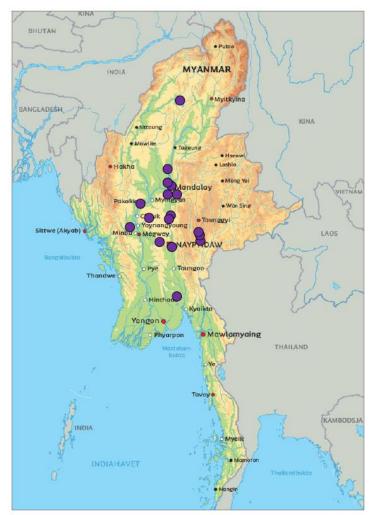
Figure 5. Lakes and reservoirs investigated in Myanmar in the period 2014-2020 (overview map from www.albatross-travel.no).

Altogether 17 lakes and reservoirs were selected in different regions in Myanmar and investigated once or multiple times at one or several sampling points in the period 2014 -2020 (**Table 1, Figure 6**). The investigations comprised physical-chemical parameters (e.g., temperature, pH, oxygen, conductivity, turbidity, ammonium, total nitrogen, total phosphorous, soluble reactive phosphorus, total organic carbon, calcium, and silicate) and biological parameters (phytoplankton and aquatic macrophyte abundance and composition) (as recommended by Mjelde et al., 2017). In addition, the presence of cyanobacteria and cyanotoxins was investigated. Water samples were analysed for the presence of hepatoxic cyanotoxins: microcystins and cylindrospermopsins, and neurotoxic saxitoxins and anatoxins and for the isolation and culturing of potential toxin producing cyanobacteria. The water samples and the cultured cyanobacterial strains were investigated with ELISA and liquid chromatography–mass spectrometry (LC–MS).

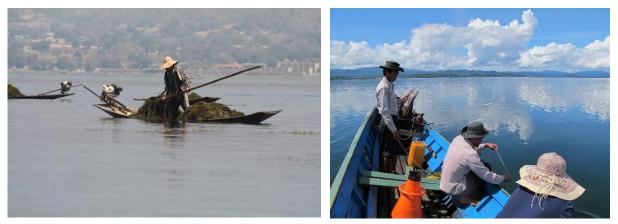
Figure 6. Macrophyte harvesting at Inlay Lake (left) and water chemistry sampling at Indawgyi Lake (right). Photos: A. Ballot and M. Mjelde.

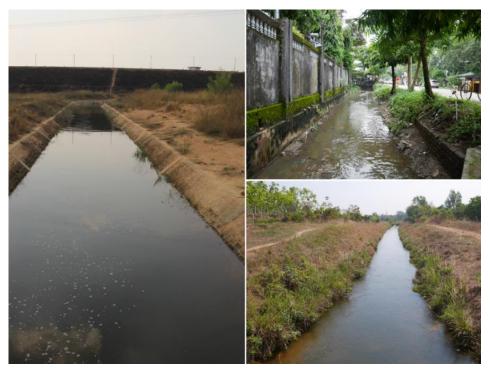
Figure 8. Hydromorphological alternations in Bago (Sittaung River catchment). Photos: T. E. Eriksen.

In the Bago sub-basin, the hydromorphology across the river network ranged from pristine rivers with no evidence of modifications, to very degraded river reaches. Overall, most river reaches assessed showed relatively little hydromorphological alternation. The main pressures of rivers in terms of

hydromorphology are the presence of dams upstream, embankments and extensive loss of riparian vegetation. The least degraded rivers are found in the upper part of the river networks. In and around Bago City, most river reaches have been physically modified to some degree and the most impacted rivers are found here (**Figure 8**). However, even in populated areas, river reaches can be found that are still in an acceptable condition regarding hydromorphological alternations.

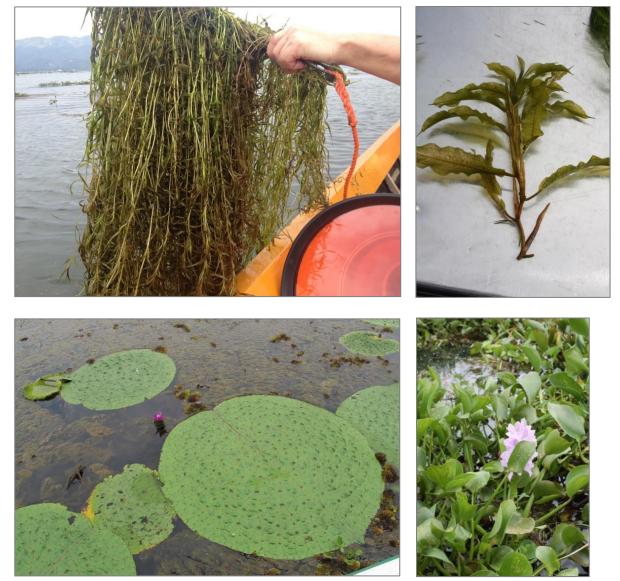
Figure 13. Two of the dominating submerged species in Inlay Lake; *Nechamandra alternifolia* (upper left) and *Potamogeton lucens* (upper right). The floating-leaved *Euryale ferox* (lower, left) was only recorded in Indawgyi Lake. The invasive *Eichhornia crassipes* (lower, right) was the most common macrophyte in lakes and reservoirs in Myanmar. Photos: A. Ballot and M. Mjelde.

Altogether, 44 species (including hybrids) of aquatic macrophytes (submerged, floating leaved and free-floating species) were recorded in the lakes (Ballot et al. 2018, Mjelde & Ballot 2016, Mjelde & Wathne 2015, Mjelde et al. 2018, Mjelde et al. 2020, Swe et al., 2021, and unpublished data) (**Figure 11**). Highest biodiversity was found in the two largest natural lakes, Inlay Lake (27 species, Swe et al., 2021) and Indawgyi Lake (21 species, Mjelde et al., 2018a), and in Moeyingyi Reservoir (18 species, Mjelde & Wathne 2015, Mjelde et al., 2016). The hypereutrophic Kantawgyi and Taung Taman lakes in the middle of Mandalay city typically had very low biodiversity, dominated by free-floating species (unpublished data) (**Figure 13**).
