# Water resources management in Tanzania

Pangani river catchment

Report Title: Water resources management in Tanzania-Pangani river catchment	Date: August	Printed: NIVA 1995
	Topic group: International activities	
Author(s): Kjersti Dagestad Leif Lien	Geographical area: Tanzania	Pages: 124
	Edition: 35

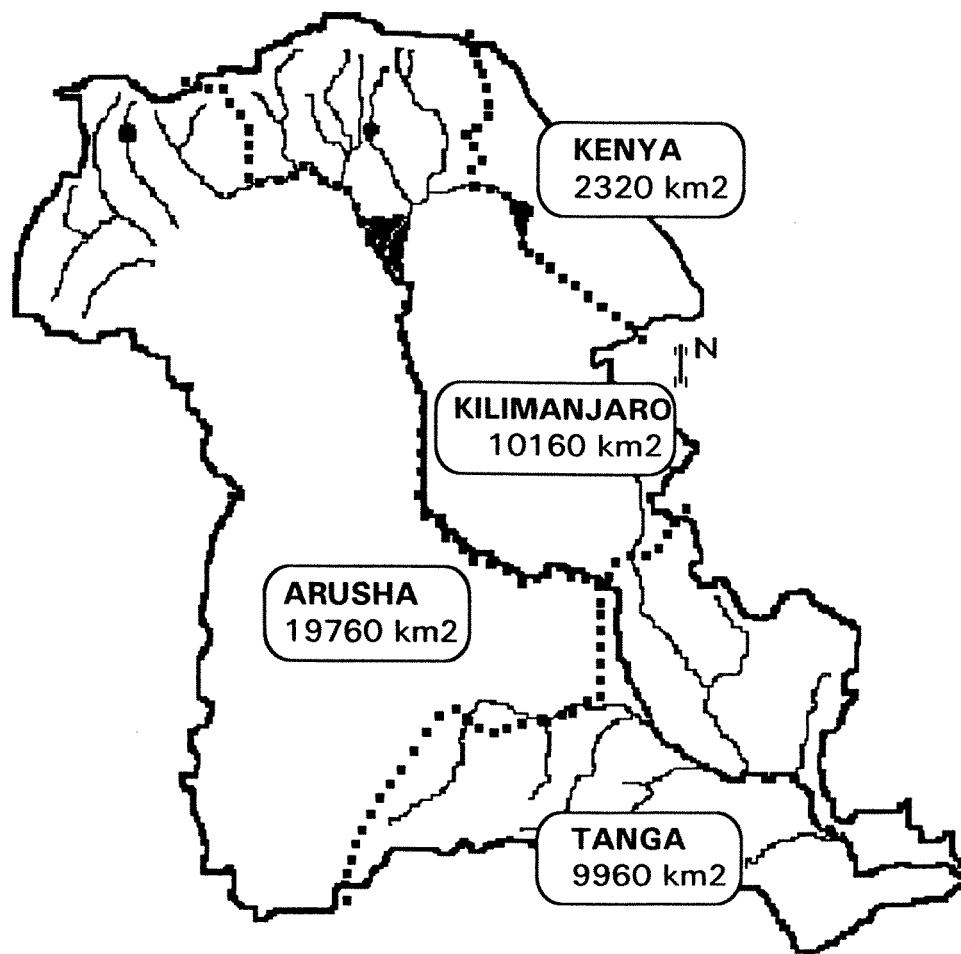
Figure 2: Pangani River's sub catchments

Figure 1 shows the catchment area to Pangani river. A detailed description of the upper parts of the catchment area is given in figure 3. The catchment covers three regions; Kilimanjaro, Arusha and Tanga. A small part is located in Kenya. The total catchment area in the different regions is shown in figure 2.

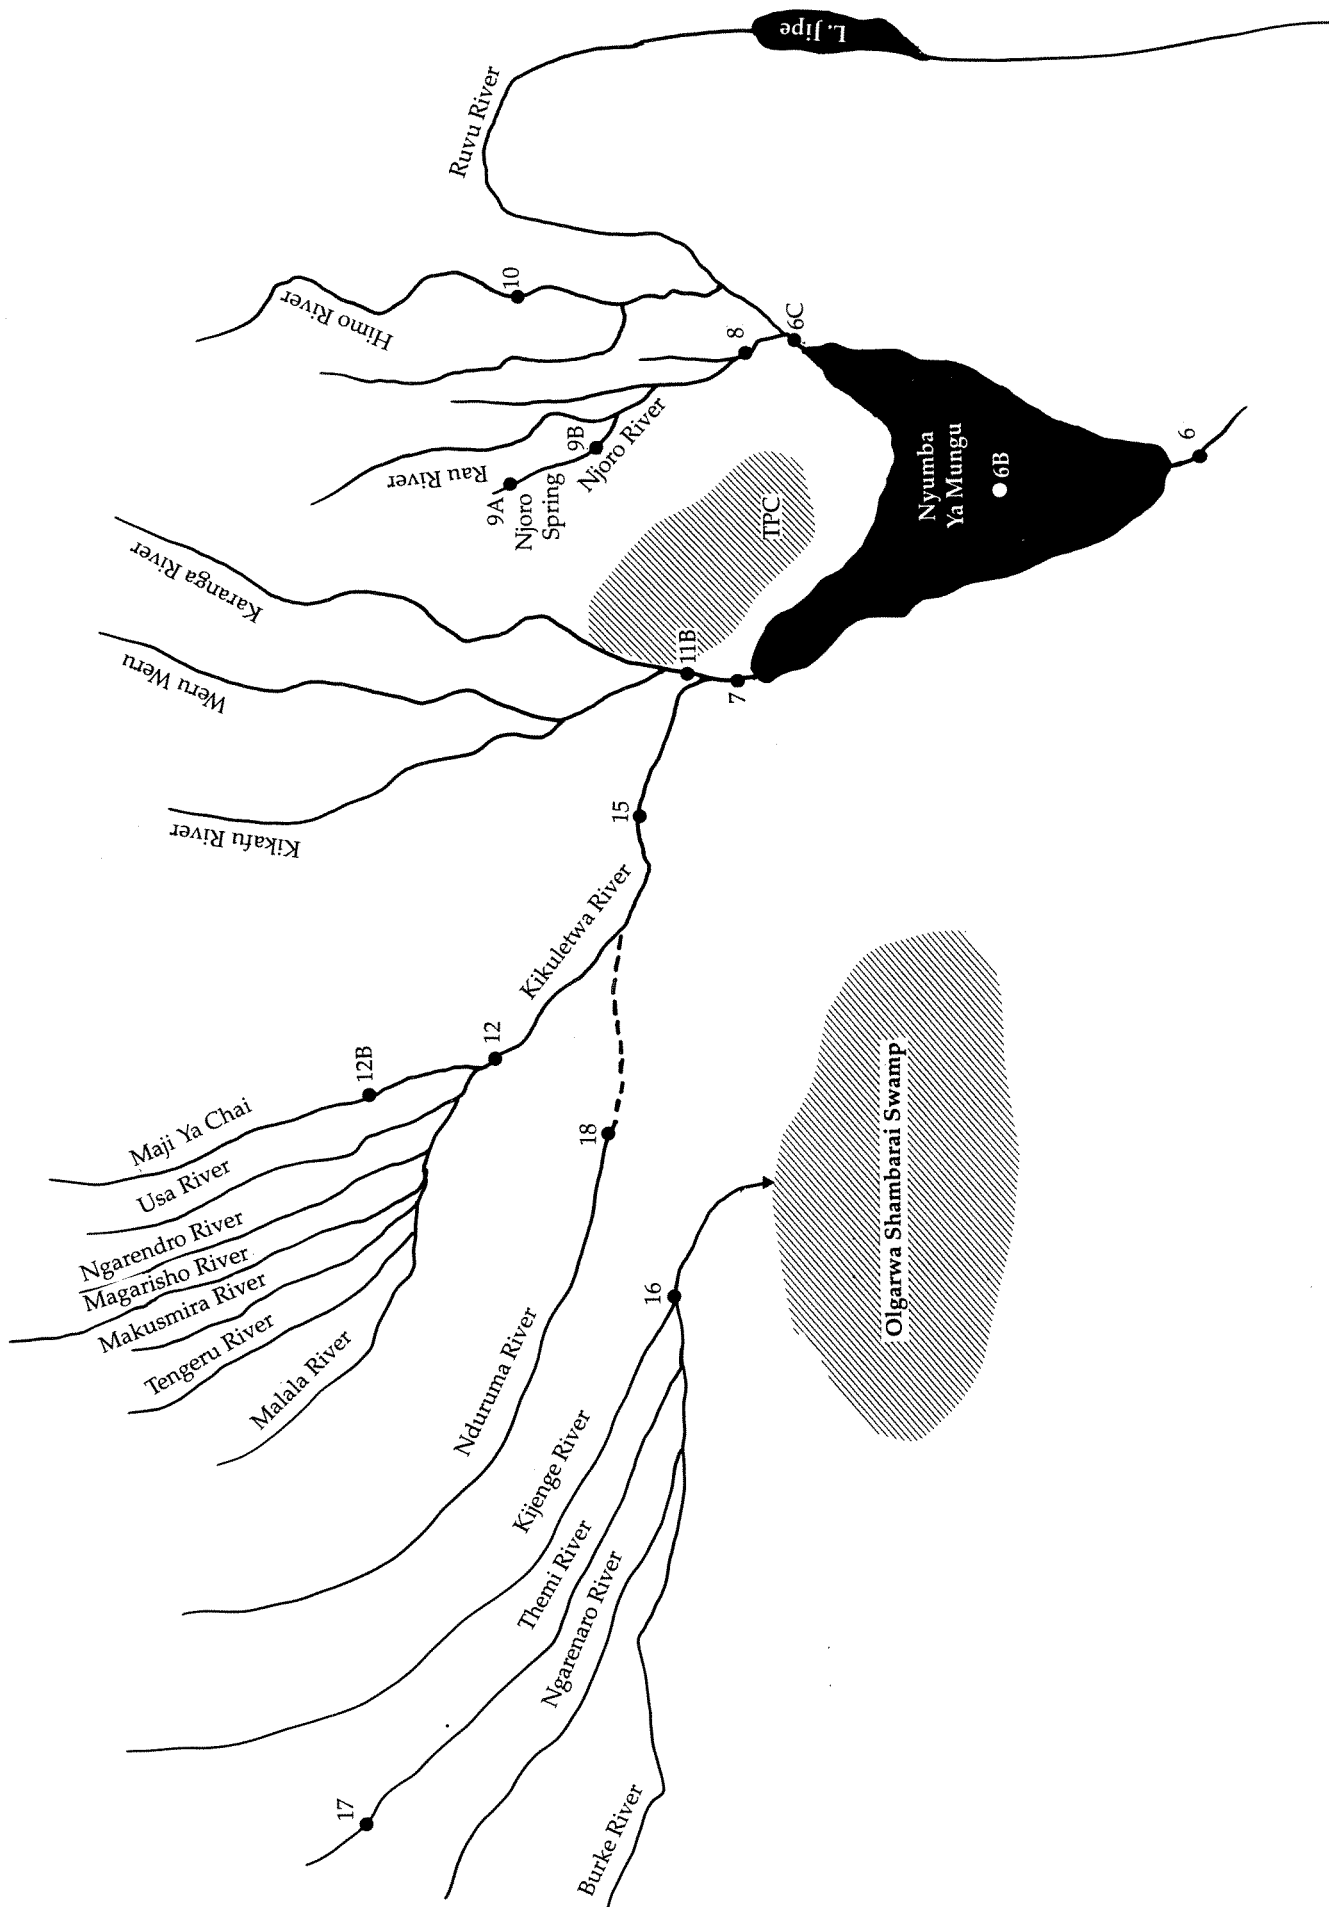
Figure 3: Water resources in the upper parts of the catchment area to Pangani River

There are two main swampy areas within the catchment to Pangani river, the Kirua and the Oligarwa Shambarai Swamp. The Oligarwa Shambarai Swamp is situated upstream NyM, and extents from Arusha to the Kilimanjaro area. Kirua swamp is located downstream NyM, and regulate the floods in Pangani river. The evaporation from the swamps is very high.

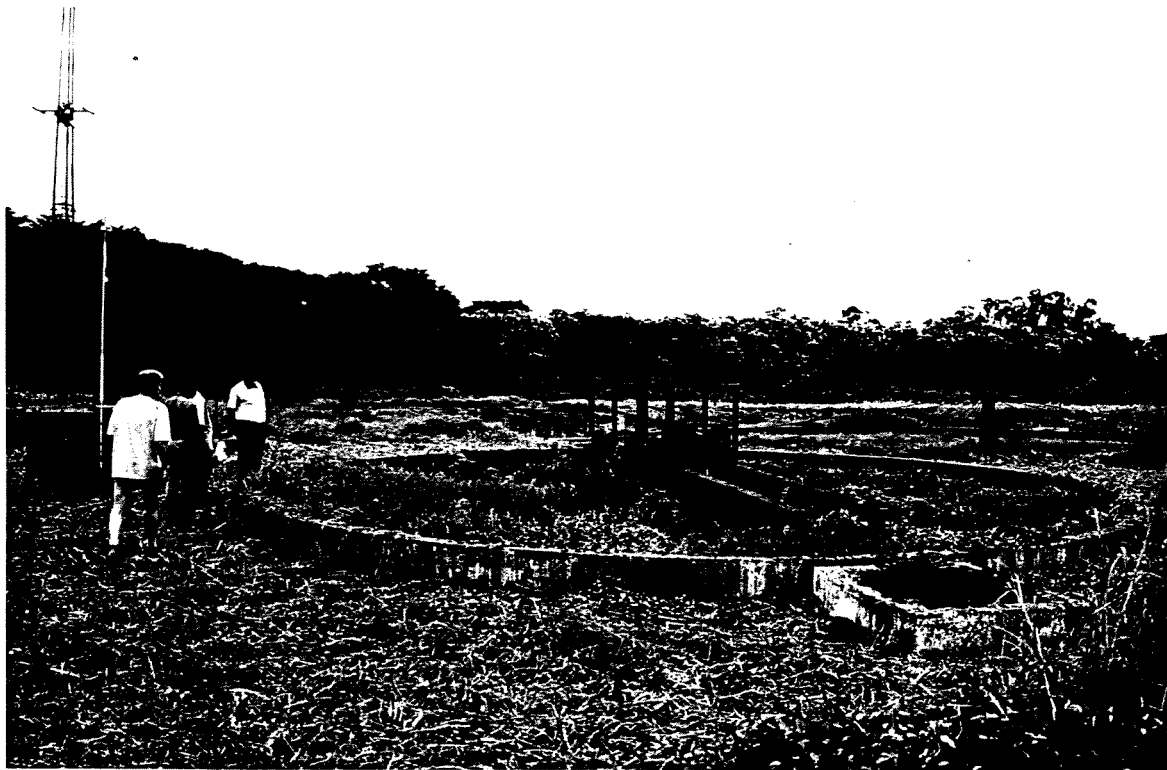
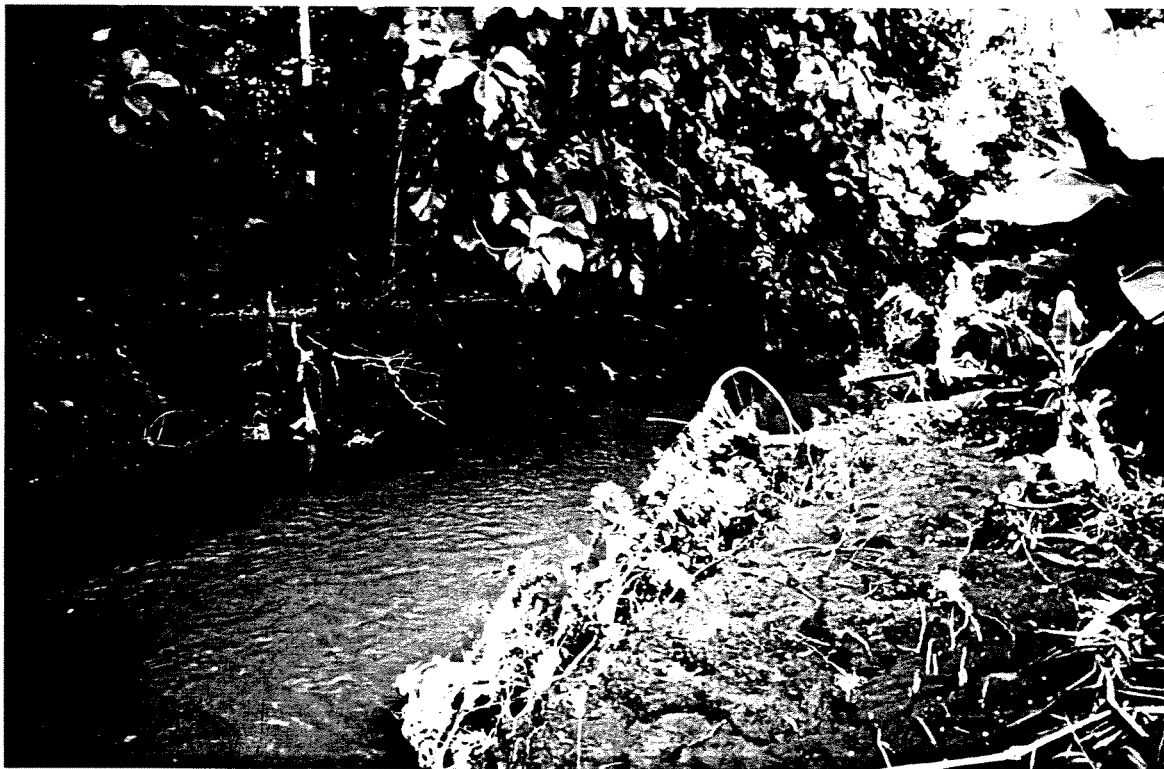
Figure 4: The old treatment plant in Moshi, with overgrown ponds and outlet of sewage to Njoro river.

A municipal dumping site with both municipal and industrial waste mixed together is located in the same area as the municipal sewage outlet in Moshi town. Leakage from this dumping site, draining to Njoro river, probably contain a lot of harmful waste including heavy metals and organic micro pollutants.

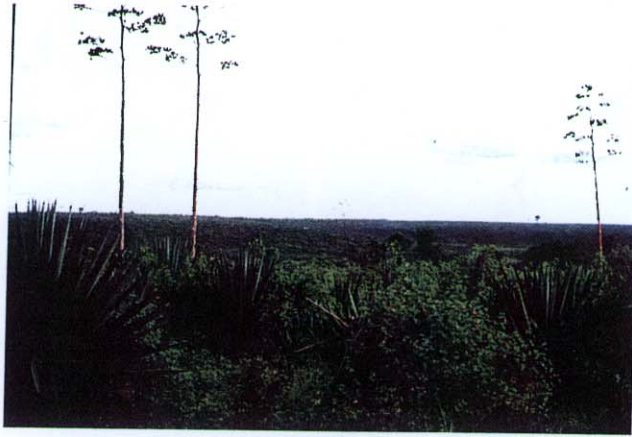
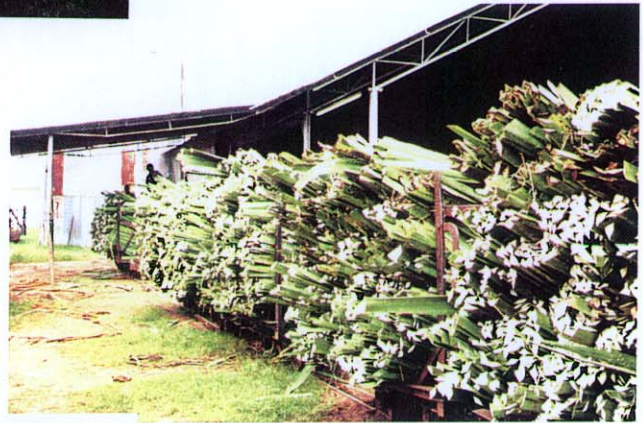
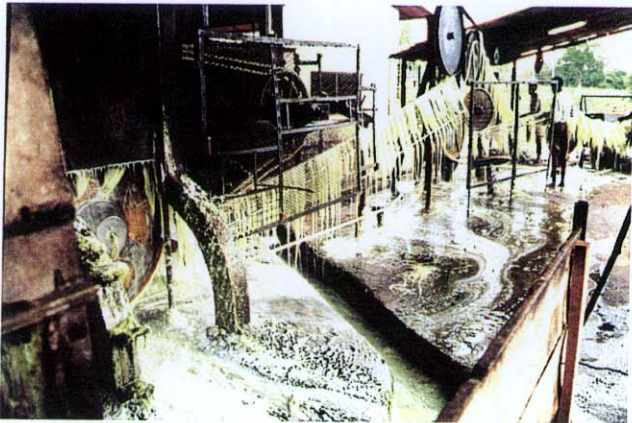
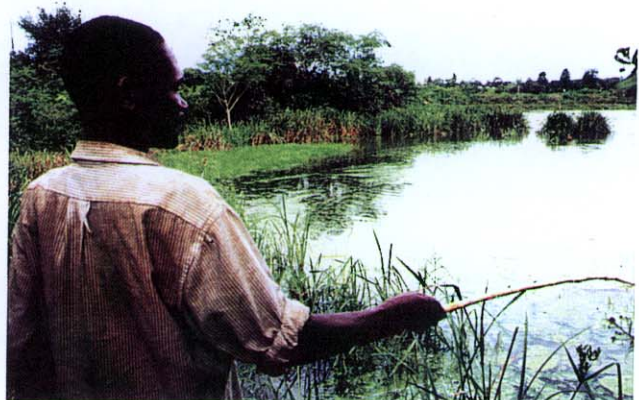
Figure 5: Growing and production of sisal at Kwamdulu sisal estate

(1. the sisal plant with the stem, 2. Sisal leaves, 3. washing of sisal, 4. the third pond before the outlet to Pangani River)

Kwamdulu was visited during the mission, and total monthly production of fibre on the estate is 140 tonnes. The sisal juice, which was very greenish, was drained to a dumping area where the liquid portion was discharged to a pond. The outlet from the first pond lead to a second pond and then to the last and third pond. A visit to the third pond demonstrated a water body with 5 species of fish (3 tilapia and 2 "cat fish"). Herons, fishermen and earlier observed crocodiles did also indicate a functioning (eco-) system. The outlet of water from the third pond visually gave an impression of clear water. However blue green algae were floating on the pond and the outlet bed had some aufwuchs (see figure 5).

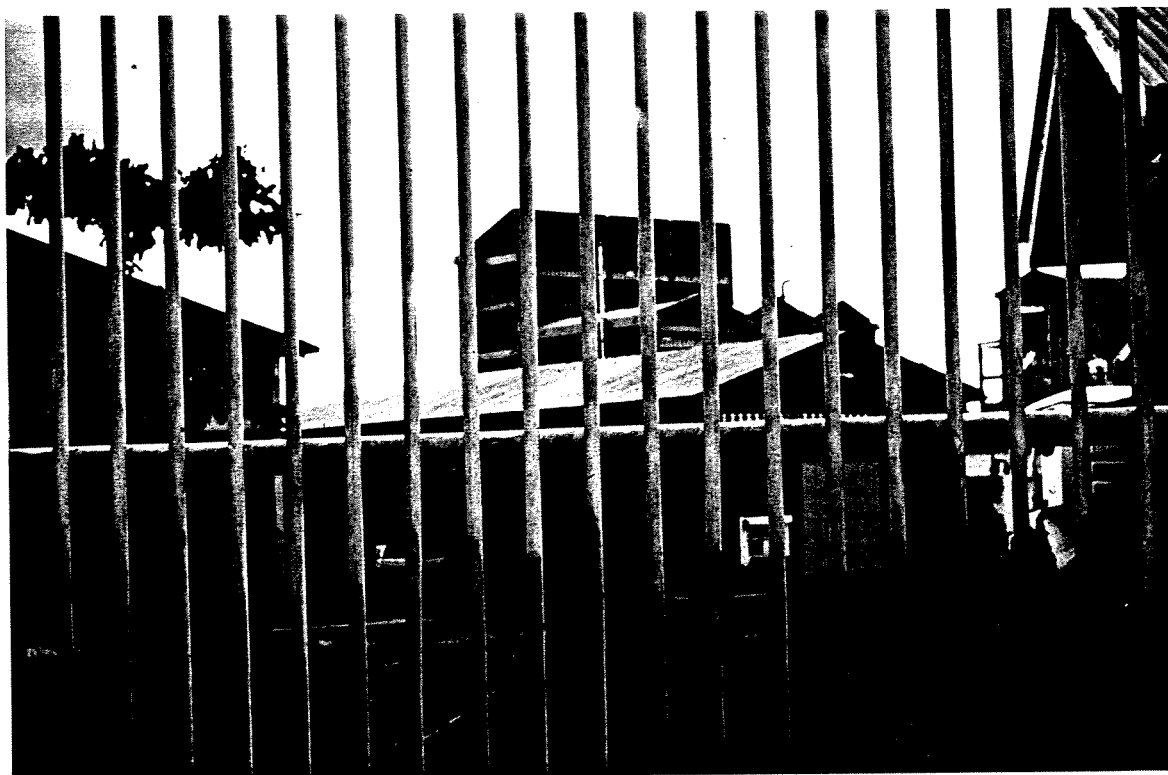
Figure 6: The pesticide factory in Moshi

The pesticide factory in Moshi has been established lately, but has not yet come into operation (figure 6). There is little to no information about the production and the effluent from the factory, and the RWE in Kilimanjaro has not despite several attempts succeeded in getting any information. It is assumed that the factory will produce copper sulphate, and the waste water will probably be discharge via storage tanks and a tunnel to Karanga river. There has been some objections by the people living in the area, but this has not been taken into consideration.

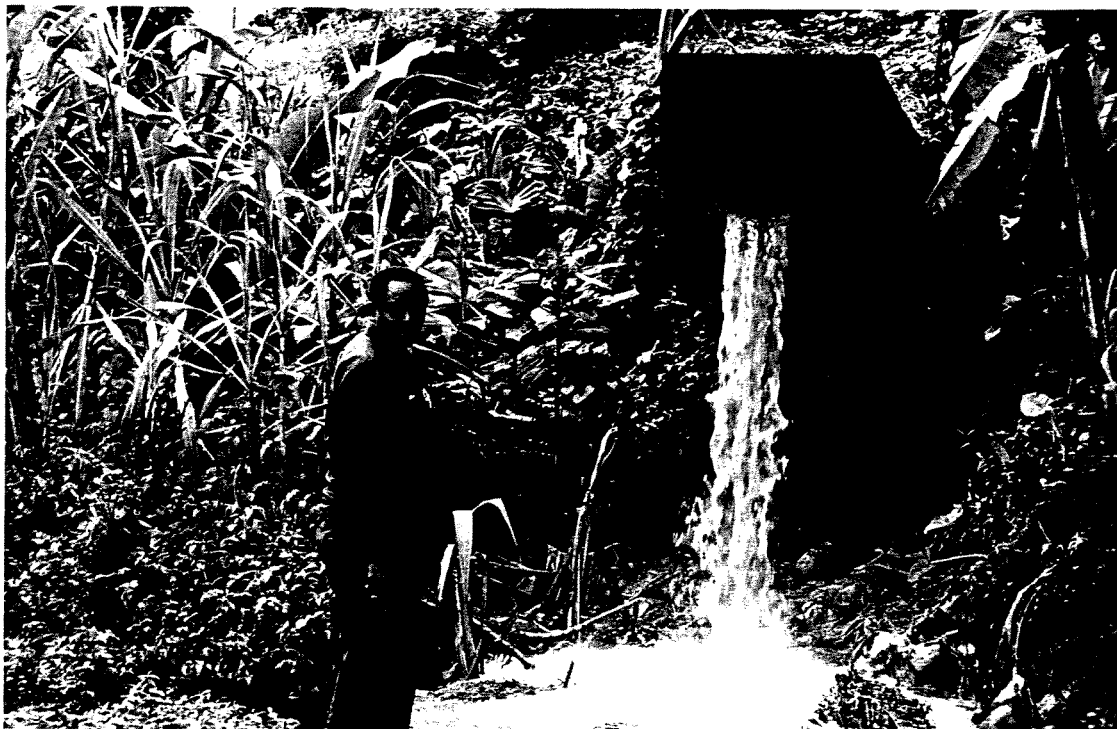
Figure 7: Mr. J. Nasari (Hydrologist at the RWE-office in Arusha) inspecting the discharge from the brewery to Thembi river.

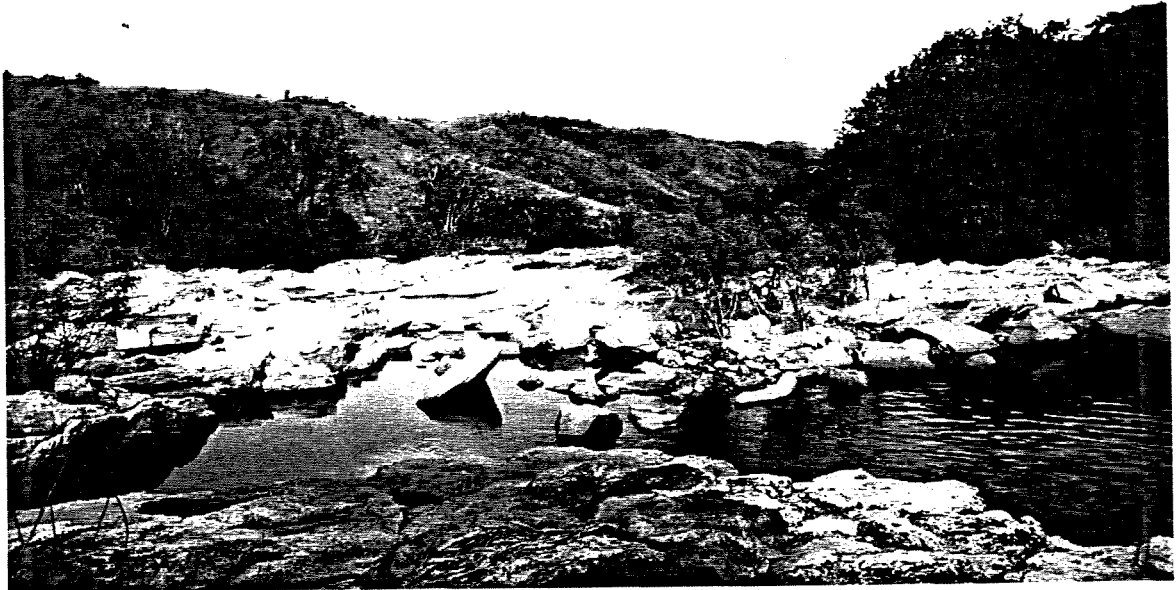
Figure 9: Thresholds in the river bed at PFRP, Hale

In general the way the rehabilitation has been done gave a very good authentic impression. The thresholds in the river bed have increased the surface of the water substantially, and the ravine forest looked healthy at present (rainy season). However regularly visits to the forest by a skilful person will reveal changes of the biota. A minimum release or short flushes of water from the intake dam might be considered as necessary if decisions are made to protect this forest.

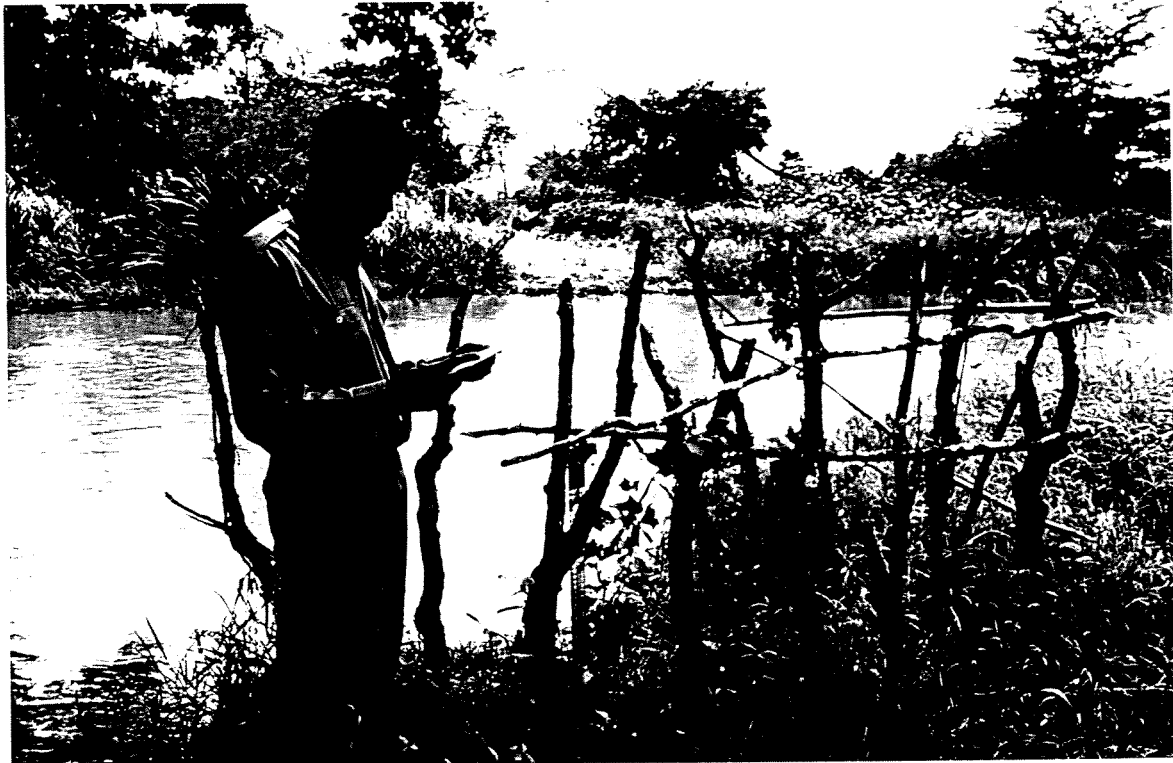
Figure 14: Mr J.Z. Riwa (PBWO) taking a reading at Buiko gauging station

Registration of hydrometeorological data has been carried out by the Regional Water Engineers Offices in the Pangani Basin since 1959. In Pangani basin 36 places are gauged, but due to poorly maintenance 5 stations have been temporarily out of order. Pangani Basin Water Office receive data from the Regional Water Engineer offices from 22 selected stations. The data are transmitted to PBWO at Hale from Arusha and Moshi by radio, and by direct delivery from Korogwe.

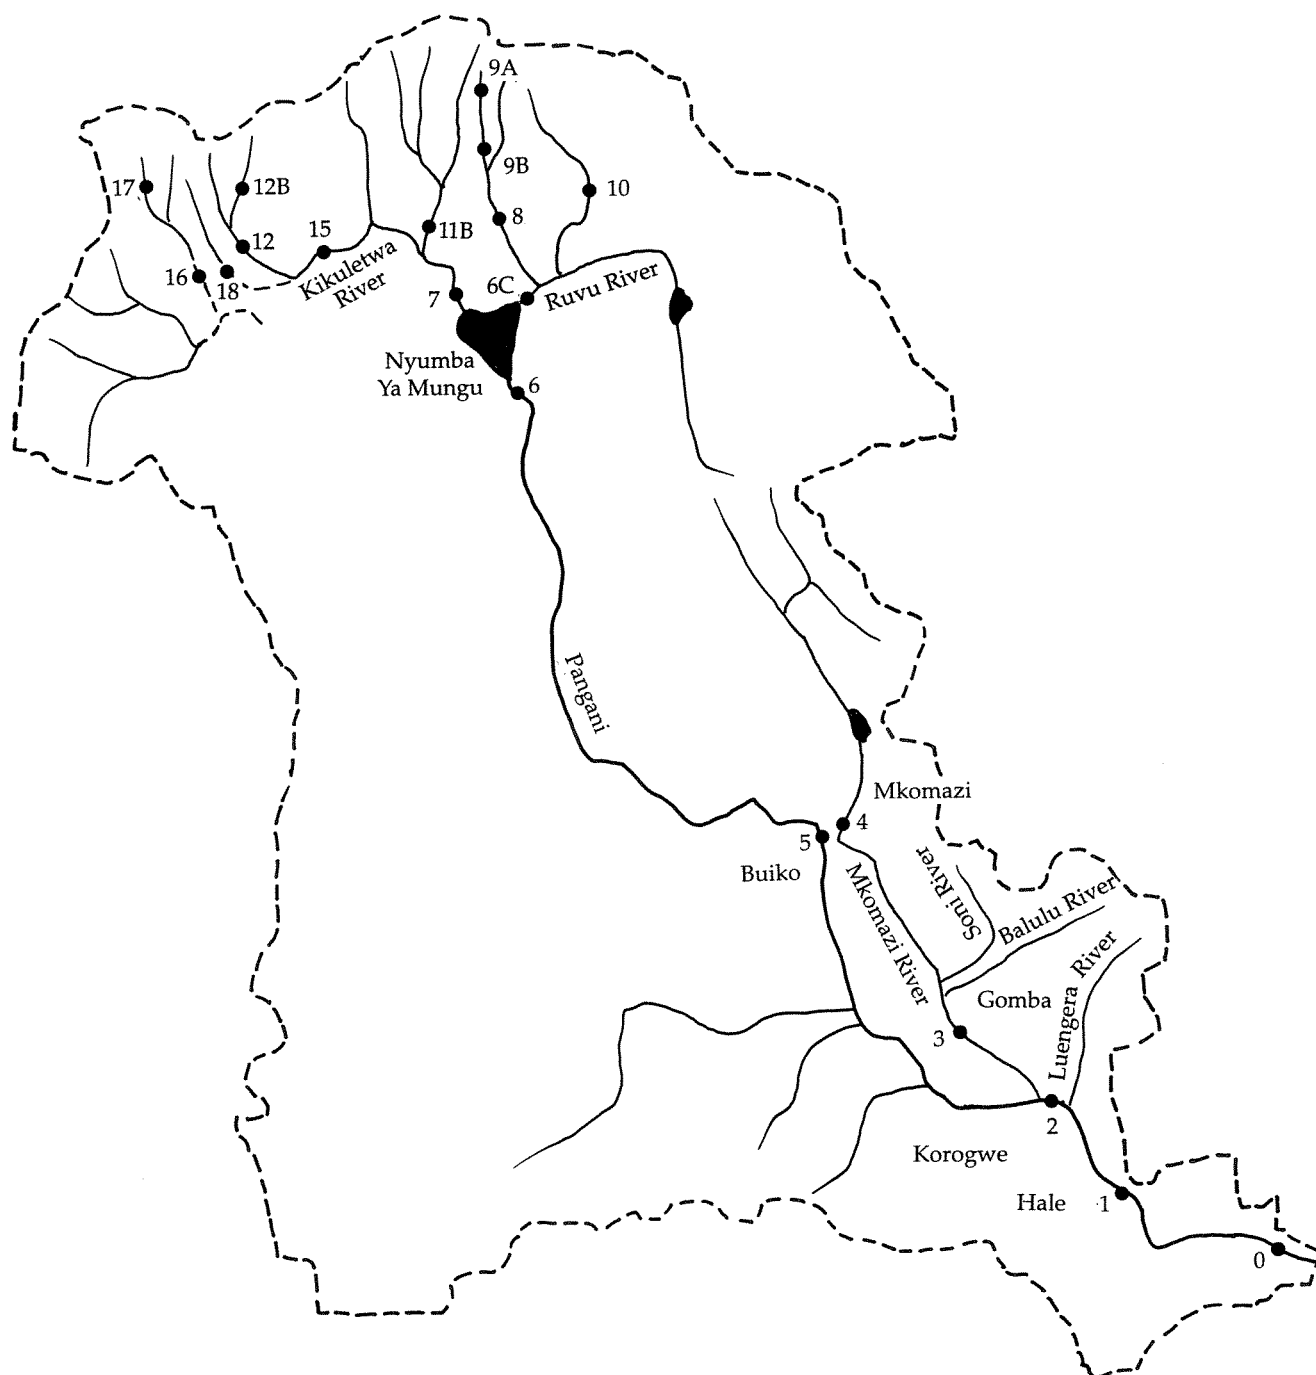
Figure 15: Location of monitoring stations (for detailed information upstream NyM see figure 3)
