REPORT SNO 3943-1998

Mangdechu Hydroelectric Project

Environmental and Socio-economic Impact
Assessment Study:

**Water Quality and Sanitation,
Aquatic Flora and Fauna**

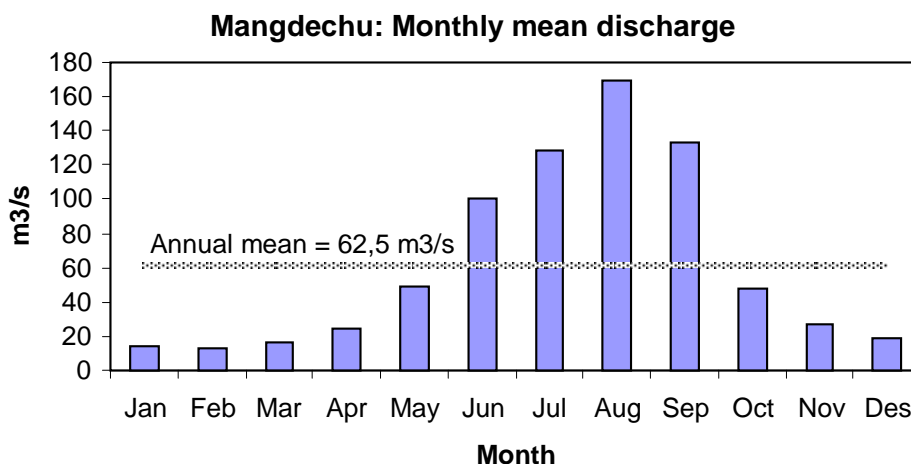
Figure 2.2 Monthly mean water flow in Mangdechu River at the dams site.

Mangdechu has an annual mean flow at the diversion dam of about 62,5 m³/s. Monthly mean discharge is lowest in February with 13 m³/s and highest in August with 170 m³/s, see Figure 2.2.

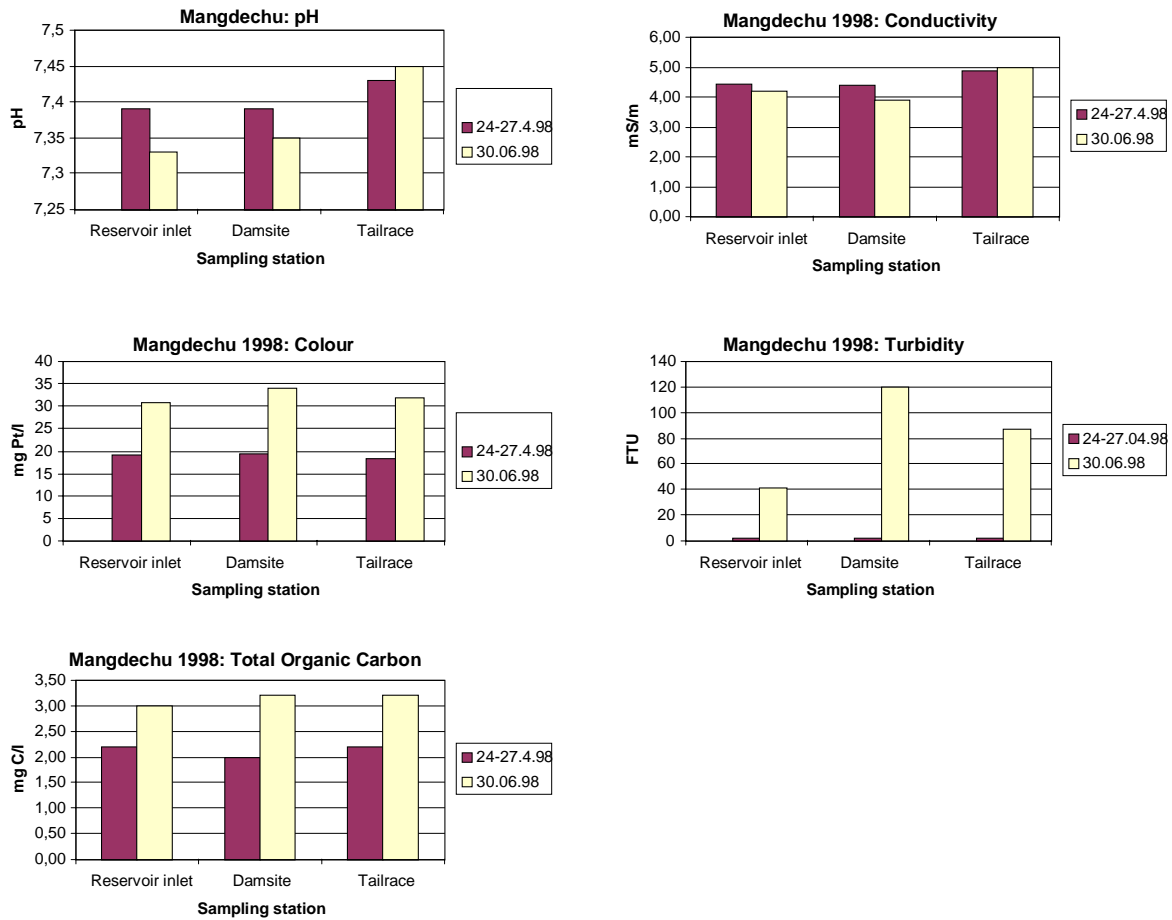
Figure 6.1 Mangdechu 1998. Some general water quality parameters. The April values represent a dry period, while the June values represent the rainy season.

The colour of the river is around 20 mgPt/l in the dry season, and increases to around 35 in the wet season. The river is little- to moderately impacted by soil humic matter, the brownish stain that is particularly appearing in rivers draining forests and boggy areas.

The turbidity of the river is very variable, ranging from 1.5 FTU in the dry season to 120 FTU in the wet season, indicating large variations in sediment load. This is due to high degree of erodability in the catchment area. Sudden rainfalls and snow-melts may in short time change the river from a clear water river to a greyish-brown muddy appearance. With a turbidity of 120 FTU the water will cause problems for most use categories, other than irrigation and concrete additions, etc.

Total organic carbon varies from 2 mg C/l in the dry season to above 3 mg C/l in the wet season. The variation correlates well with the colour which indicates that the carbon mainly consists of dissolved compounds. This is in agreement with the findings that almost all the particulate matter consisted of inorganic particles (see paragraph dealing with suspended sediments), and that no free floating algae (plankton) were observed (see the chapter dealing with aquatic flora and fauna).

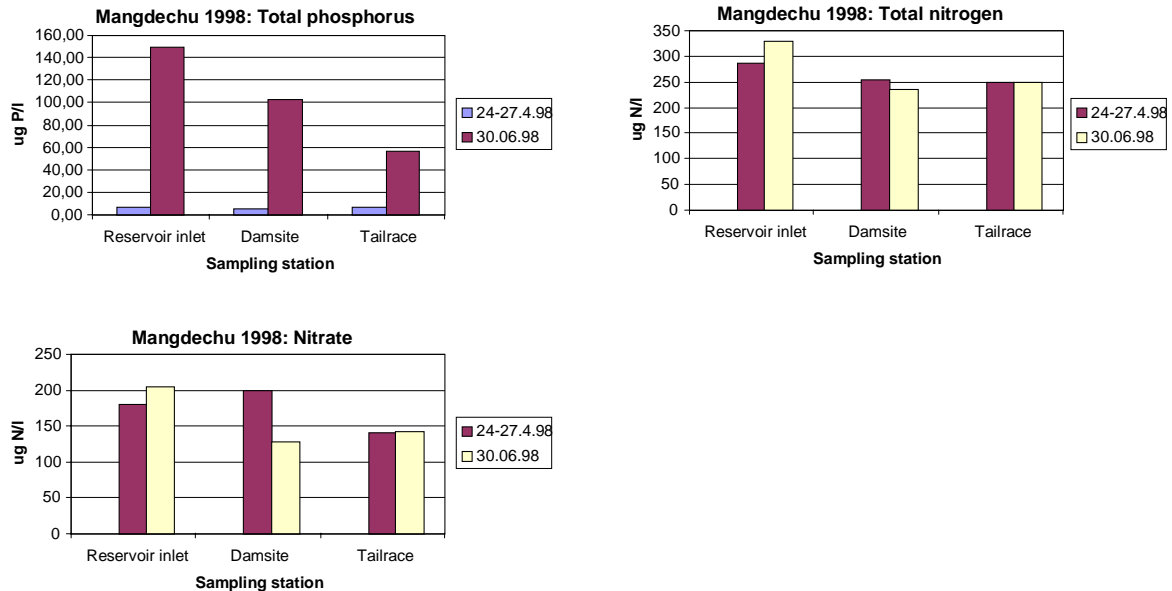
Figure 6.4 Mangdechu 1998. Observed concentrations of the plant nutrients phosphorus and nitrogen. The April values represent the dry season, while the June values represent the rainy season.

Figure 6.4 shows the concentration of the nutrients phosphorus and nitrogen. The concentration of total phosphorus in this river is completely determined by the content of erosion material, and is quite insignificantly impacted by anthropogenic effluents. In the dry, low flow season the concentration of total phosphorus was only 5-6 $\mu\text{g P/l}$, while in the wet season it increased up to as high value as 150 $\mu\text{gP/l}$. This high concentration of erosion derived total-P is firmly bound to soil particles and is only to a minor extent available to aquatic plants. High turbidity during erosion periods of high P-concentrations also reduces the plants possibility to utilise the high total-P concentrations during the wet season.

As well as the low total-P concentration during low flow periods, the low values of total nitrogen and nitrate clearly show the nutrient poor status (oligotrophic) of Mangdechu. Nitrogen is not attracted to particles, and is therefore not increasing due to erosion activity. For that reason there is not a significant difference between values from the wet and the dry season. Almost all the nitrogen is in the form of nitrate, which indicate low uptake by algae and other aquatic plants.

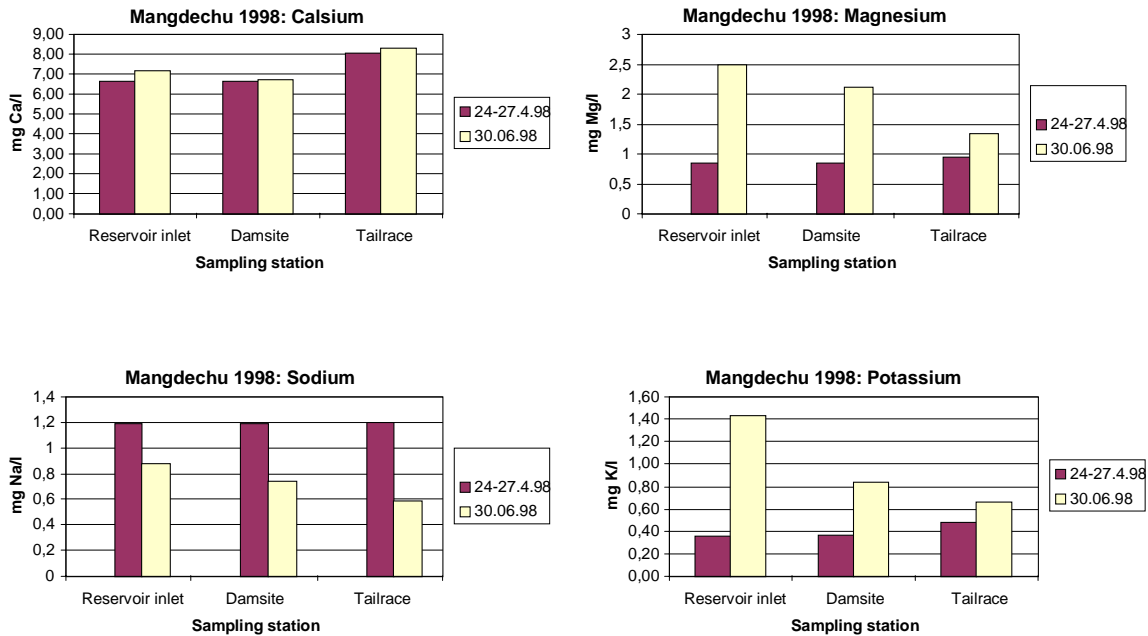
Figure 6.5 Main cations in Mangdechu during the water quality sampling (April data represents dry season, while June data represent wet season).

Low levels of sodium indicates that the area are not impacted much from depositions of sea salt aerosols.

The highly mobile ion Na has very little particle affinity, and the concentration during high flow is diluted. For the other less mobile ions there is an increase in the concentration as the erosion increases during periods of high flow.

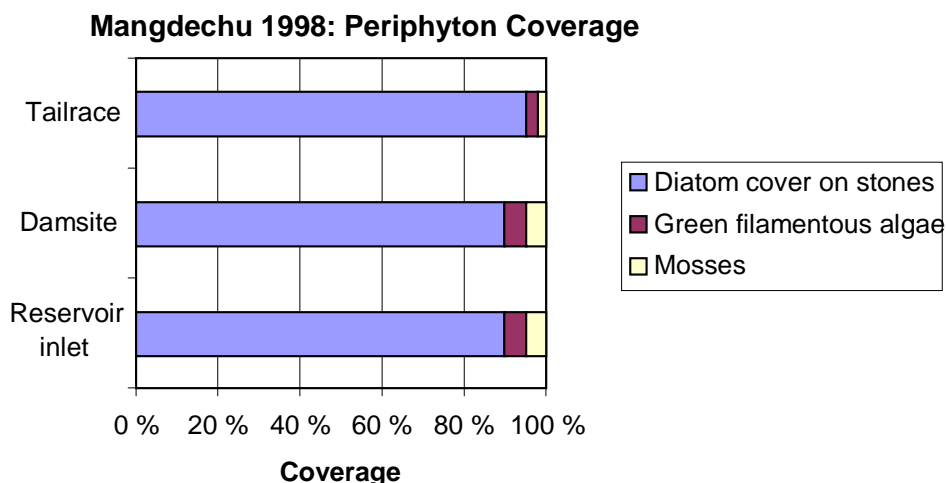
Figure 8.1 Approximate bottom coverage of the periphyton elements cited. Visually judged in the field.

The thin, and slippery diatom cover appeared on all stones in the river, and constitutes the main primary producer group in Mangdechu, see Figure 8.1. Mosses and filamentous algae were rather rare. The high water velocity, vigorous rapids and alteration in water flow restrict the possibility for growth of other plants than the thin diatom cover on stones.
