REPORT SNO 5056-2005

Molde- and Fannefjord, Møre and Romsdal

Assessment of discharges of municipal
waste water with regard to the
requirement of secondary treatment in
the EU Urban Waste Water Directive

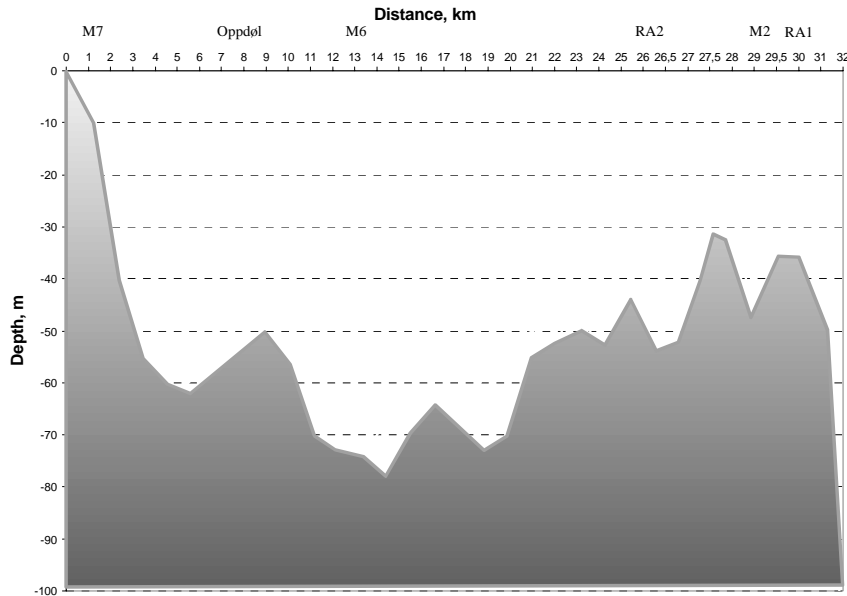
Figure 2. Transect profile from Fannefjord to Moldefjord, as from sea chart no. 33 and 34.

The length of the fjord system is ca. 33 km and the surface area is ca. 50 km. To the west the Moldefjord has a sill at 30-32 m depth (east from station M2, see **Figure 1**) and in the east the Fannefjord has a maximum depth of 75 m (**Figure 2**). The water mass below 30-35 m is therefore cut off from the coastal water.

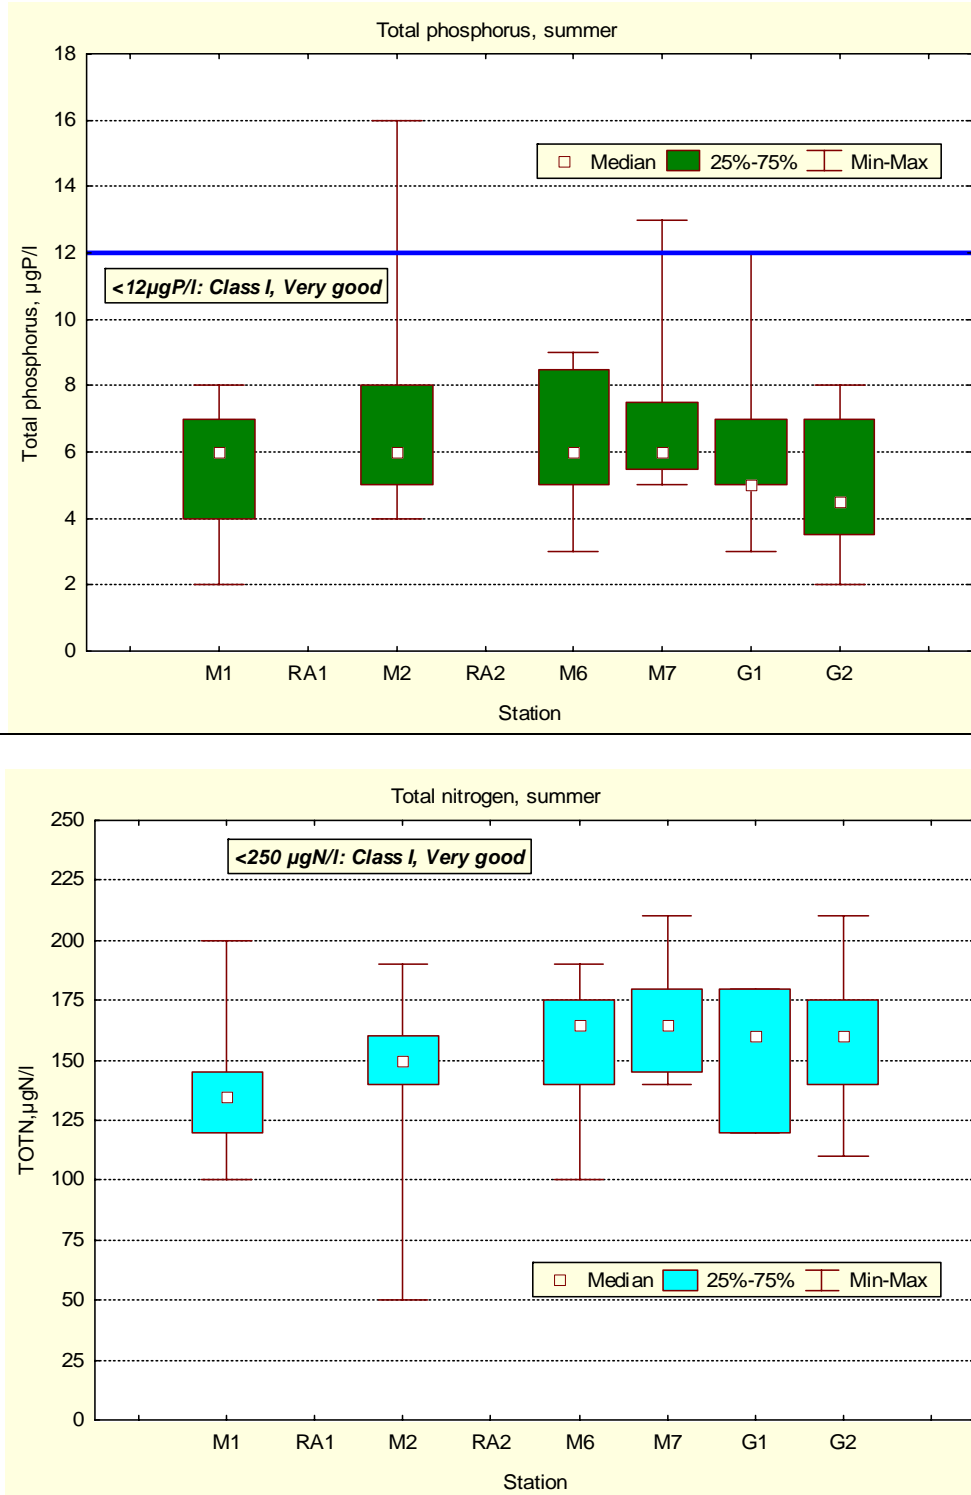
Figure 3. Measurements of total phosphorus and total nitrogen within the top 15 m at M2, and within the top 2 m at the other stations, during the summer period (June- September). Note that the limits between status classes I and II is 250 µgN/l.

Studies of water quality (nutrients and chlorophyll *a*), from the surface to 15 m depth show environmental conditions corresponding to class I (Very Good) according to the classification system. Both phosphorus and nitrogen lies with a good margin under the limit to class II (**Figure 3**).

This is little different between station M1, located in the strait and other stations deeper in the fjord area, whereas stations located by the fish-farm (G1 and G2) show concentrations significantly lower than the two other stations located in Fannefjord (M6 and M7).

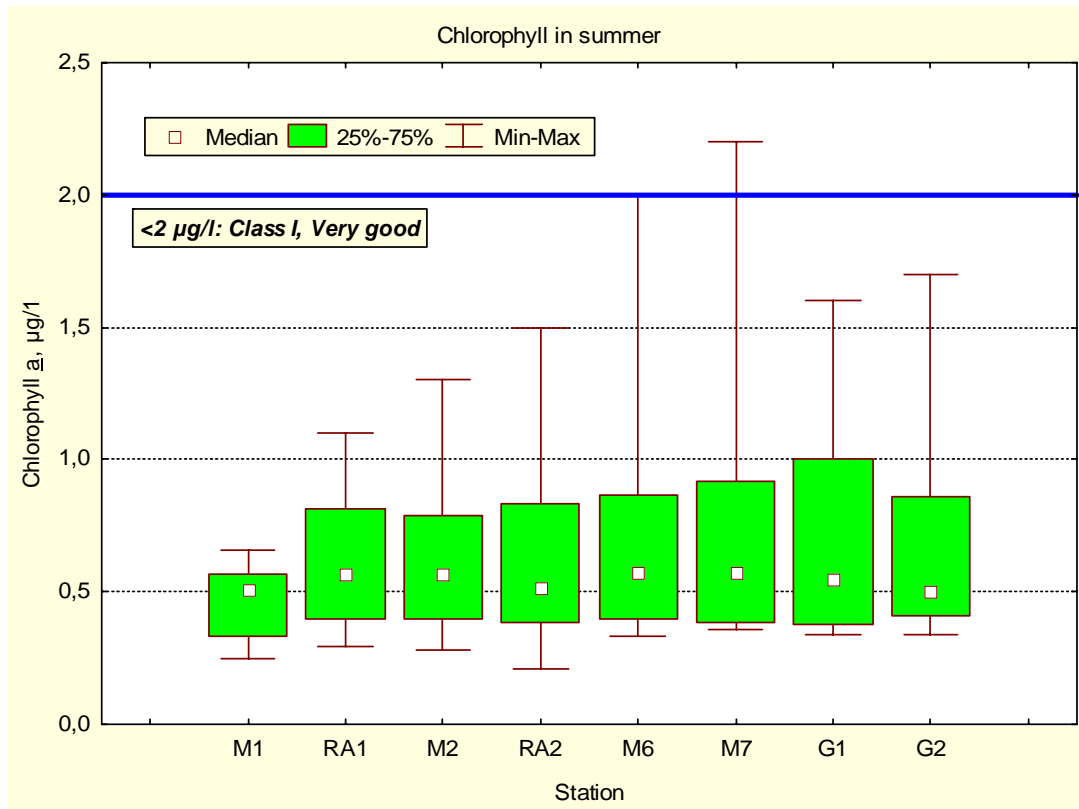
Figure 4. Measurements of chlorophyll_a within the top 15 m at RA1, M2 and RA2, and within the top 2 m at other stations, during the summer period (June – September).

Chlorophyll_a was used as a proxy for phytoplankton biomass. It is not surprising to observe higher concentration inside the fjord area although the difference is quite limited (**Figure 4**).

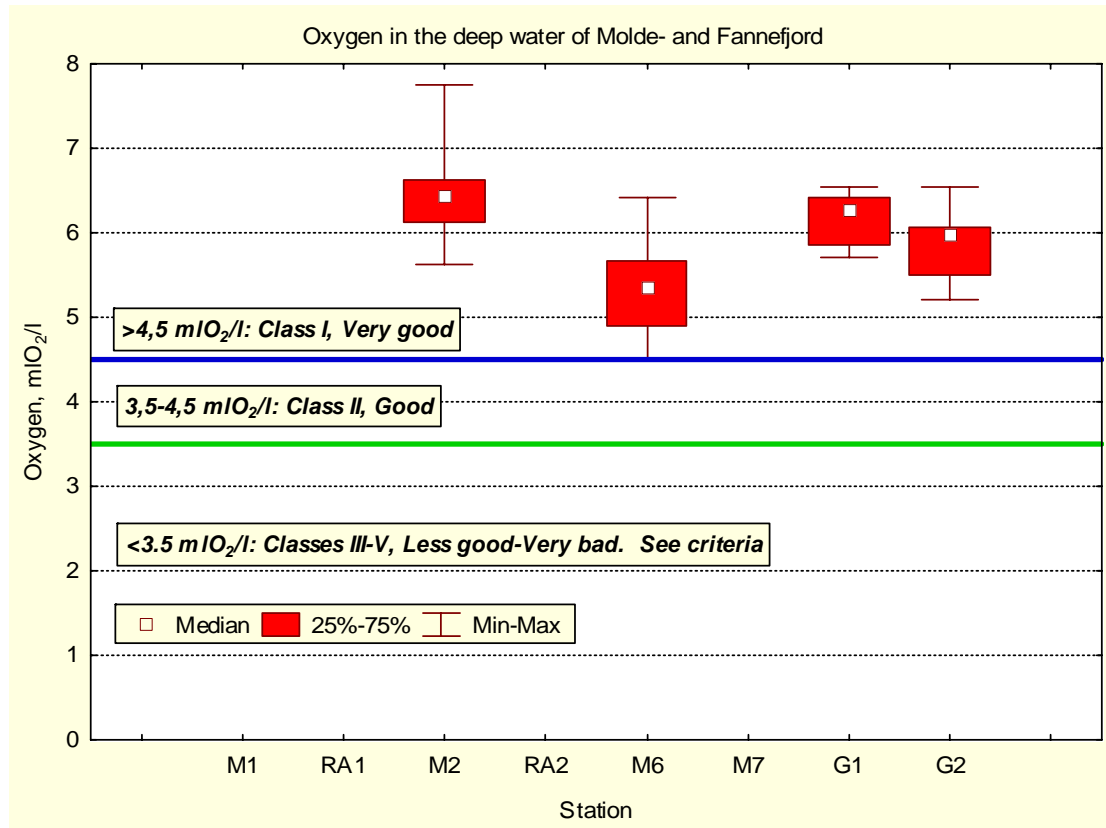
Figure 5. Measurements of oxygen conditions in Moldefjord (M3), Fannefjord (M6) and near by the fish-farm in Grønnes (G1 and G2).

According to this classification system the oxygen conditions in both fjord basins were Very Good (<4.5 mlO₂/l) (**Figure 5**). Compared with data from 1983-85 (Nilsen et al., 1987) there is no sign of increased oxygen consumption or decreased oxygen concentration.
