Repeated environmental baseline survey at
AF Miljøbase Vats in conjugation with the
Ekofisk cessation EPRD project

Title Repeated environmental baseline survey at AF Miljøbase Vats in conjugation with the Ekofisk cessation EPRD project	Serial No. 6879-2015 - Rev. 1	Date 20.11.2015
	Project no. O-15236 Sub-No.	Pages Price 31 + appendix
Author(s) Jonny Beyer, Astri Kvassnes, Jarle Håvardstun, Mats Walday, Hege Gundersen & Morten Schaanning	Topic group Monitoring, baseline	Distribution Open
	Geographical area Rogaland, Norway	Printed NIVA

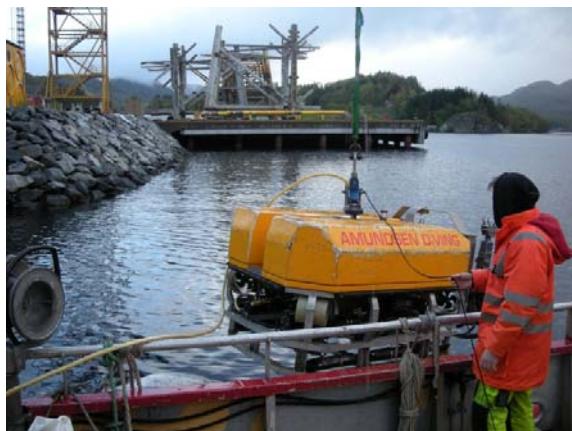
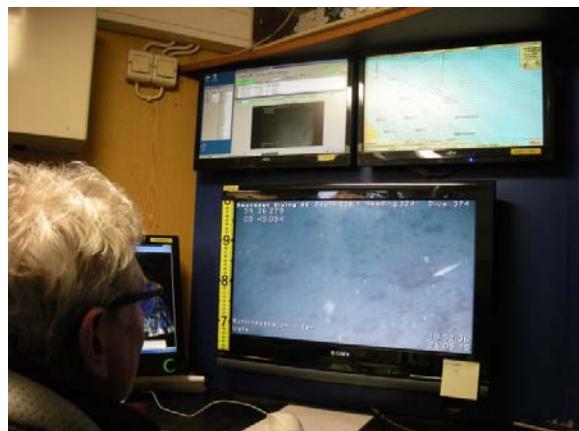
Figure 4: Left: The Argus Mariner ROV from Amundsen Diving which was used during the registrations 26th-27th of May 2015. Right: The control room of parent vessel MS Scuba where the ROV pilot sits and where the recordings and records were made.

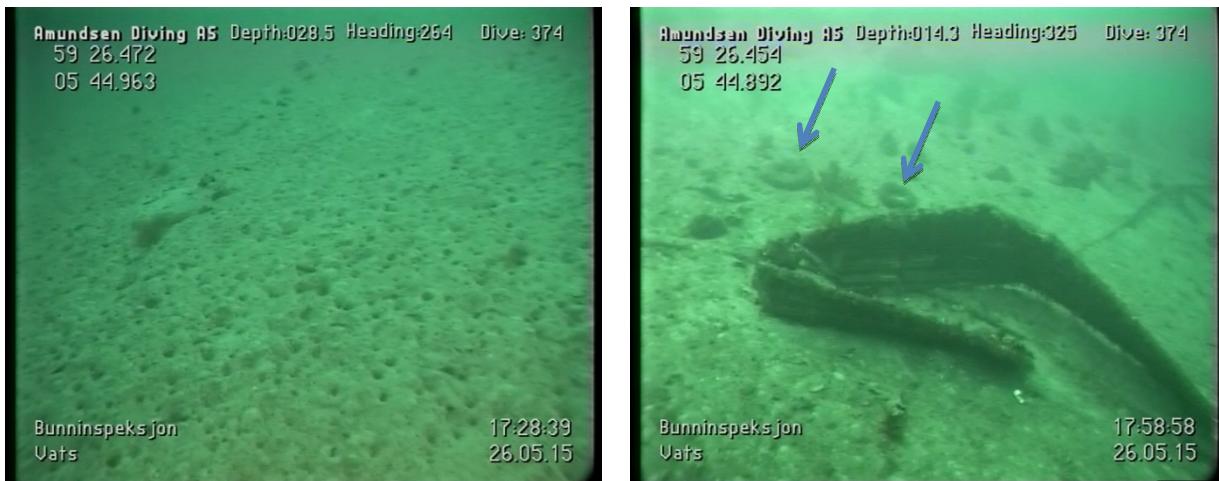
Figure 5: Left: Many holes and grooves in the bottom indicate a live bottom. Here at ca. 30 m depth in the area north of the main quay. Right: A piece of corrugated iron and in the background tires (arrow) can be seen. The picture is taken from ca. 15 m depth in the area north of the main quay. Relatively many tires were observed at approximately 10-15m depth in this area.

Generally in both Raunesvika and Grønavika, the seabed was in a 'living bottom' condition status. In both areas, we encountered holes and traces of benthic animals on the sediment surface (Figure 5). There was relatively little degree of fouling to be found on the rocks and boulders on the seabed. This was especially the case in the slightly deeper areas of Grønavika south of the quay where the seafloor was filled with a lot of rocks (Figure 6). In the upper 10-12 m we found scattered occurrences of sugar kelp and commonly occurring threadlike brown algae (Figure 6). A few places, dense occurrences of large hydroids were observed and in the shallow part of the study area, quite a lot of small wrasse fish were observed along the shoreline. We also saw a several larger fish individuals which most probably were saithe. It is a challenge to estimate the density of fish at a location as based on ROV filming as it is very likely that the same fish will be recorded several times during the filming.

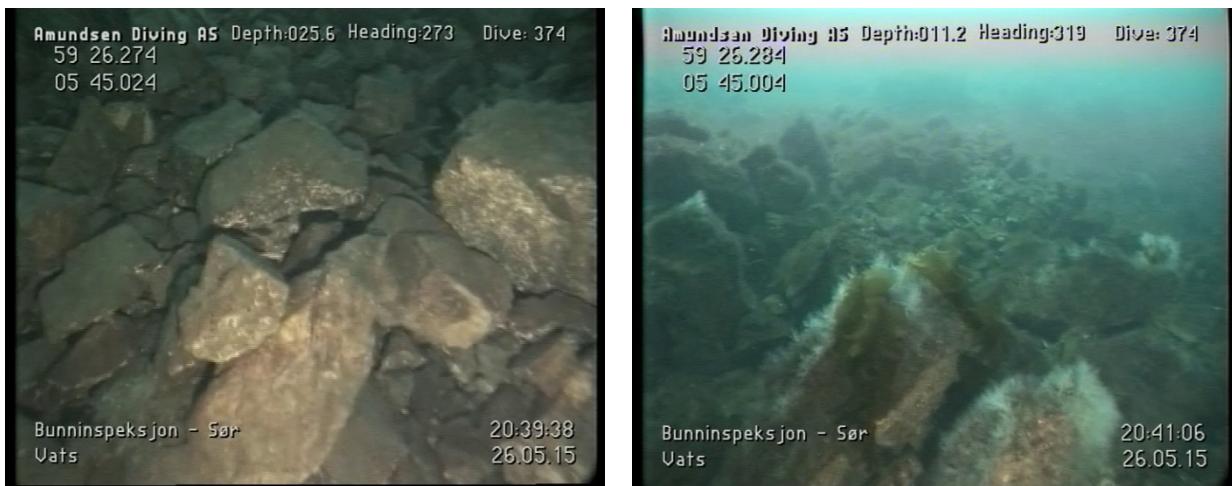
Figure 6: These pictures show the area south of the main quay which was scattered with large rocks and boulders. Left picture show rocks at 26 m depth with only little algal fouling. Right picture: at approx. 11 m depth there was with significantly more fouling present, in particular sugar kelp and hydroids as can be seen on the rocks in the foreground.

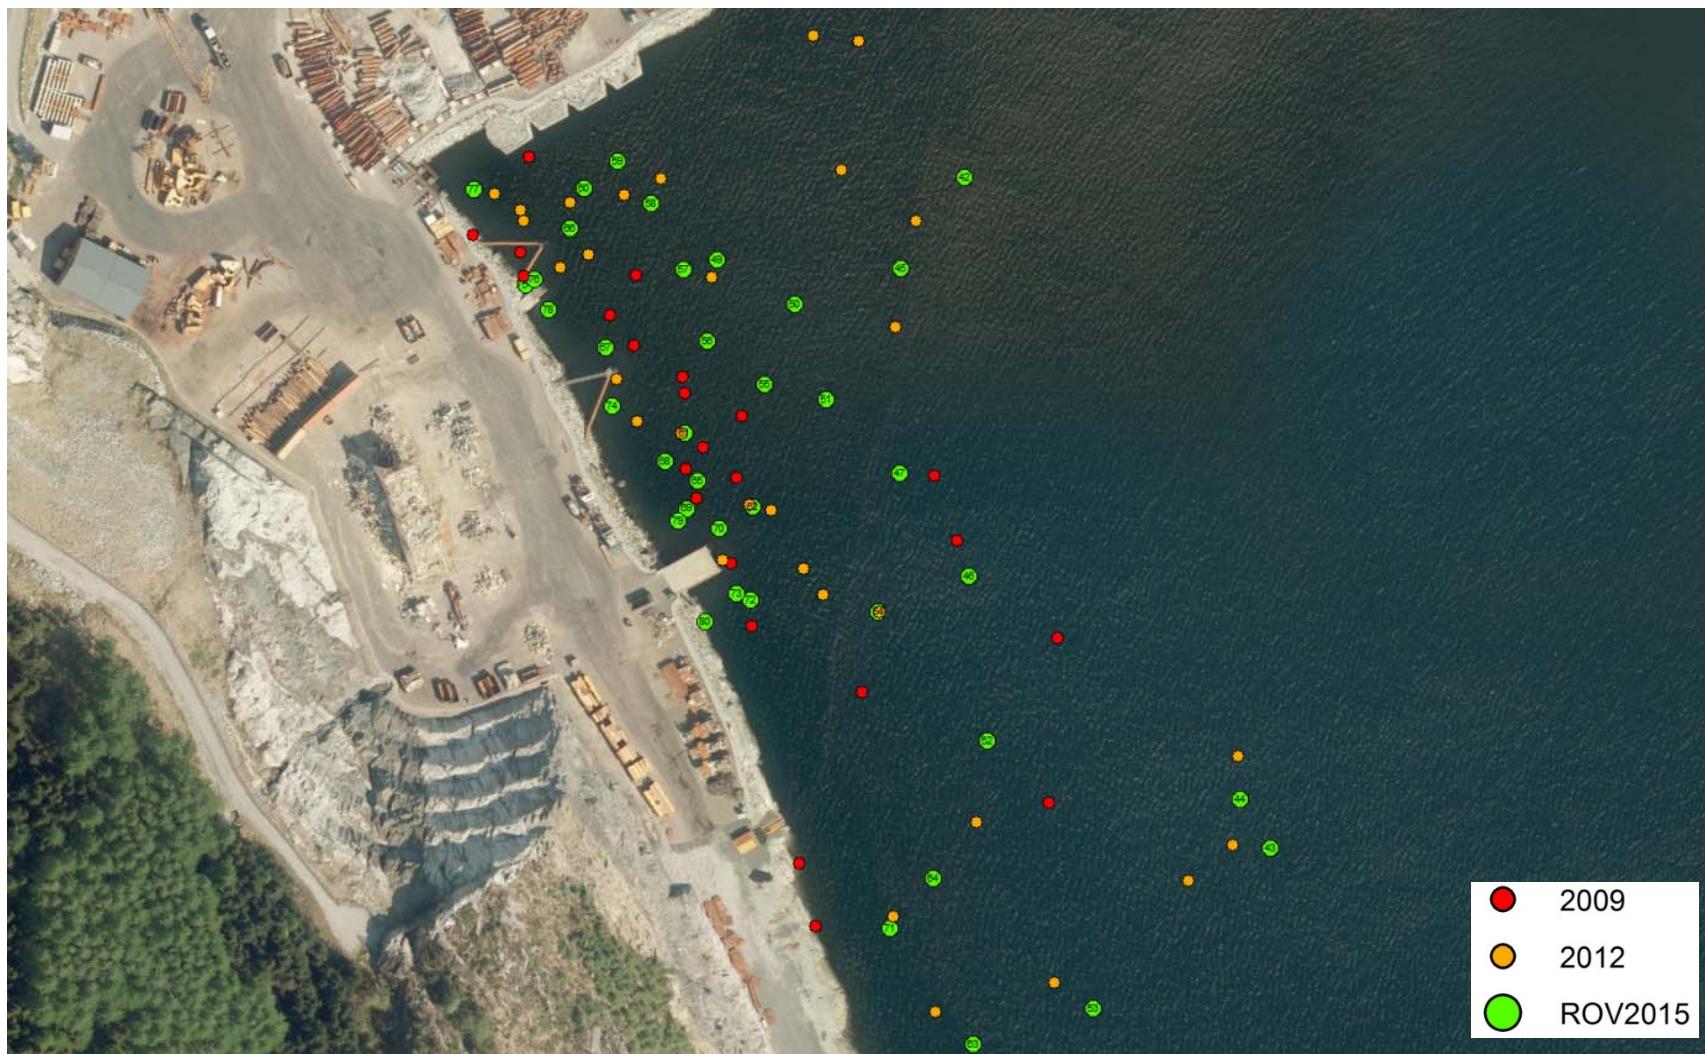
Figure 9: This picture shows the positions of all anthropogenic materials that have been registered and positioned in the area Grønavika (south of the main quay) during the ROV surveys conducted in 2009, 2012 and 2015. For data registered in 2015, each individual debris object is given an ID number which also is referring to the observations summarised in Table 2.

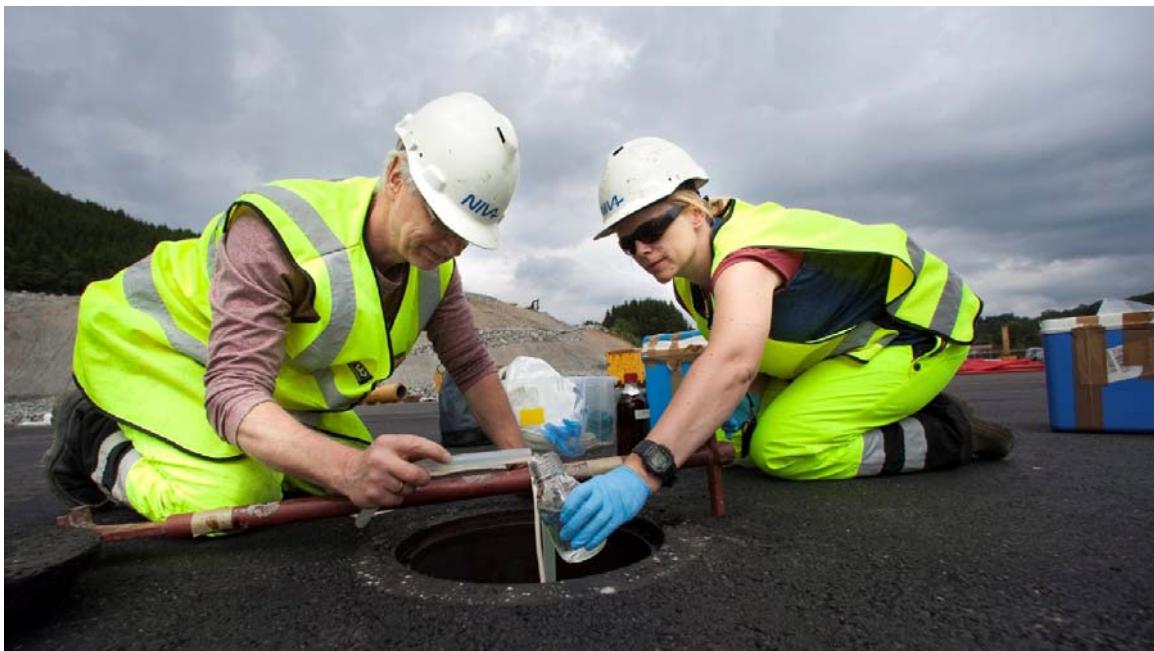
Figure 10: This picture shows how groundwater samples for analysis of contaminant levels were collected from four wells in the quay deck.

The main purpose of the sampling of the groundwater wells is to investigate whether the membrane functions properly, and is successful in preventing leaks to the subsoil area. The water sample is obtained by use of a 5-meter long water-hose and a sub-surface pump. Each well is sampled with its individual and clean pump and hose. The water was siphoned directly into the sample bottles, sealed and sent to the laboratory.

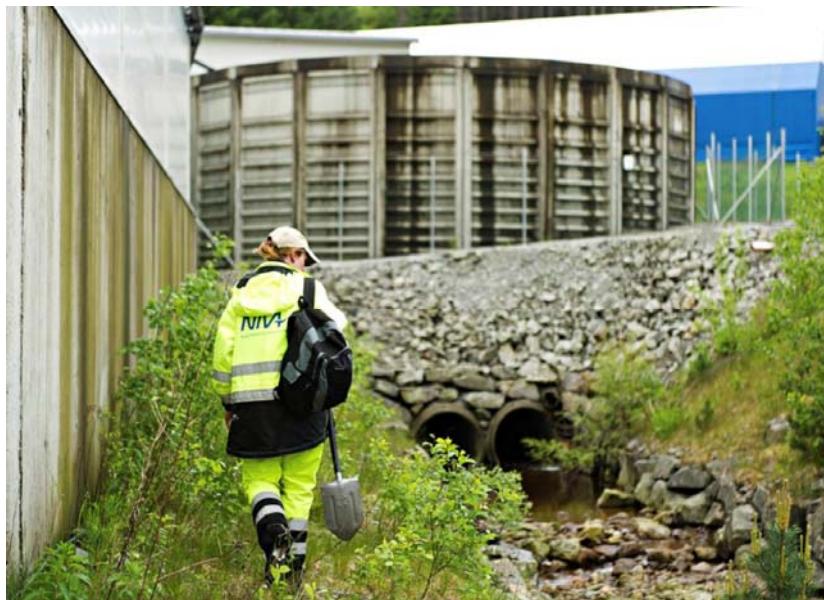
Figure 13: Collection of soil samples was done from two positions within the narrow riverside brim which is located between the Raunes River and the concrete wall which borders the north end of the AFE BV area.

The J1 station was located close to seals in the northern wall where a study performed by COWI had found elevated levels of mercury and zinc and is taken at the same site as the R11 sample in the COWI report (Misund, 2009).

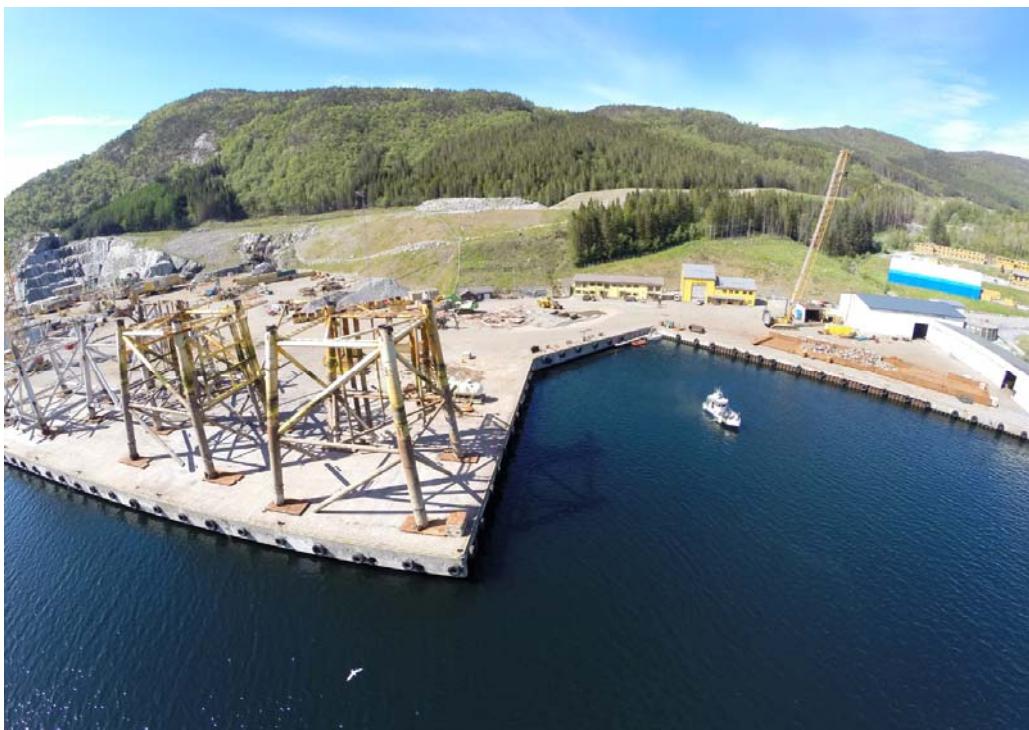
Figure 14: Drone picture from the sediment collection in Raunesvika in 2015, with the boat located approximately over the Raunes 2 sediment station.
