Repeated environmental baseline survey at AF Miljøbase Vats in conjugation with the Ekofisk cessation EPRD project

Title Repeated environmental baseline survey at AF Miljøbase Vats in conjugation with the Ekofisk cessation EPRD project	Serial No. 6879-2015 - Rev. 1	Date 20.11.2015
	Project no. Sub-No. O-15236	Pages Price 31 + appendix
Author(s) Jonny Beyer, Astri Kvassnes, Jarle Håvardstun, Mats Walday, Hege Gundersen & Morten Schaanning	Topic group Monitoring, baseline	Distribution Open
	Geographical area Rogaland, Norway	Printed NIVA

**Repeated environmental baseline survey at
AF Miljøbase Vats in conjugation with the
Ekofisk cessation EPRD project**

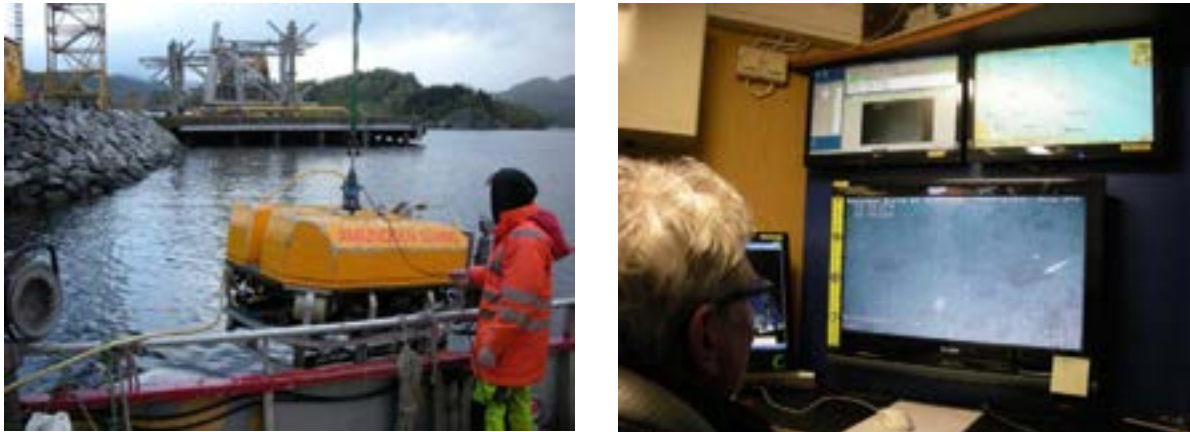
Figure 4: Left: The Argus Mariner ROV from Amundsen Diving which was used during the registrations 26th-27th of May 2015. Right: The control room of parent vessel MS Scuba where the ROV pilot sits and where the recordings and records were made.

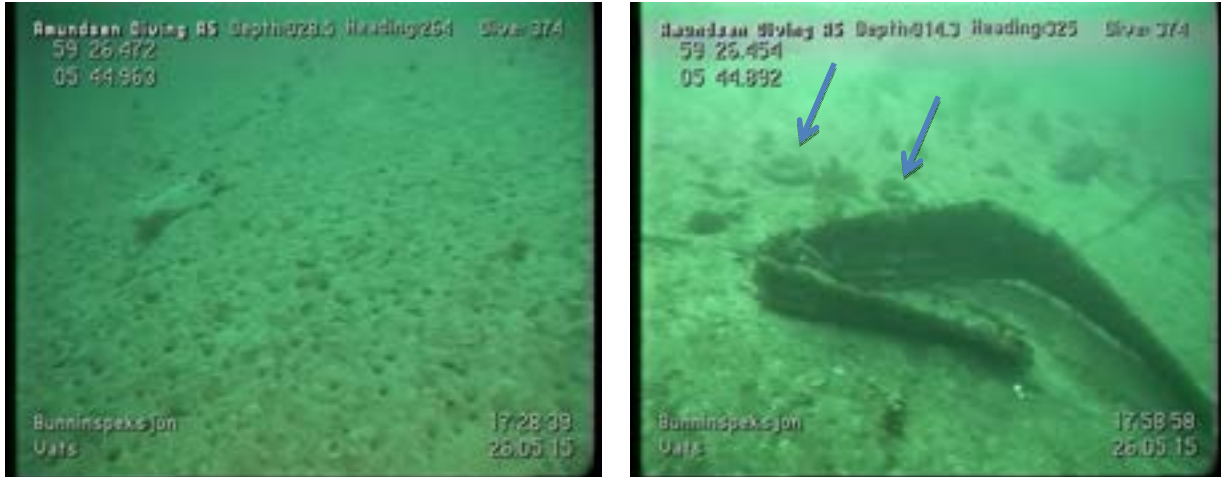
Figure 5: Left: Many holes and grooves in the bottom indicate a live bottom. Here at ca. 30 m depth in the area north of the main quay. Right: A piece of corrugated iron and in the background tires (arrow) can be seen. The picture is taken from ca. 15 m depth in the area north of the main quay. Relatively many tires were observed at approximately 10-15m depth in this area.

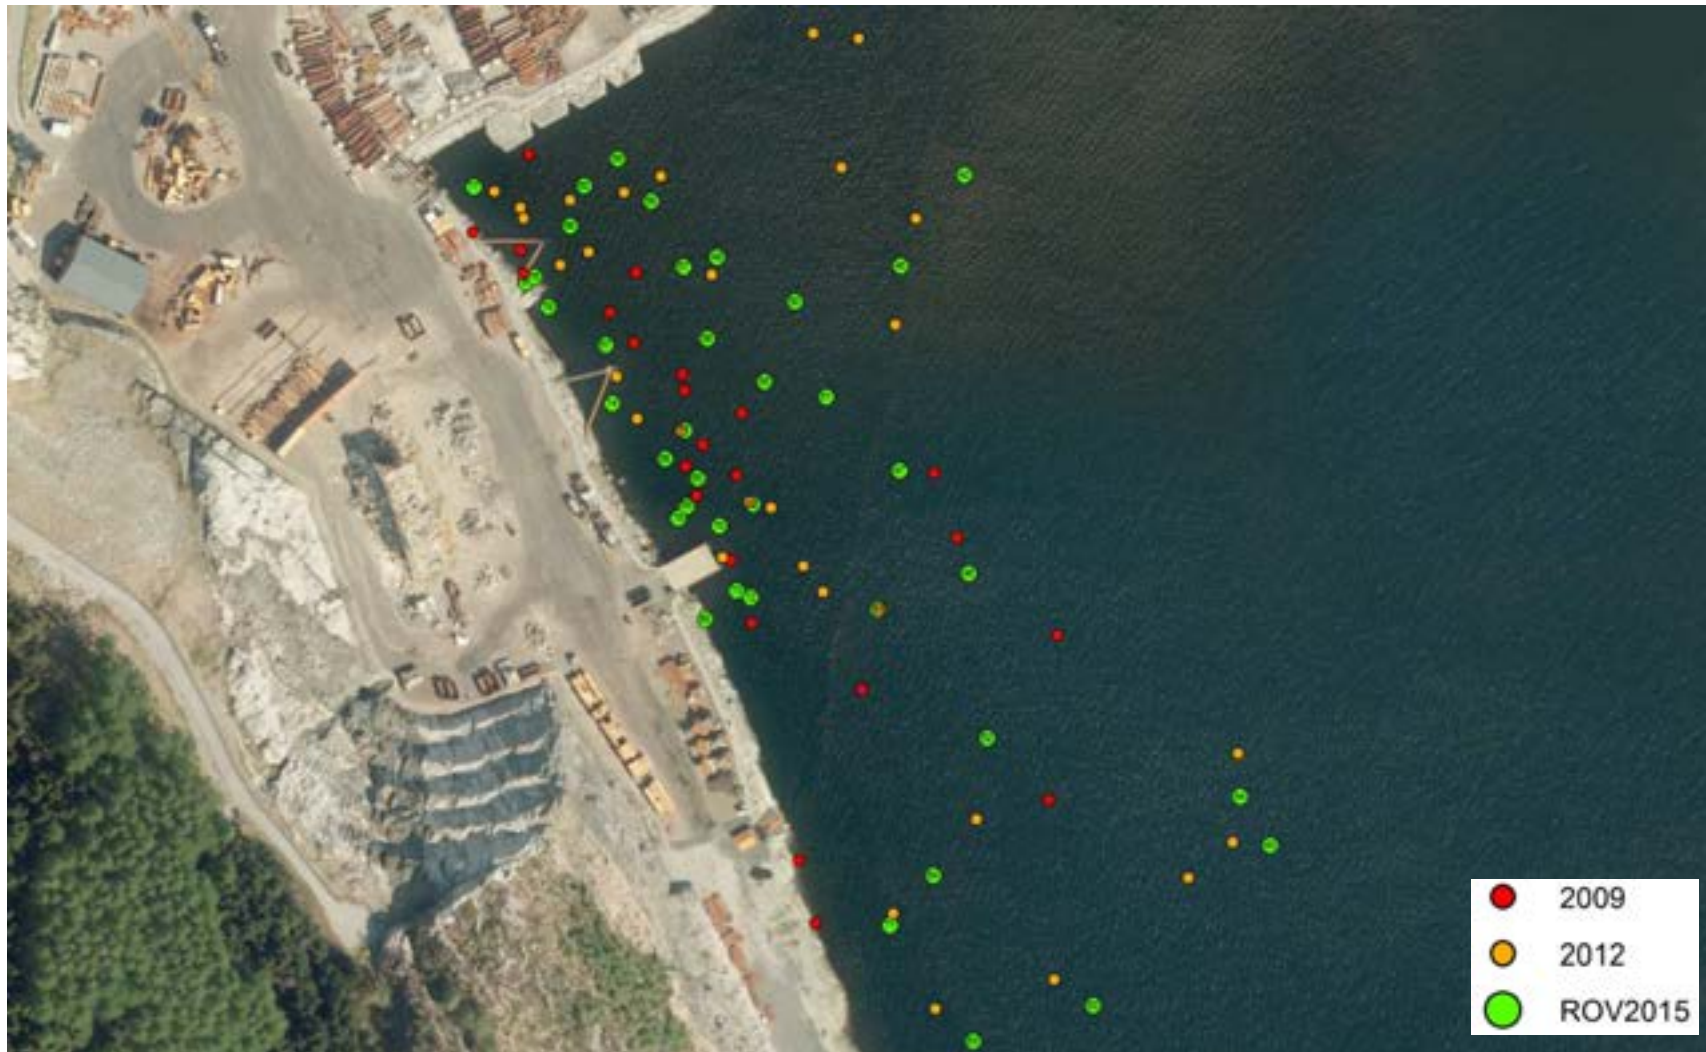
Figure 9: This picture shows the positions of all anthropogenic materials that have been registered and positioned in the area Grønnavika (south of the main quay) during the ROV surveys conducted in 2009, 2012 and 2015. For data registered in 2015, each individual debris object is given an ID number which also is referring to the observations summarised in Table 2.

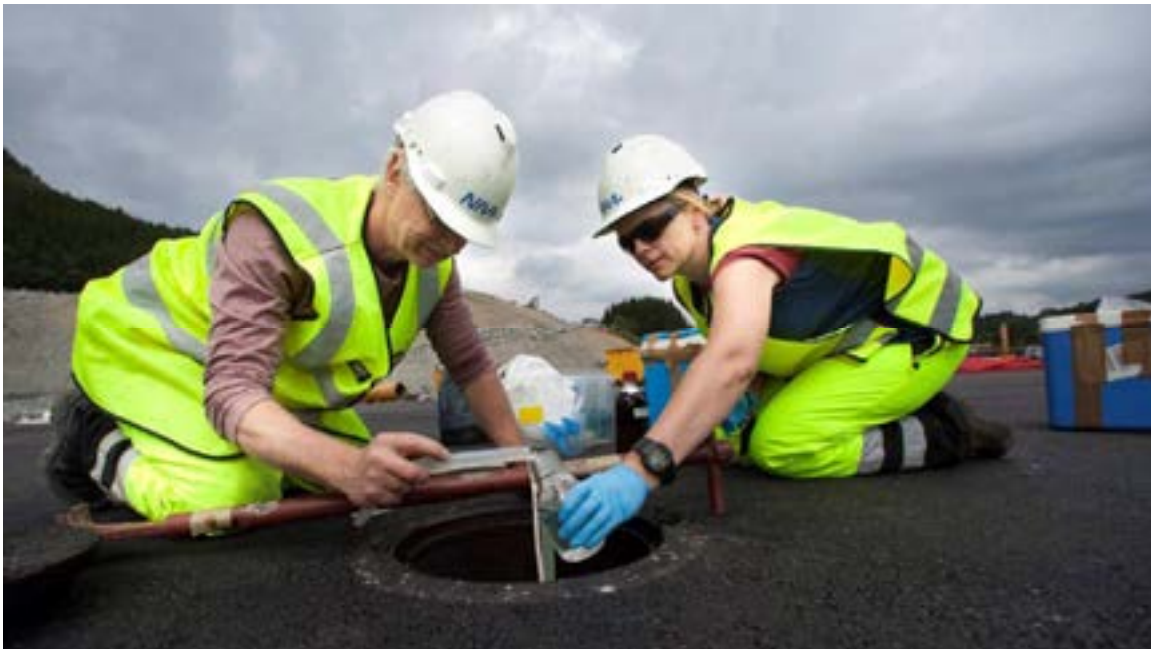
The main purpose of the sampling of the groundwater wells is to investigate whether the membrane functions properly, and is successful in preventing leaks to the subsoil area. The water sample is obtained by use of a 5-meter long water-hose and a sub-surface pump. Each well is sampled with its individual and clean pump and hose. The water was siphoned directly into the sample bottles, sealed and sent to the laboratory.

Figure 10: This picture shows how groundwater samples for analysis of contaminant levels were collected from four wells in the quay deck.

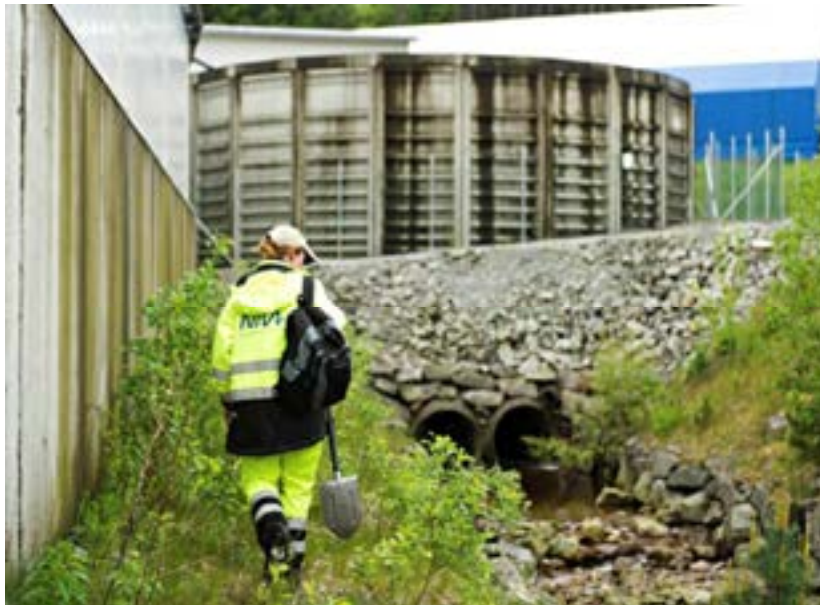
Figure 13: Collection of soil samples was done from two positions within the narrow riverside brim which is located between the Raunes River and the concrete wall which borders the north end of the AFEVBV area.

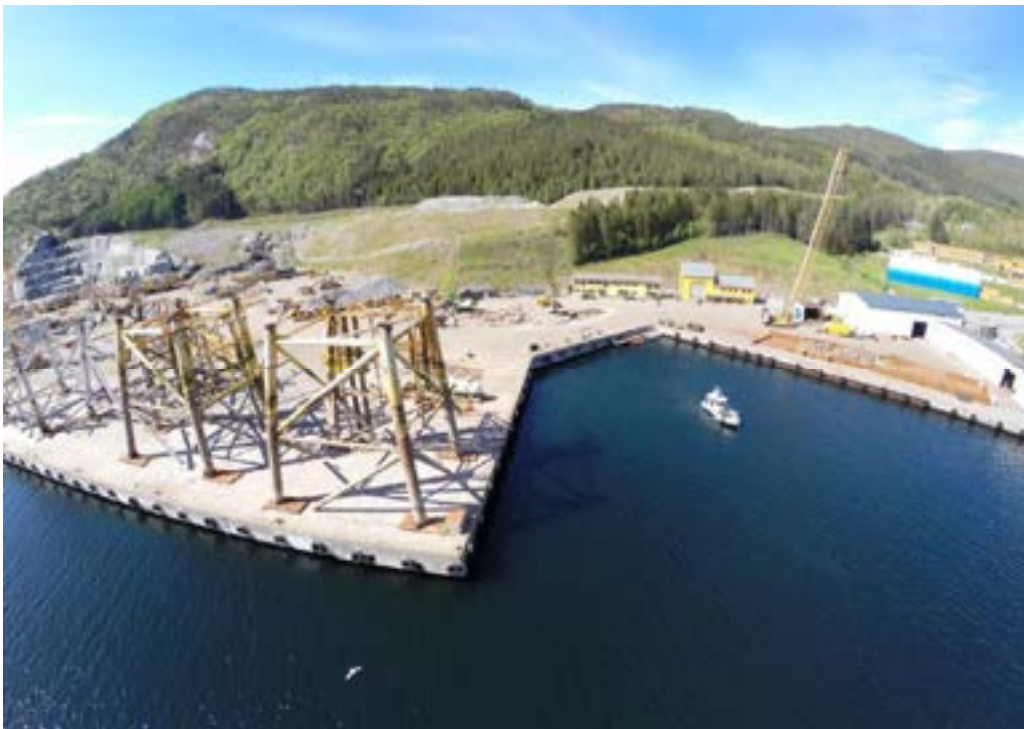
Figure 14: Drone picture from the sediment collection in Raunesvika in 2015, with the boat located approximately over the Raunes 2 sediment station.
