Report title:	Date:
A Water Pricing Study for the Republic of Zambia Appendix III Summary of Technical Findings	May, 31. 1984
	Project No: 0-82013

A WATER PRICING STUDY FOR THE REPUBLIC OF ZAMBIA

Appendix III

SUMMARY OF TECHNICAL FINDINGS

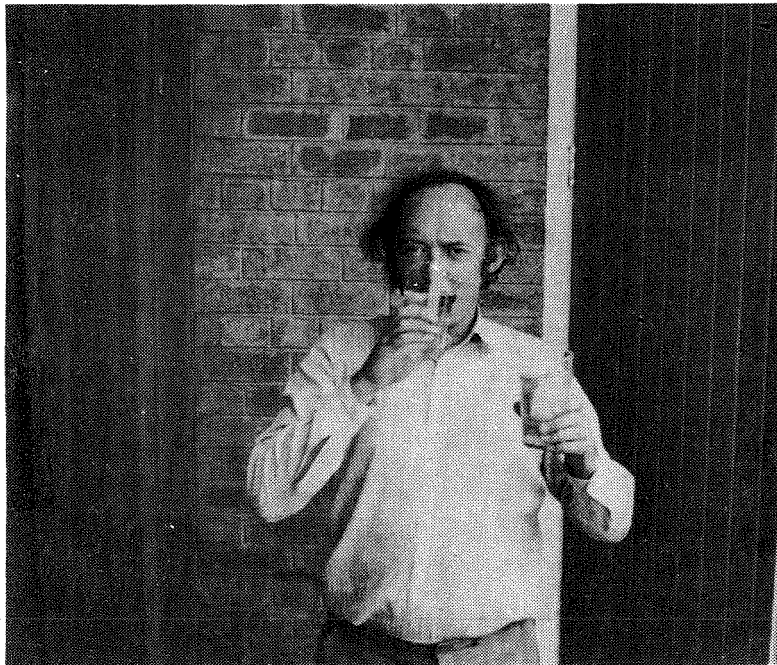
Figure 1. Raw water and treated water samples.

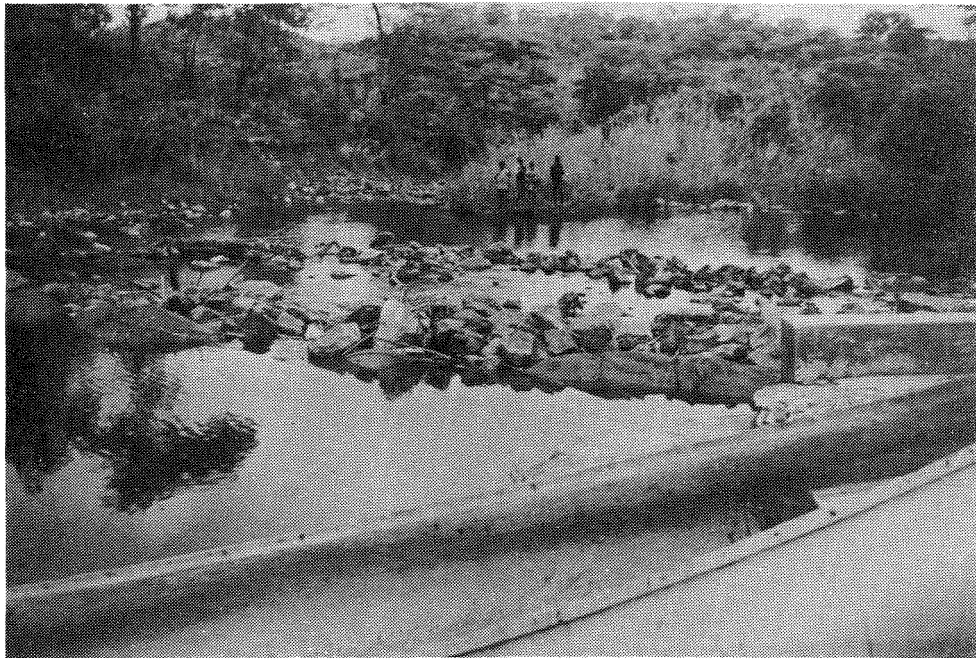
Surface water development for water supply involves the regulation of natural river flows. At nine of the schemes the regulation is arranged by direct abstraction at river intakes and three of them are equipped with provisional rubble weirs across the river (Figure 2).

Figure 2.   Rough rubble weir downstream the river intake (Kasempa).

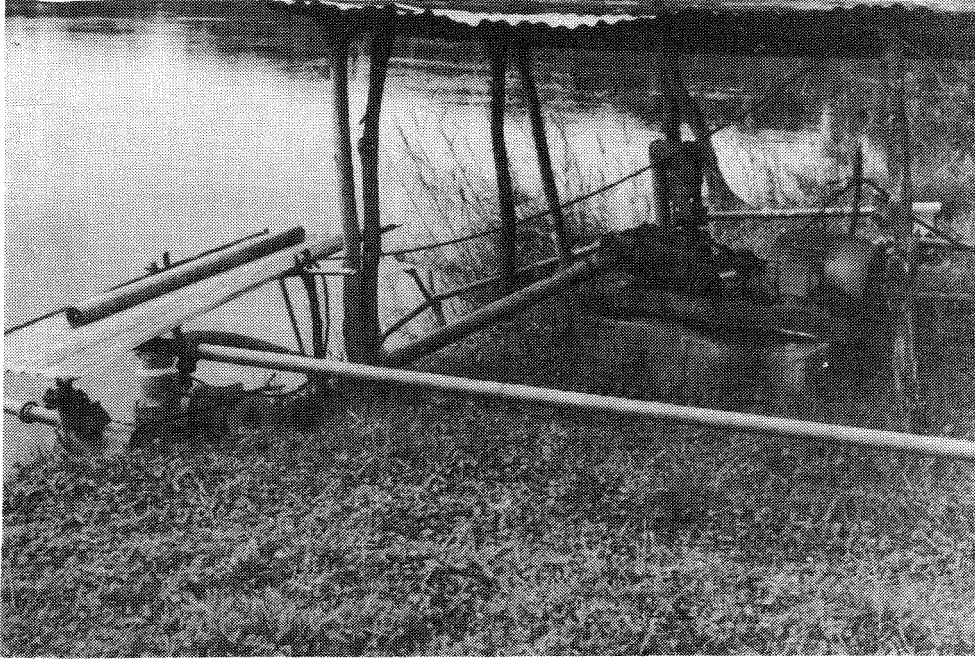
As can be seen from the Figures 5 and 6, the raw water intake arrangements are apparently improvised.

Figure 5. Raw water pumps at Kabompo River.

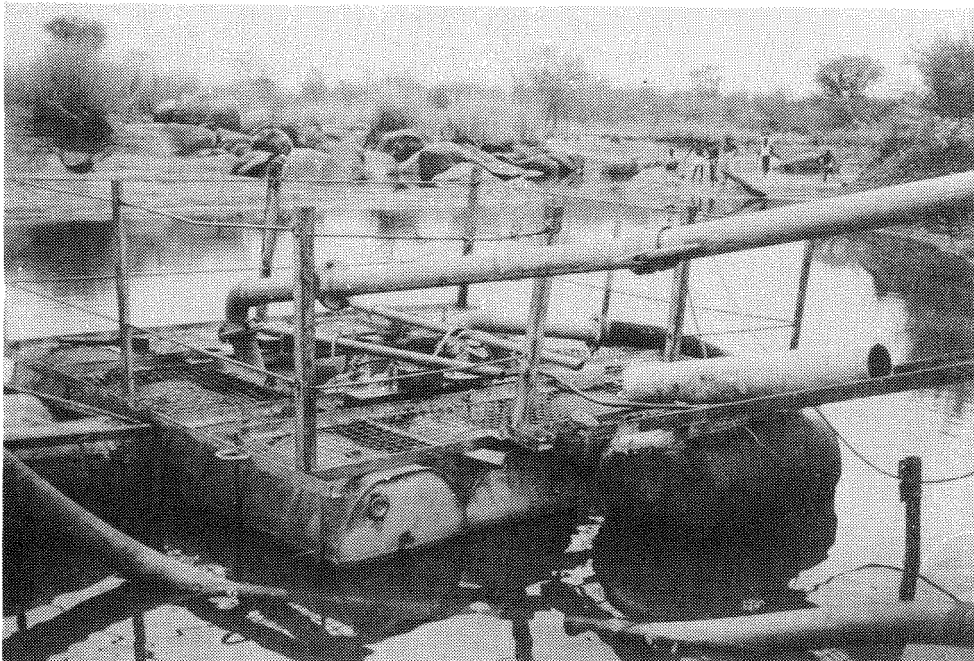
Figure 6. Pontoon mounted raw water pumps (Kalomo).

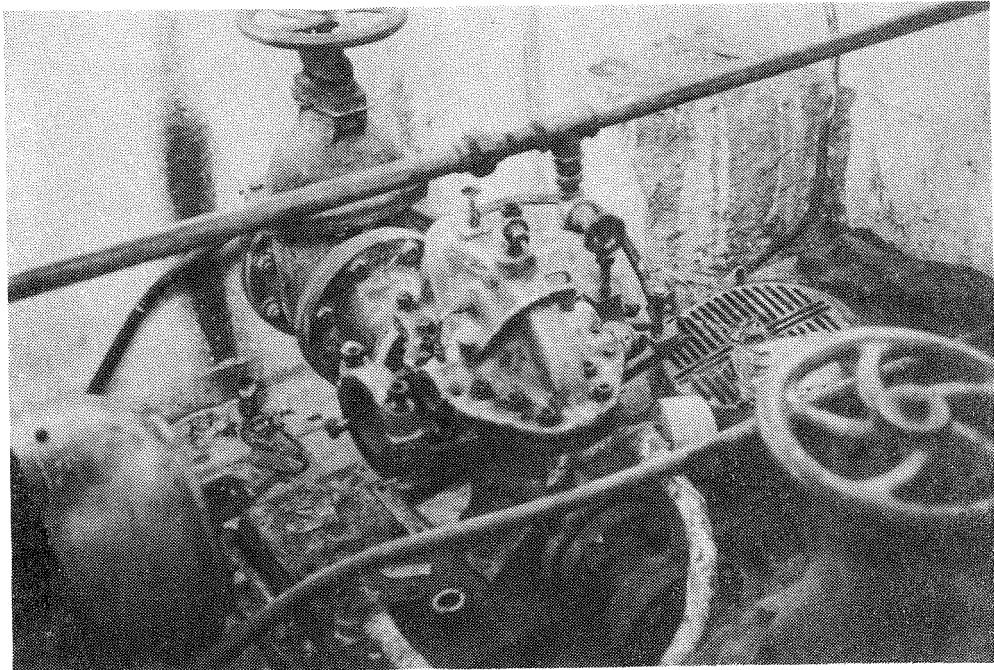
The pumping stations at the schemes visited were in various states of disrepair. Many of pumps had been dismantled and set aside for spares (Figure 7).

Figure 7. A dismantled centrifugal pump.

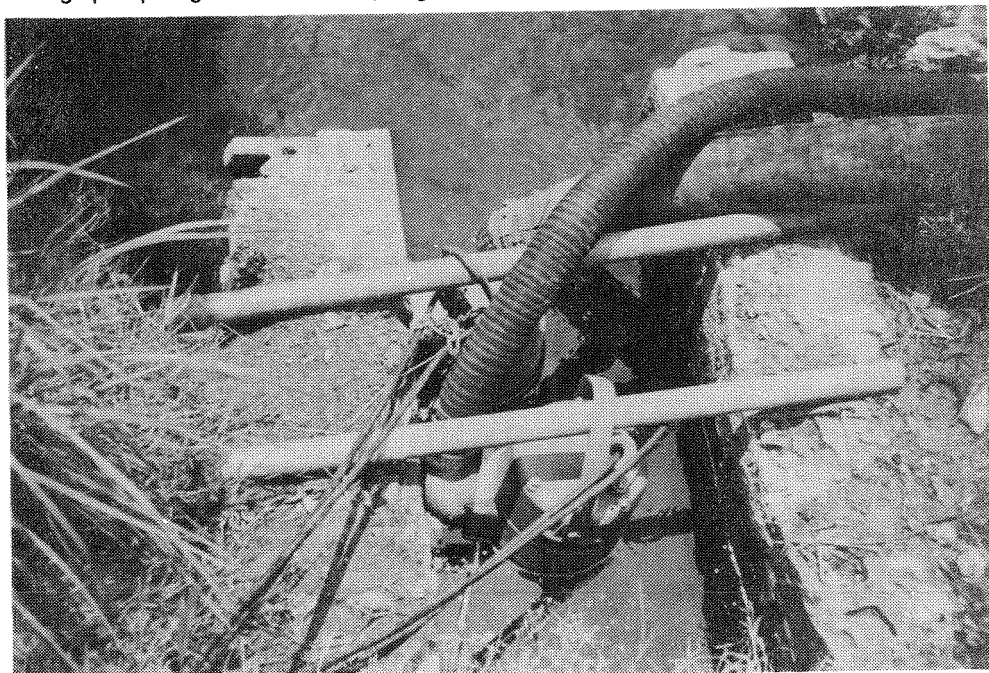
At some schemes pumping of raw water is performed by submersible pumps suspended in the intake sump beside the suction pipeline of the existing pumping stations (Figure 8).

Figure 8. Submerged type of low lift pumps (Solwezi).

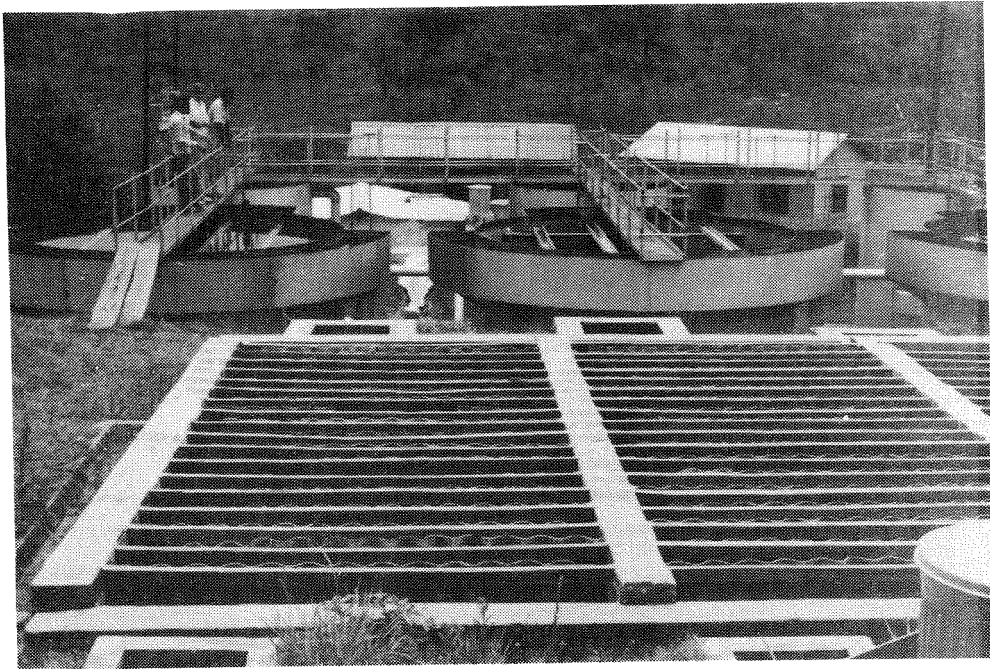
Figure 12. Package treatment plant at Solwezi.

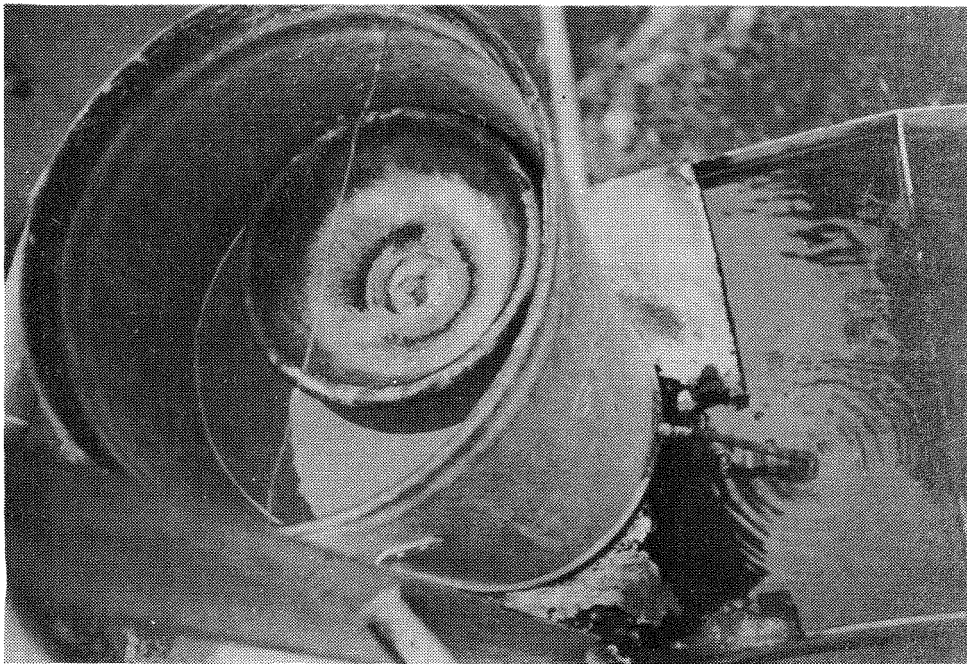
Figure 13. Dosage of chemicals carried out by the drip and bowl
method.

Although it is a cheap and extremely simple method it needs a complete understanding of its capability and limitations.

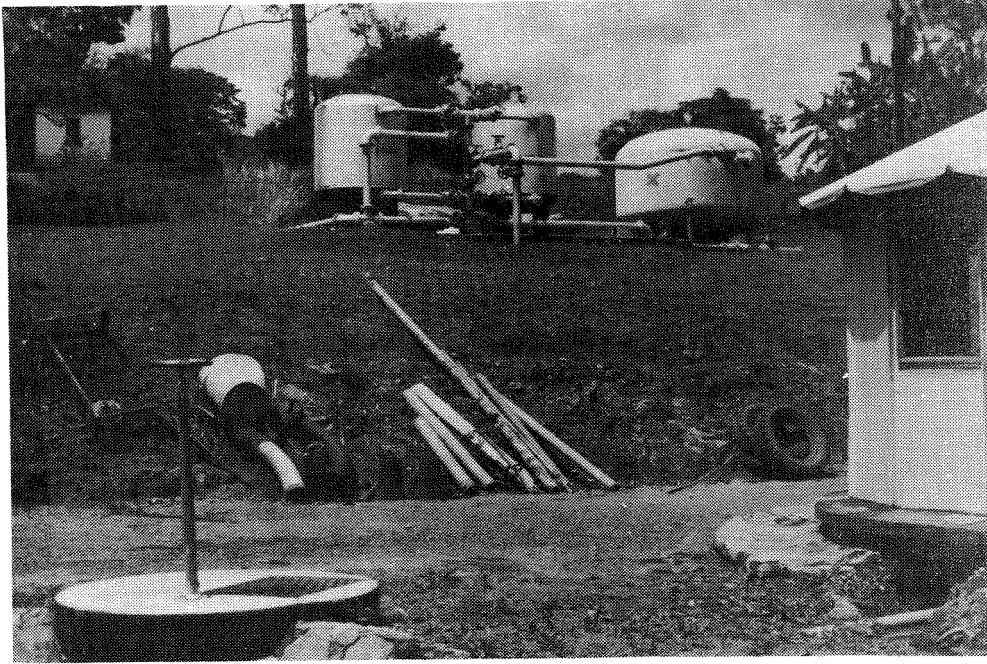
Figure 14. Pressure sand filter at Mwinilunga.

a) Before backwashing.

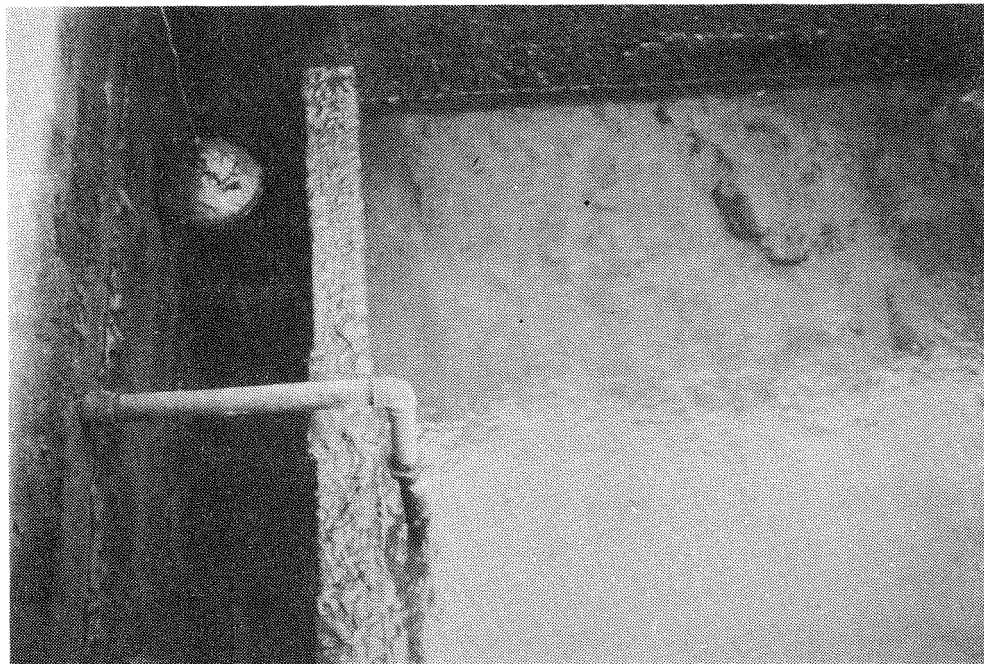
b) During backwashing.

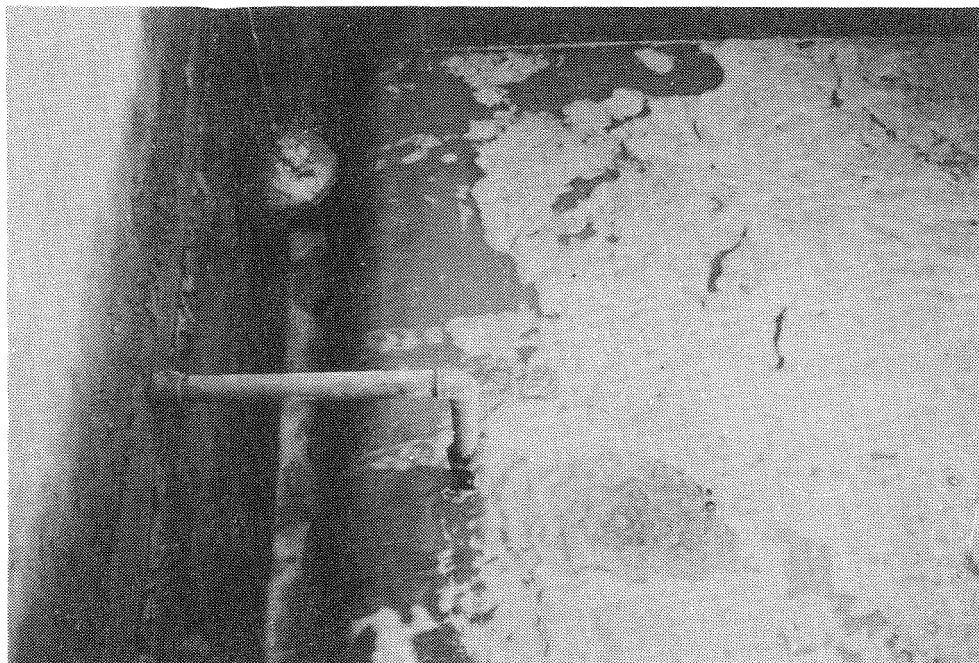
Figure 15. Rapid sand filters at Choma.

A major problem at most of the plants was difficulty in obtaining filter sand of suitable uniformity and grade.

As a result, losses of sand during backwashing etc. were not replaced or were replaced by unsuitable sand. Insufficient backwashing was recognized as a problem at some plants (figure 16).

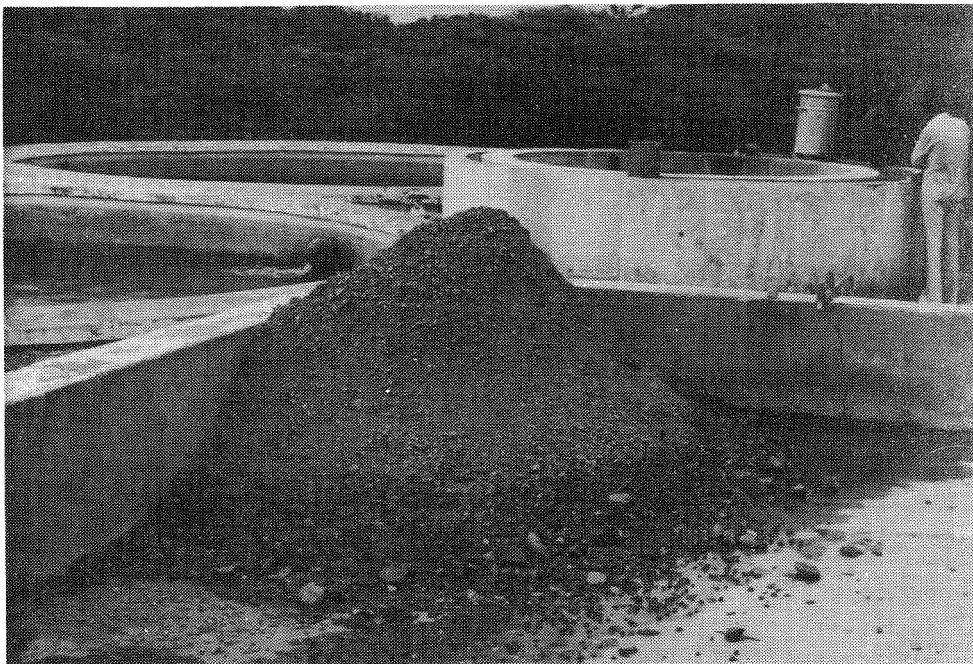
Three of the schemes in the study sample have slow sand filters. The spare sand sample in figure 16 illustrates the problem of getting sand with proper quality.

Figure 16. Slow sand filters at Kasempa.

Probably because of silting all the slow sand filters were operating at reduced capacity and pre-treatment is a requirement. Consequently the filters were by-passed during peak load periods in order to reduce the manpower input to a realistic level.

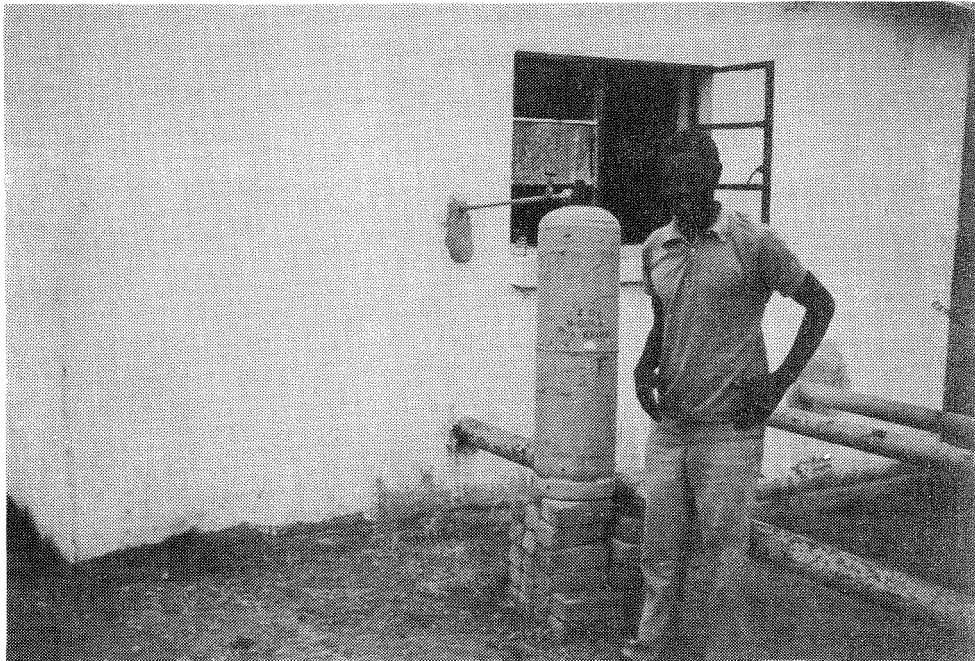
The installation shown in Figure 17 is not suitable for controlled addition of chlorine due to the lack of flow measuring equipment and weight equipment.

Figure 17. Gas chlorinator installation at Kalomo water works.

One should also keep in mind the hazards of leaks on the joints and chlorine pipes. At one particular plant leakage of chlorine caused serious corrosion problems of the electric equipment.
