Askøy municipality. Environmental status and assessment of municipal waste water with regard to the requirement of secondary treatment in the EU Urban Waste Water Directive

Title Askøy municipality. Environmental status and assessment of municipal waste water with regard to the requirement of secondary treatment in the EU Urban Waste Water Directive.	Report No.. 6108-2011	Date 28.01.2011
	Project No. 29247	Pages Price 34
Author(s) Torbjørn M. Johnsen	Topic group Marine ecology	Distribution Free
	Geographical area Hordaland	Printed NIVA

**Environmental status and assessment of municipal
waste water with regard to the requirement of
secondary treatment in the EU Urban Waste Water
Directive**

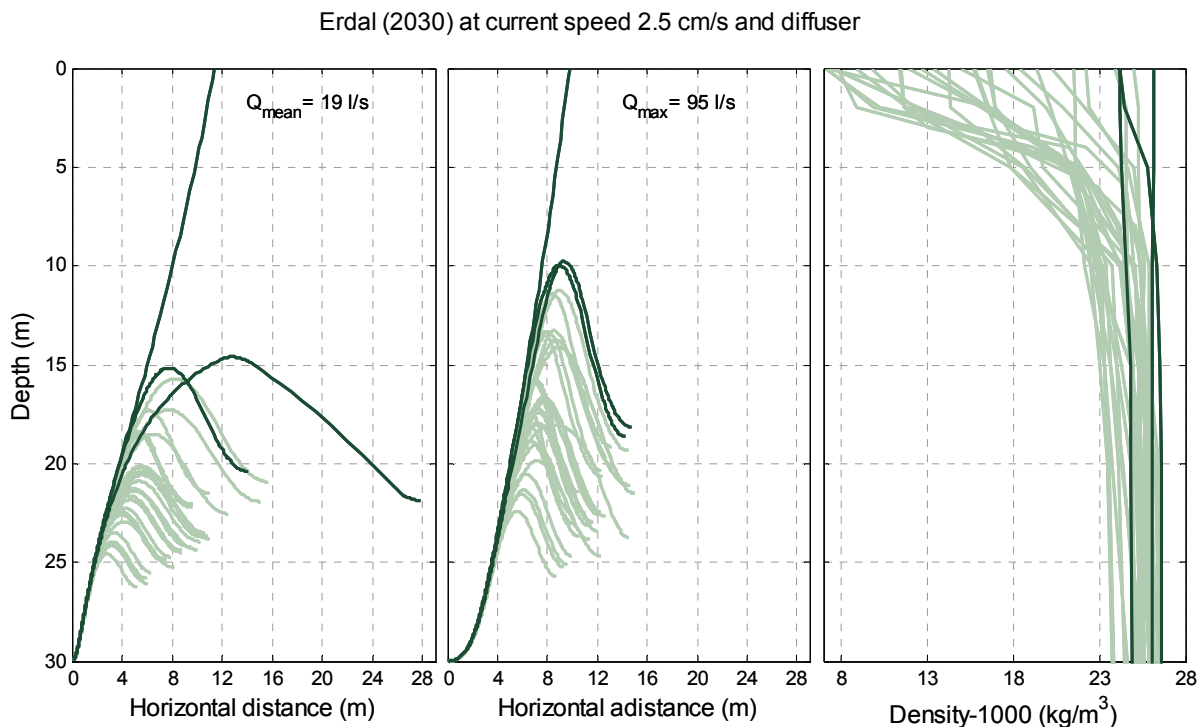
Model calculation of discharge trapping depths relied on ambient current, discharge data for 2007 and 2030 (**Table 1**), and hydrographic conditions at Erdal showed that for most of the hydrographic conditions the discharge trapping depths were deeper than 4 m (discharge depth: 30 m). However, in cases with weak stratification and low current speed the discharge water may reach the surface. For the calculated discharge and water flow in 2030, the best results (trapping depths deeper than 10 m) were achieved if the discharge plume was positioned at 30 m depth and with use of a diffuser (**Figure 9**).

Figure 9. Discharge trapping depth at Erdal calculated for discharge water flows of 19 and 95 l/s in 2030, at 30 m depth, current speed 2.5 cm/s, and use of diffuser (15 holes, diameter = 8 cm, 3 m between holes). Right panel show the different stratification scenarios used. The three situations giving the worst cases are marked with darker colour.

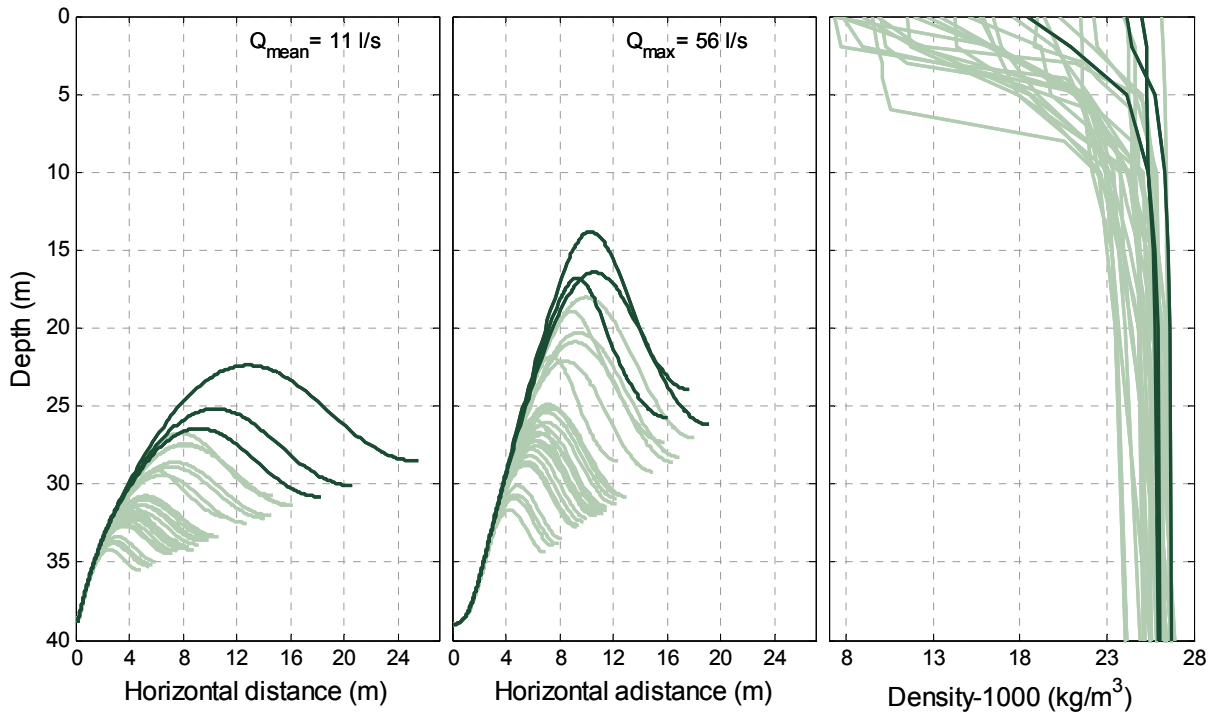
Florvåg (2030) at current speed 2.5 cm/s and diffuser

At Florvåg the discharge depth is 39 m and model calculations by use of data for 2007 discharges showed that the discharge trapping depth is deeper than 12 m. The model calculations for discharge and water flow in 2030 showed that use of a diffuser and a position of the discharge plume at 40 m depth will be acceptable with discharge trapping depths always deeper than 12 m (**Figure 10**).

Figure 10. Discharge trapping depth at Florvåg calculated for discharge water flows of 11 and 56 l/s in 2030, at 39 m depth, current speed 2.5 cm/s, and use of diffuser (15 holes, diameter = 8 cm, 3 m between holes). Right panel show the different stratification scenarios used. The three situations giving the worst cases are marked with darker colour.

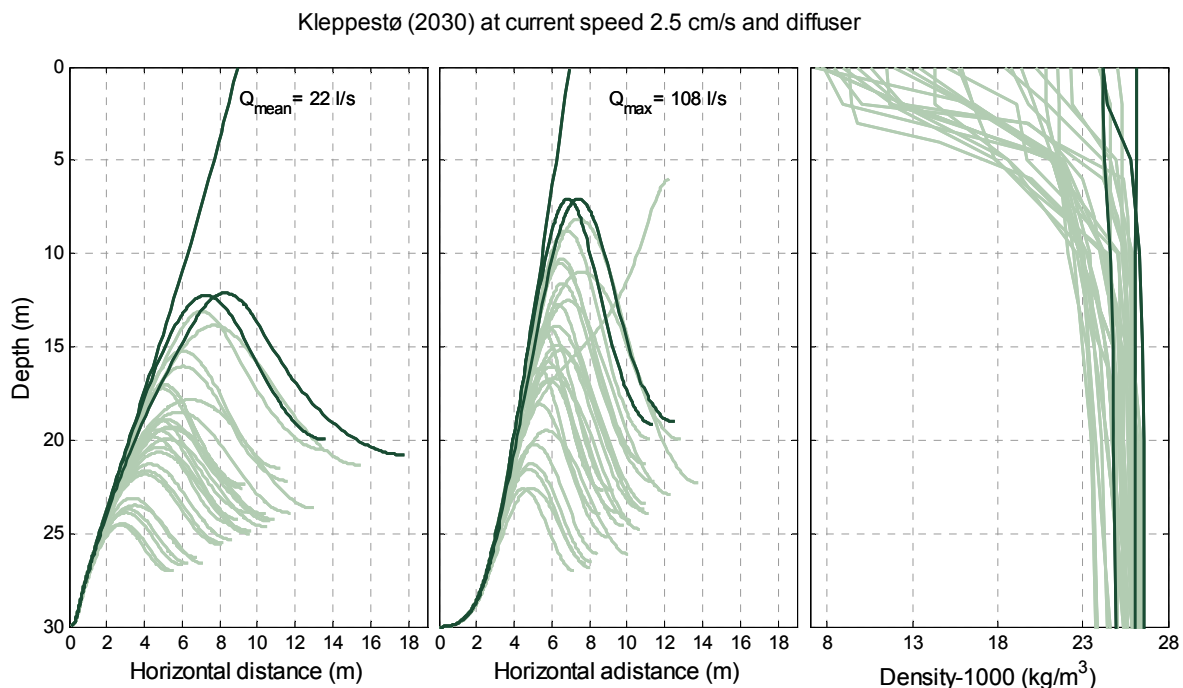
Figure 14 shows the results of model calculation of discharge trapping depths at Kleppestø based on description of discharges in 2030 at average current speeds and average and maximum water flows. The conclusion of these calculations is that a discharge depth of 30 m and use of a diffuser will in nearly all situations result in discharge trapping depths deeper than 7 m.

Figure 14. Discharge trapping depth at Kleppestø calculated for discharge water flows of 22 and 108 l/s in 2030, at 30 m depth, current speed 2.5 cm/s, and use of diffuser (15 holes, diameter = 8 cm, 3 m between holes). Right panel show the different stratification scenarios used. The three situations giving the worst cases are marked with darker colour.

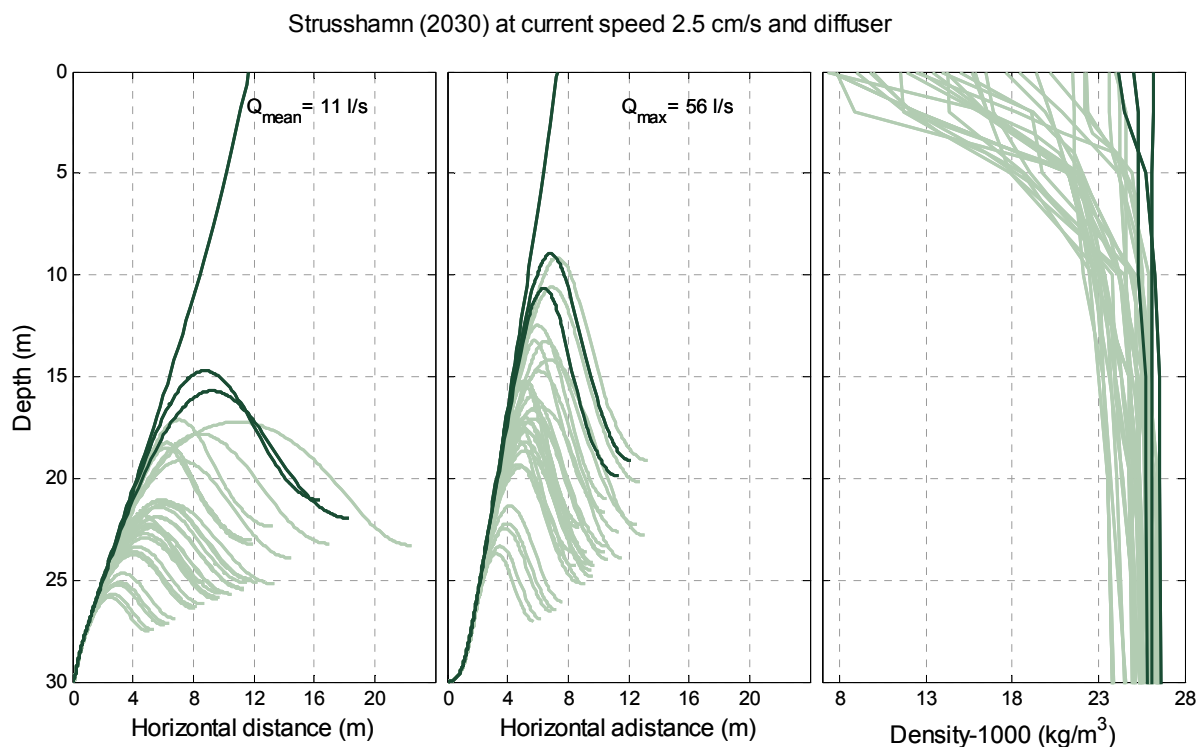
The calculations for Strusshamn by using a discharge depth of 30 m and use of a diffuser will also give very good results with trapping depths deeper than 9 m in nearly all situations (**Figure 15**).

Figure 15. Discharge trapping depth at Strusshamn calculated for discharge water flows of 11 and 56 l/s in 2030, at 30 m depth, current speed 2.5 cm/s, and use of diffuser (15 holes, diameter = 8 cm, 3 m between holes). Right panel show the different stratification scenarios used. The three situations giving the worst cases are marked with darker colour.

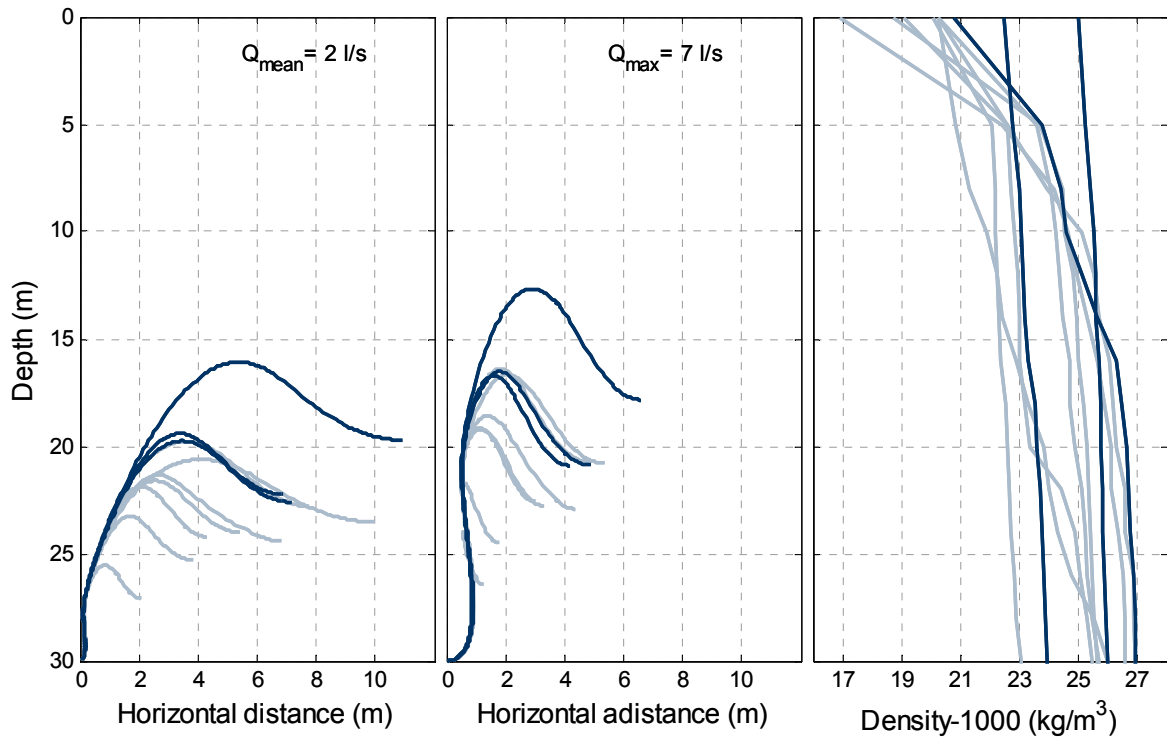
Kollefvåg (2030) at current speed 2.4 cm/s

For Kollevåg the calculations are made for a discharge depth of 30 m, but the real discharge depth is 45 m. Despite this the discharge trapping depths at Kollevåg are deeper than 12 m.

Figure 19. Discharge trapping depth at Kollevåg calculated for discharge water flows of 2 and 7 l/s in 2030, at 30 m depth, and current speed 2.5 cm/s. Right panel show the different stratification scenarios used. The three situations giving the worst cases are marked with darker colour.

- Kollevåg – the discharge can remain as it is to-day (**Figure 19**).
- Hauglandshella – lowering the discharge depth to 40 m or a discharge depth at 30 m and use of a diffusor (**Figure 20, Figure 21**).
- Juvik – lowering the discharge depth to 40 m or a discharge depth at 30 m and use of a diffusor (**Figure 22, Figure 23**).
- Eide (Hetlevik) – lowering the discharge depth to 40 m or a discharge depth at 30 m and use of a diffusor (**Figure 24, Figure 25**).
- Haugadalen (Follese) – lowering the discharge depth to 40 m or a discharge depth at 30 m and use of a diffusor (**Figure 26, Figure 27**).

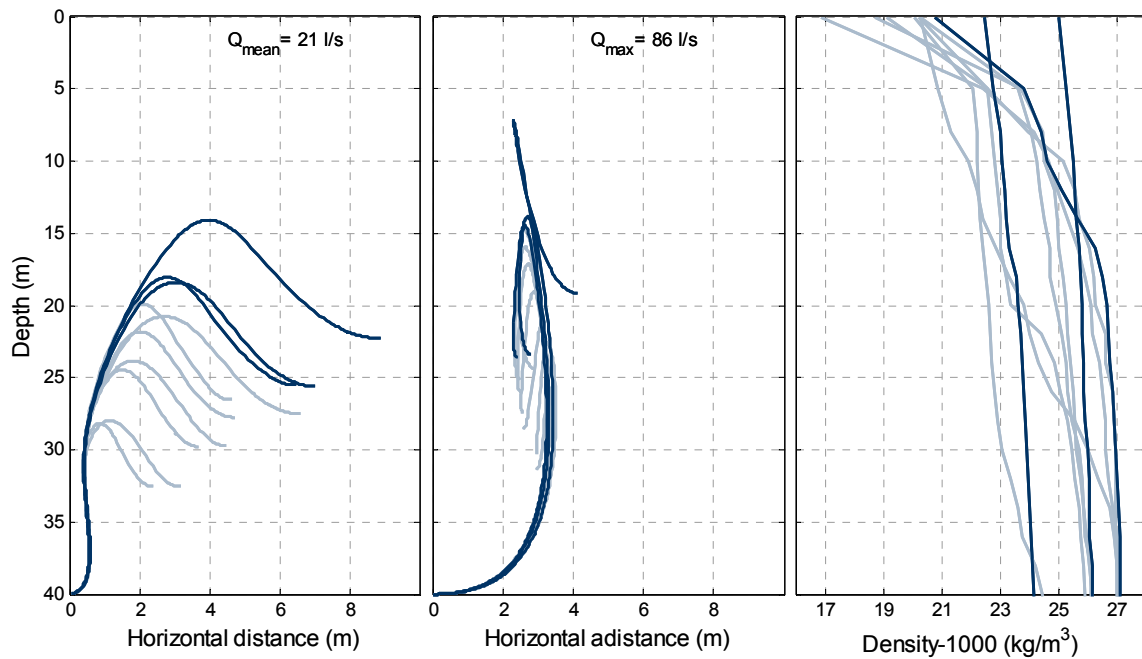
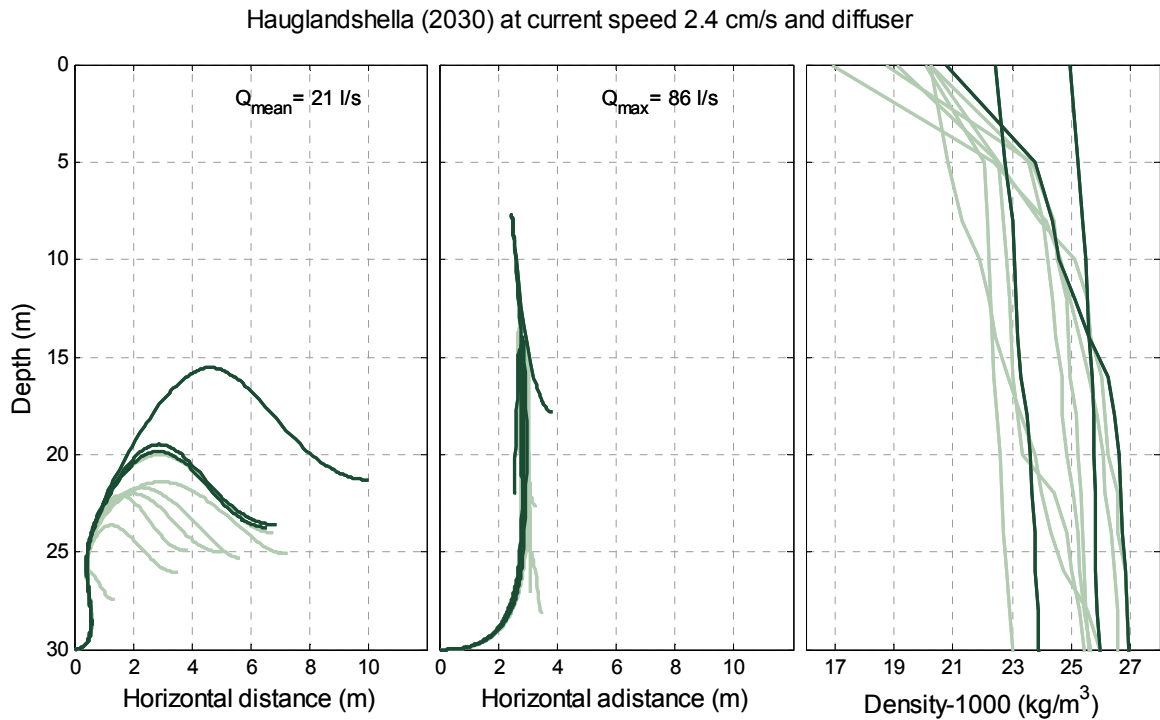
Hauglandshella (2030) at current speed 2.4 cm/s

Figure 20. Discharge trapping depth at Hauglandshella calculated for discharge water flows of 21 and 86 l/s in 2030, discharge depth of 40 m, and current speed 2.4 cm/s. Right panel show the different stratification scenarios used. The three situations giving the worst cases are marked with darker colour.

Figure 21. Discharge trapping depth at Hauglandshella calculated for discharge water flows of 21 and 86 l/s in 2030, discharge depth of 30 m, current speed 2.4 cm/s, and use of a diffuser (10 holes, diameter = 8 cm, 3 m between holes). Right panel show the different stratification scenarios used. The three situations giving the worst cases are marked with darker colour.

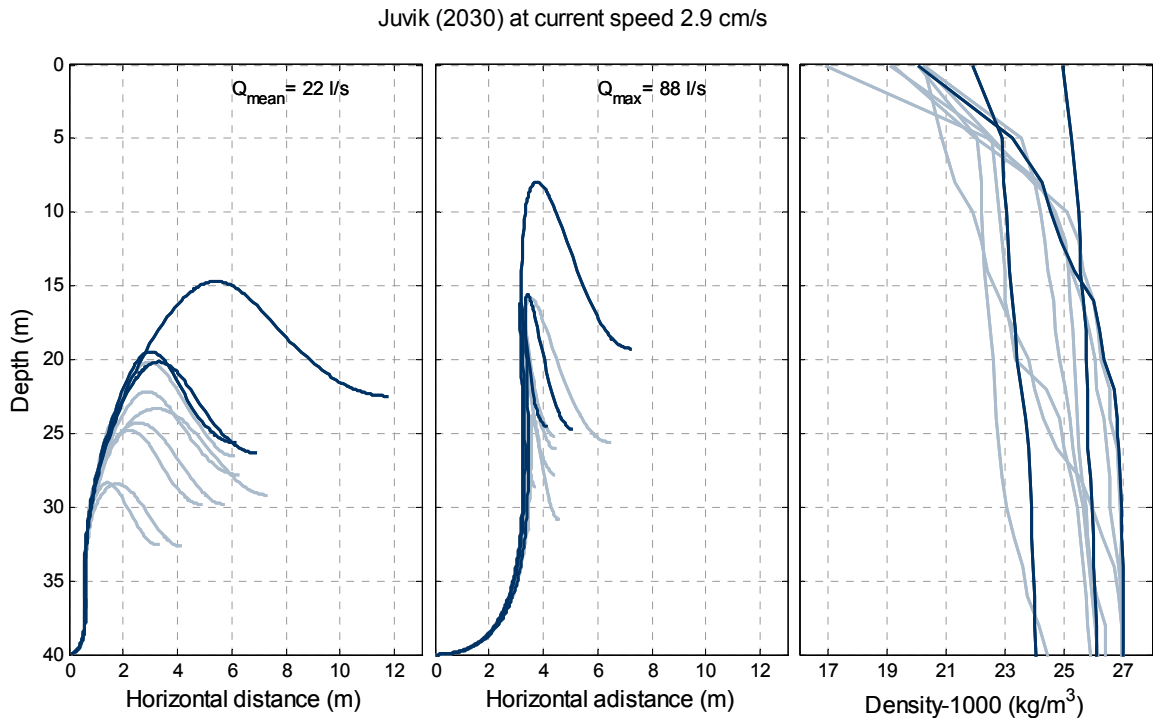
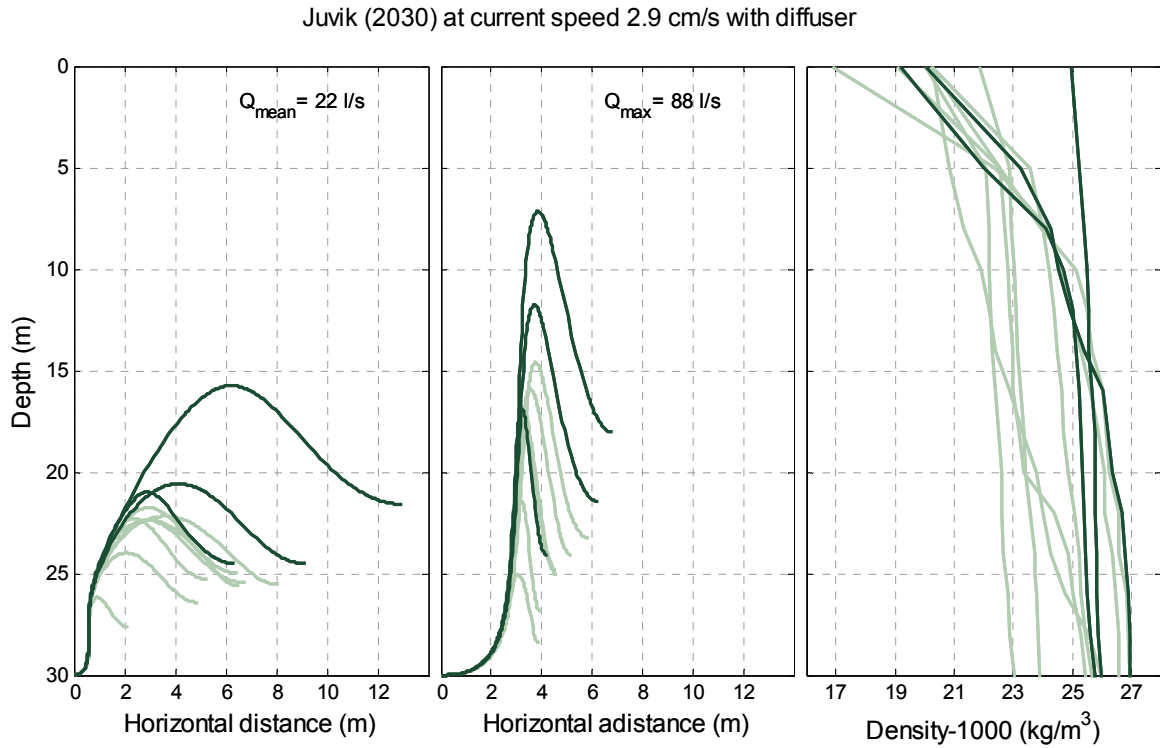
Figure 22. Discharge trapping depth at Juvik calculated for discharge water flows of 22 and 88 l/s in 2030, discharge depth of 40 m, and current speed 2.9 cm/s. Right panel show the different stratification scenarios used. The three situations giving the worst cases are marked with darker colour.

Figure 23. Discharge trapping depth at Juvik calculated for discharge water flows of 22 and 88 l/s in 2030, discharge depth of 30 m, current speed 2.9 cm/s, and use of a diffuser (10 holes, diameter = 8 cm, 3 m between holes). Right panel show the different stratification scenarios used. The three situations giving the worst cases are marked with darker colour.

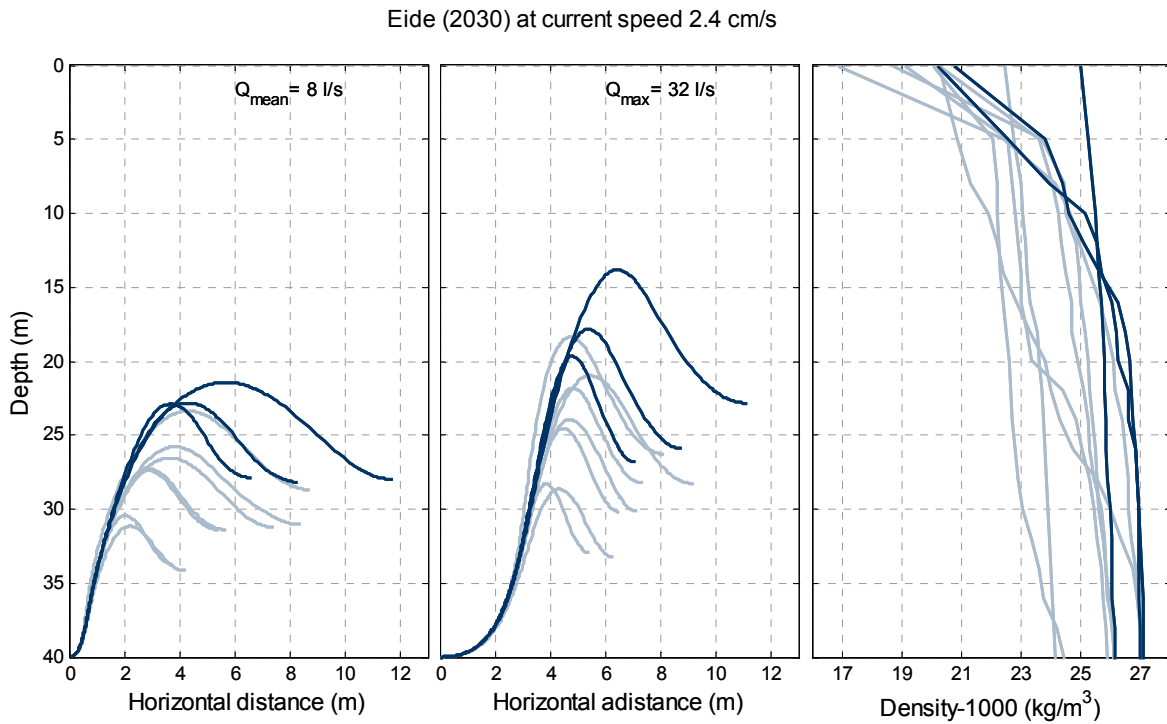
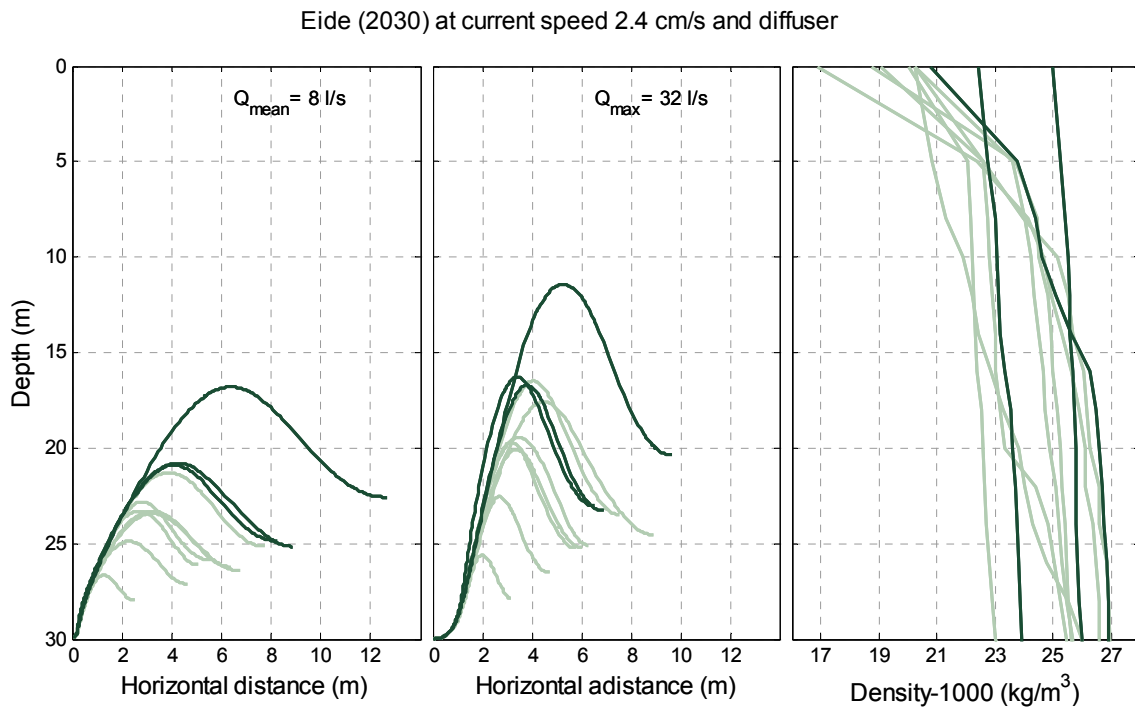
Figure 24. Discharge trapping depth at Eide calculated for discharge water flows of 8 and 32 l/s in 2030, discharge depth of 40 m, and current speed 2.4 cm/s. Right panel show the different stratification scenarios used. The three situations giving the worst cases are marked with darker colour.

Figure 25. Discharge trapping depth at Juvik calculated for discharge water flows of 22 and 88 l/s in 2030, discharge depth of 30 m, current speed 2.4 cm/s, and use of a diffuser (10 holes, diameter = 8 cm, 3 m between holes). Right panel show the different stratification scenarios used. The three situations giving the worst cases are marked with darker colour.

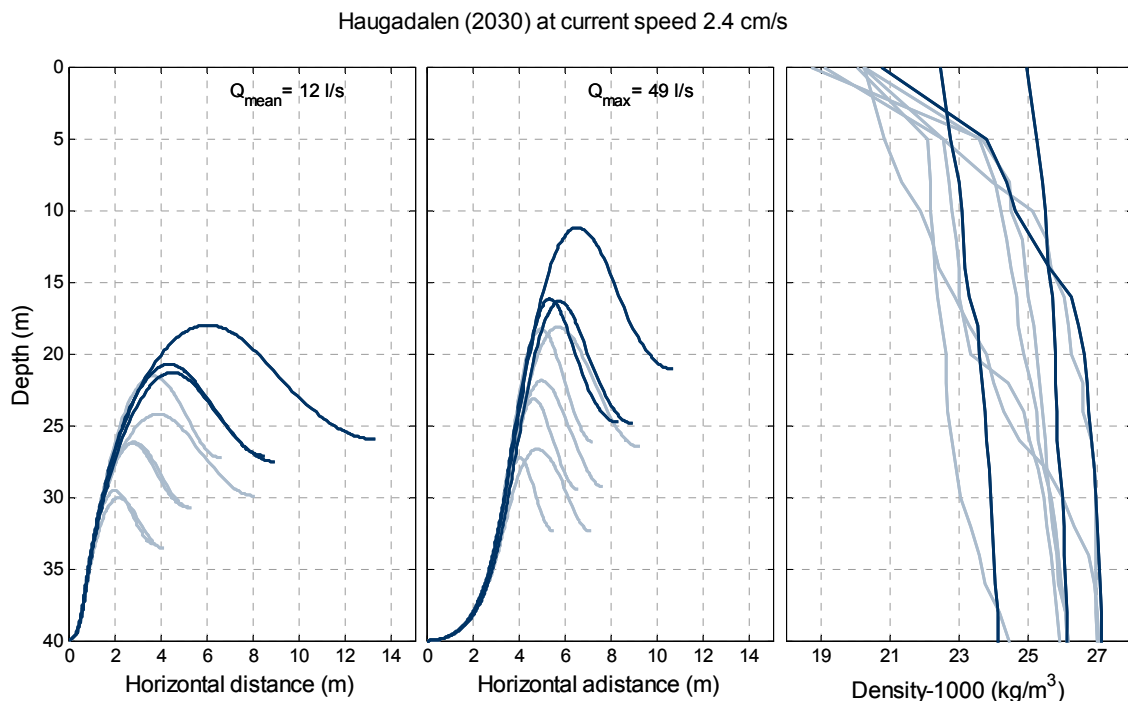
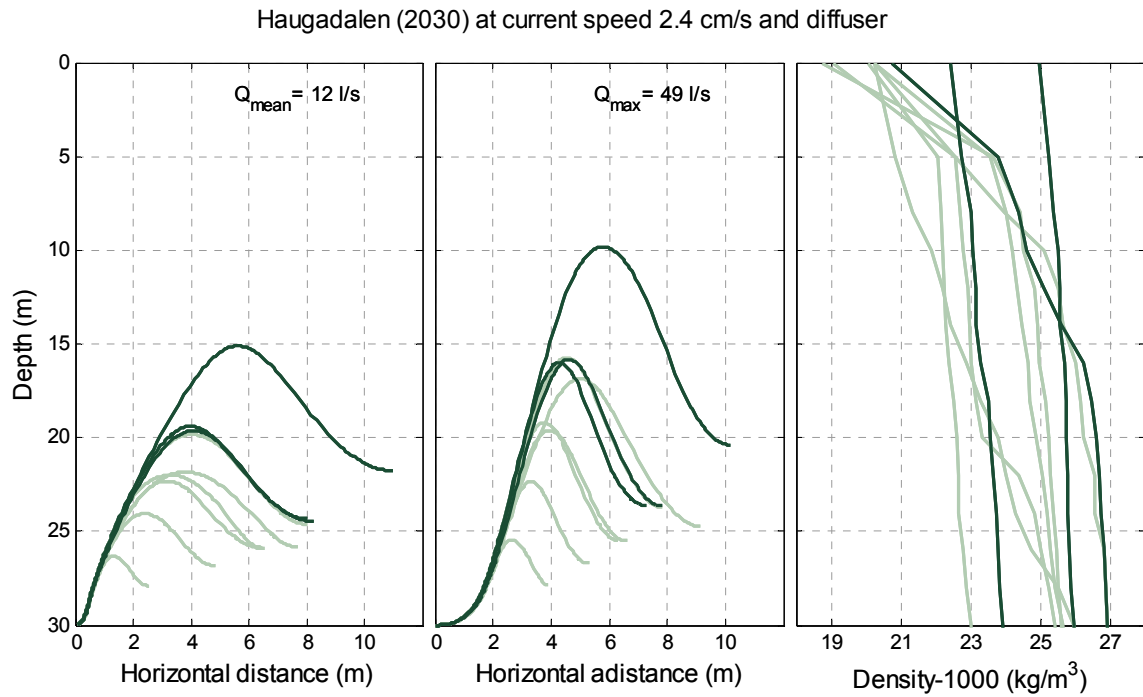
Figure 26. Discharge trapping depth at Haugadalen calculated for discharge water flows of 12 and 49 l/s in 2030, discharge depth of 40 m, and current speed 2.4 cm/s. Right panel show the different stratification scenarios used. The three situations giving the worst cases are marked with darker colour.

Figure 27. Discharge trapping depth at Haugadalen calculated for discharge water flows of 12 and 49 l/s in 2030, discharge depth of 30 m, current speed 2.9 cm/s, and use of a diffuser (10 holes, diameter = 8 cm, 3 m between holes). Right panel show the different stratification scenarios used. The three situations giving the worst cases are marked with darker colour.
