Askøy municipality. Environmental status and assessment of municipal waste water with regard to the requirement of secondary treatment in the EU Urban Waste Water Directive

Title Askøy municipality. Environmental status and assessment of municipal waste water with regard to the requirement of secondary treatment in the EU Urban Waste Water Directive.	Report No.. 6108-2011	Date 28.01.2011
	Project No. 29247	Pages Price 34
Author(s) Torbjørn M. Johnsen	Topic group Marine ecology	Distribution Free
	Geographical area Hordaland	Printed NIVA

Client(s) Askøy municipality, 5323 Kleppestø, Norway	Client ref.
---	-------------

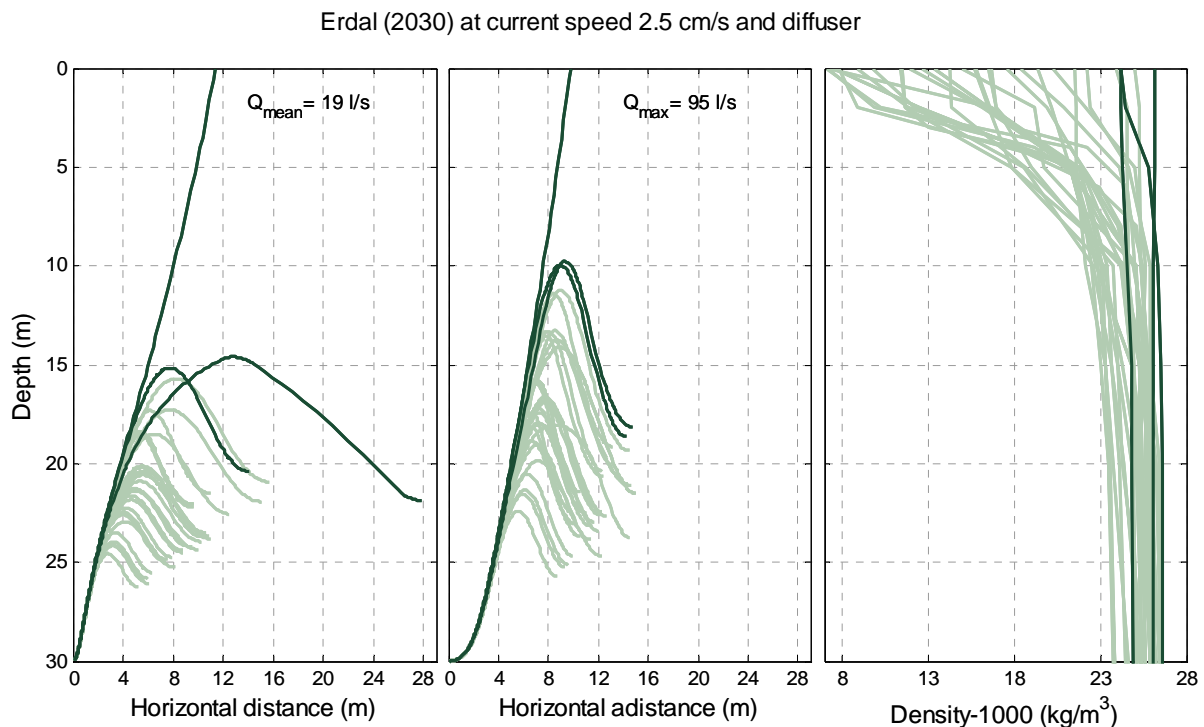
Model calculation of discharge trapping depths relied on ambient current, discharge data for 2007 and 2030 (**Table 1**), and hydrographic conditions at Erdal showed that for most of the hydrographic conditions the discharge trapping depths were deeper than 4 m (discharge depth: 30 m). However, in cases with weak stratification and low current speed the discharge water may reach the surface. For the calculated discharge and water flow in 2030, the best results (trapping depths deeper than 10 m) were achieved if the discharge plume was positioned at 30 m depth and with use of a diffuser (**Figure 9**).

Figure 9. Discharge trapping depth at Erdal calculated for discharge water flows of 19 and 95 l/s in 2030, at 30 m depth, current speed 2.5 cm/s, and use of diffuser (15 holes, diameter = 8 cm, 3 m between holes). Right panel show the different stratification scenarios used. The three situations giving the worst cases are marked with darker colour.

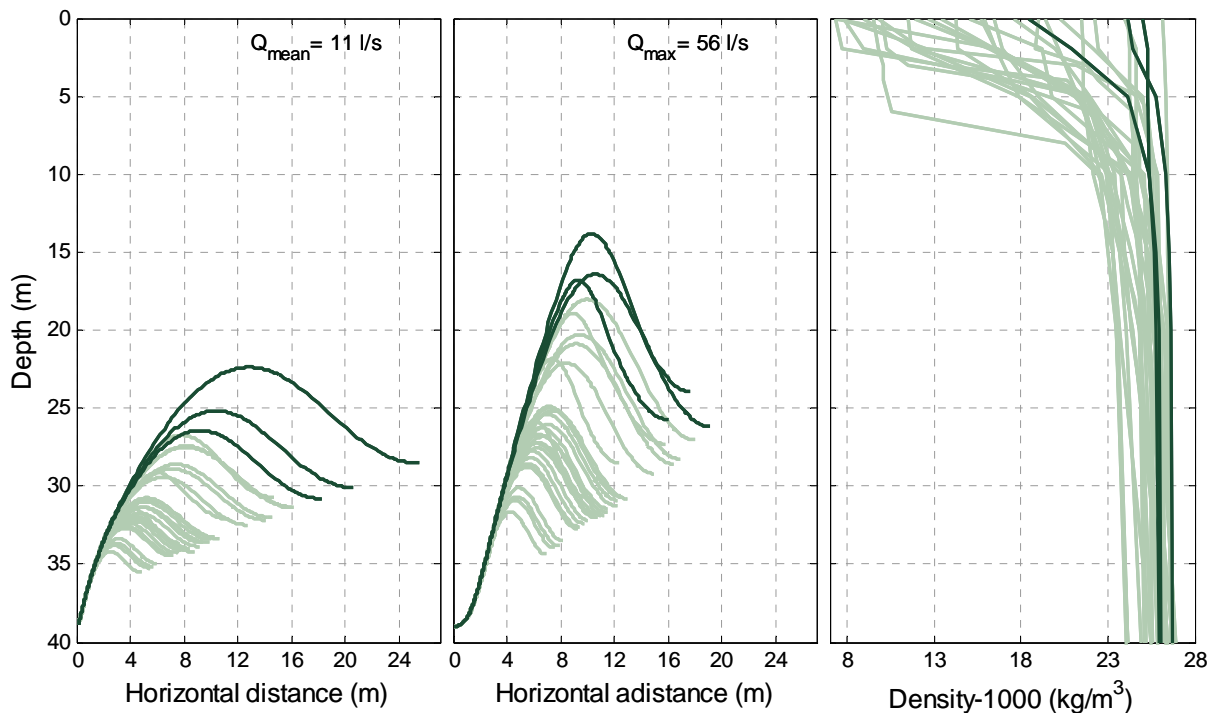
At Florvåg the discharge depth is 39 m and model calculations by use of data for 2007 discharges showed that the discharge trapping depth is deeper than 12 m. The model calculations for discharge and water flow in 2030 showed that use of a diffuser and a position of the discharge plume at 40 m depth will be acceptable with discharge trapping depths always deeper than 12 m (**Figure 10**).

Figure 10. Discharge trapping depth at Florvåg calculated for discharge water flows of 11 and 56 l/s in 2030, at 39 m depth, current speed 2.5 cm/s, and use of diffuser (15 holes, diameter = 8 cm, 3 m between holes). Right panel show the different stratification scenarios used. The three situations giving the worst cases are marked with darker colour.

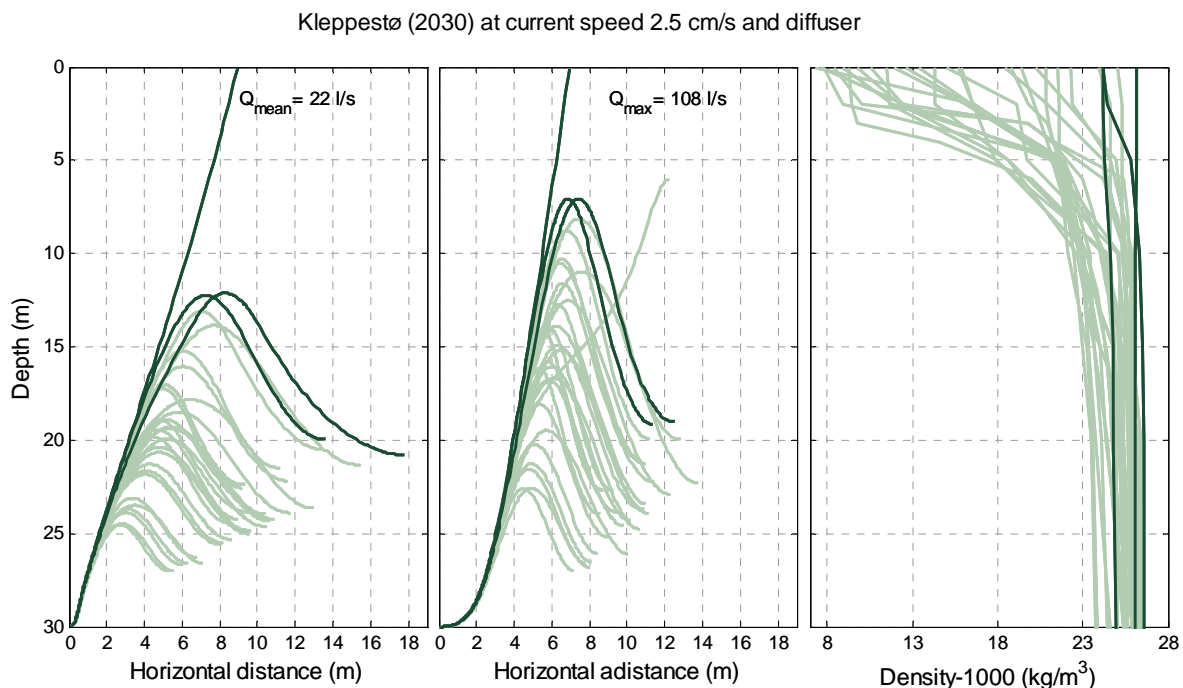
Figure 14 shows the results of model calculation of discharge trapping depths at Kleppestø based on description of discharges in 2030 at average current speeds and average and maximum water flows. The conclusion of these calculations is that a discharge depth of 30 m and use of a diffuser will in nearly all situations result in discharge trapping depths deeper than 7 m.

Figure 14. Discharge trapping depth at Kleppestø calculated for discharge water flows of 22 and 108 l/s in 2030, at 30 m depth, current speed 2.5 cm/s, and use of diffuser (15 holes, diameter = 8 cm, 3 m between holes). Right panel show the different stratification scenarios used. The three situations giving the worst cases are marked with darker colour.

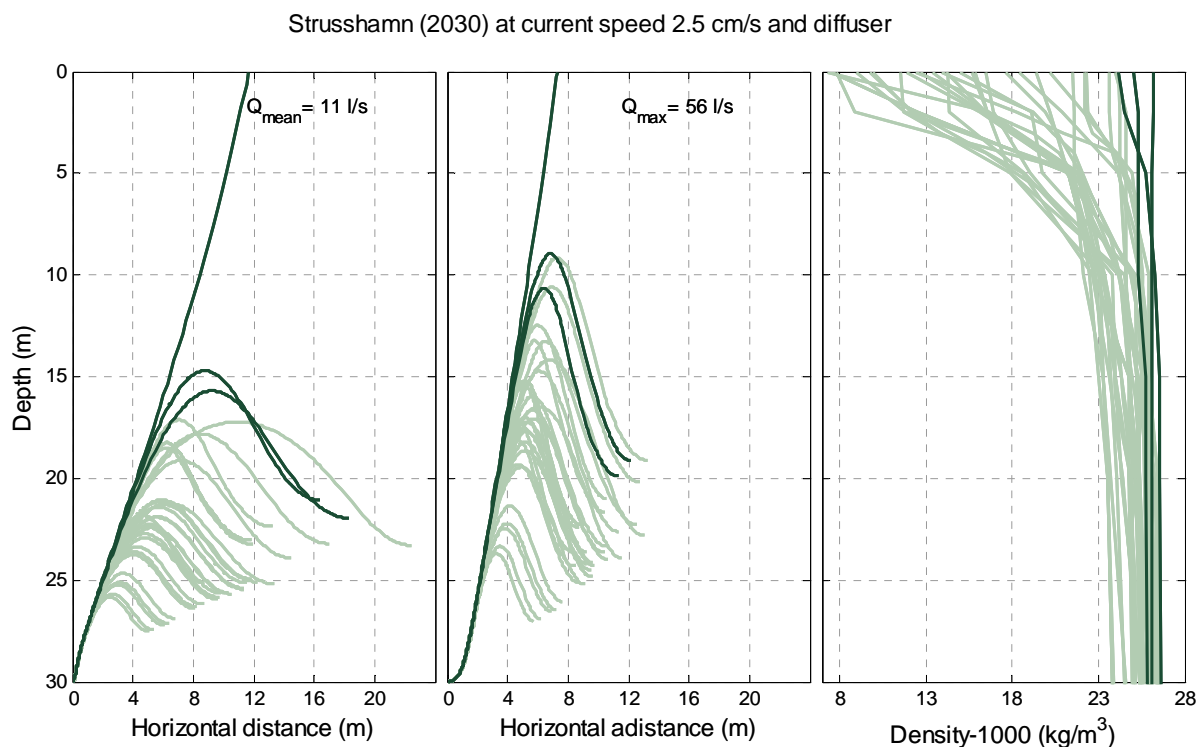
The calculations for Strusshamn by using a discharge depth of 30 m and use of a diffuser will also give very good results with trapping depths deeper than 9 m in nearly all situations (**Figure 15**).

Figure 15. Discharge trapping depth at Strusshamn calculated for discharge water flows of 11 and 56 l/s in 2030, at 30 m depth, current speed 2.5 cm/s, and use of diffuser (15 holes, diameter = 8 cm, 3 m between holes). Right panel show the different stratification scenarios used. The three situations giving the worst cases are marked with darker colour.

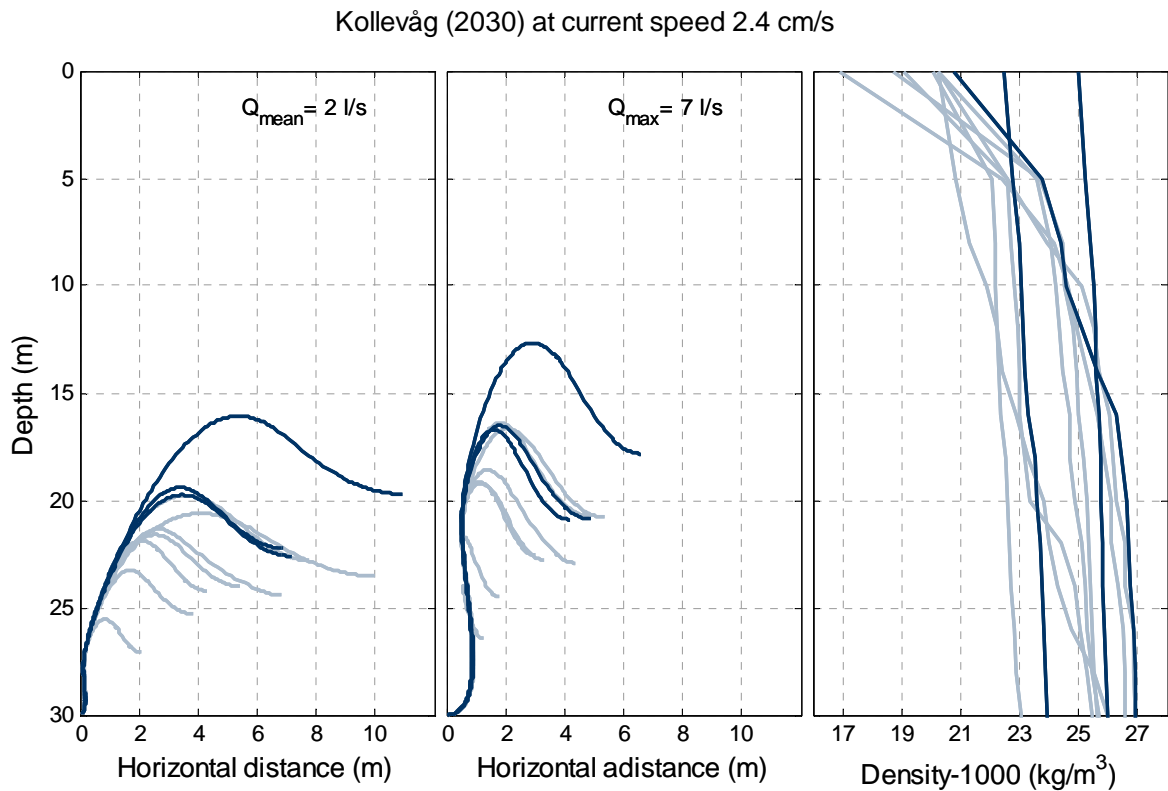
For Kollevåg the calculations are made for a discharge depth of 30 m, but the real discharge depth is 45 m. Despite this the discharge trapping depths at Kollevåg are deeper than 12 m.

Figure 19. Discharge trapping depth at Kollevåg calculated for discharge water flows of 2 and 7 l/s in 2030, at 30 m depth, and current speed 2.5 cm/s. Right panel show the different stratification scenarios used. The three situations giving the worst cases are marked with darker colour.

- Kollevåg – the discharge can remain as it is to-day (**Figure 19**).
- Hauglandshella – lowering the discharge depth to 40 m or a discharge depth at 30 m and use of a diffusor (**Figure 20, Figure 21**).
- Juvik – lowering the discharge depth to 40 m or a discharge depth at 30 m and use of a diffusor (**Figure 22, Figure 23**).
- Eide (Hetlevik) – lowering the discharge depth to 40 m or a discharge depth at 30 m and use of a diffusor (**Figure 24, Figure 25**).
- Haugadalen (Follese) – lowering the discharge depth to 40 m or a discharge depth at 30 m and use of a diffusor (**Figure 26, Figure 27**).

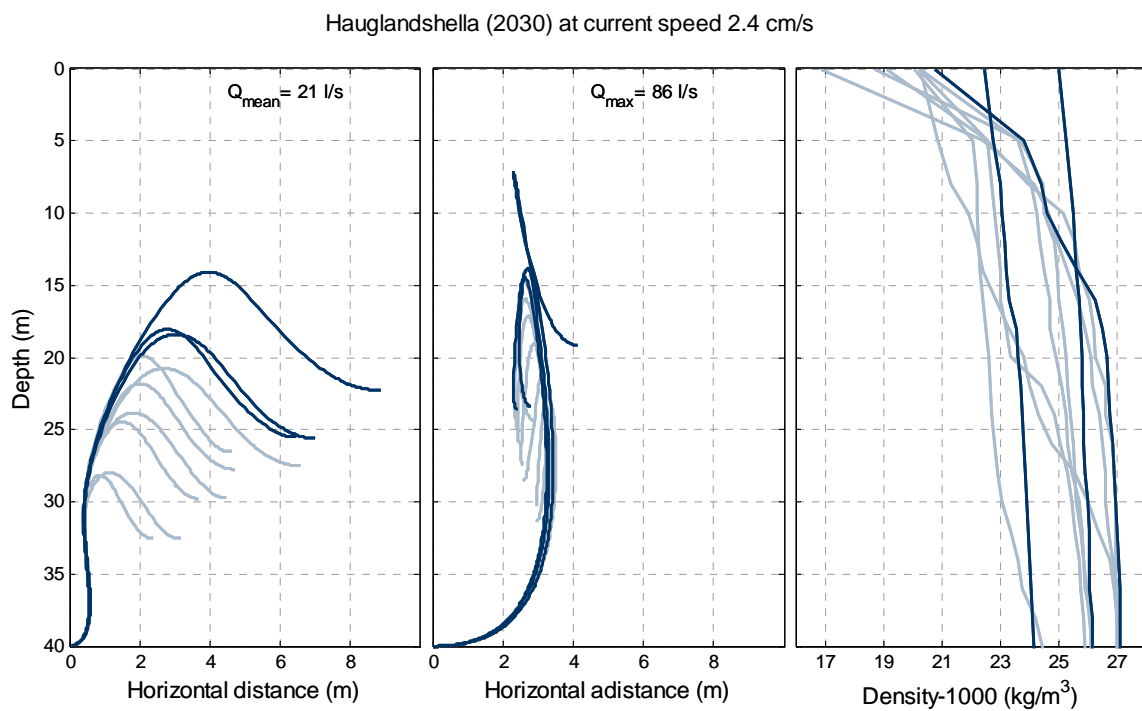
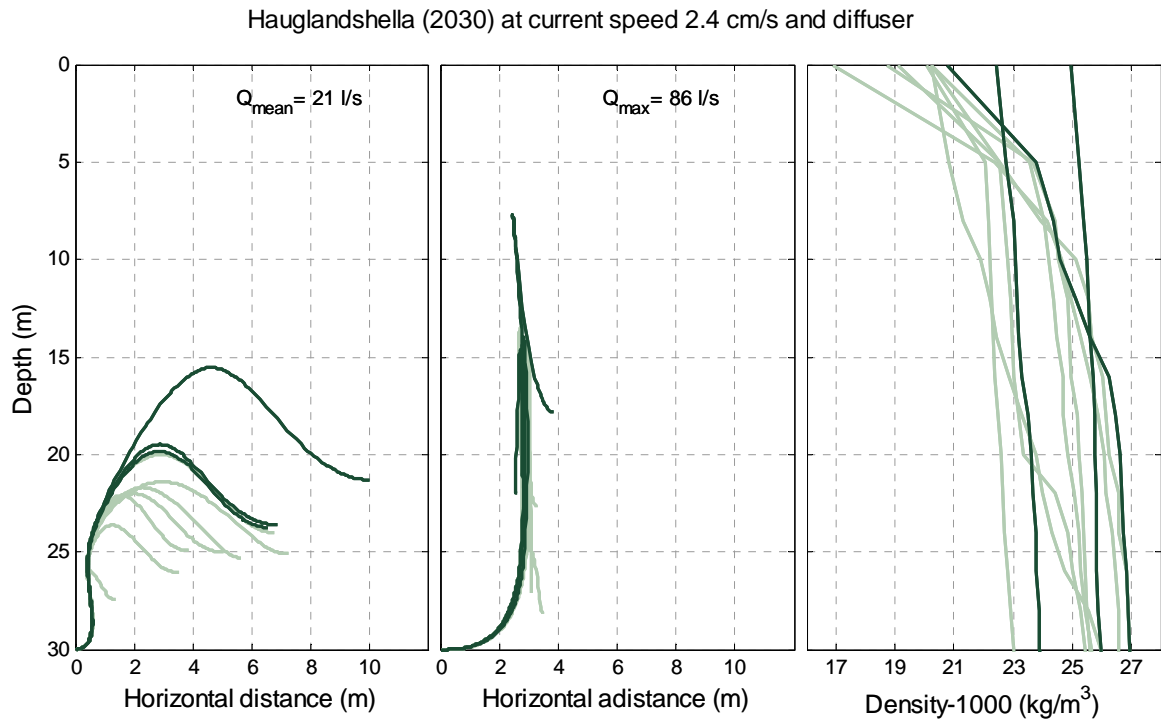
Figure 20. Discharge trapping depth at Hauglandshella calculated for discharge water flows of 21 and 86 l/s in 2030, discharge depth of 40 m, and current speed 2.4 cm/s. Right panel show the different stratification scenarios used. The three situations giving the worst cases are marked with darker colour.

Figure 21. Discharge trapping depth at Hauglandshella calculated for discharge water flows of 21 and 86 l/s in 2030, discharge depth of 30 m, current speed 2.4 cm/s, and use of a diffuser (10 holes, diameter = 8 cm, 3 m between holes). Right panel show the different stratification scenarios used. The three situations giving the worst cases are marked with darker colour.

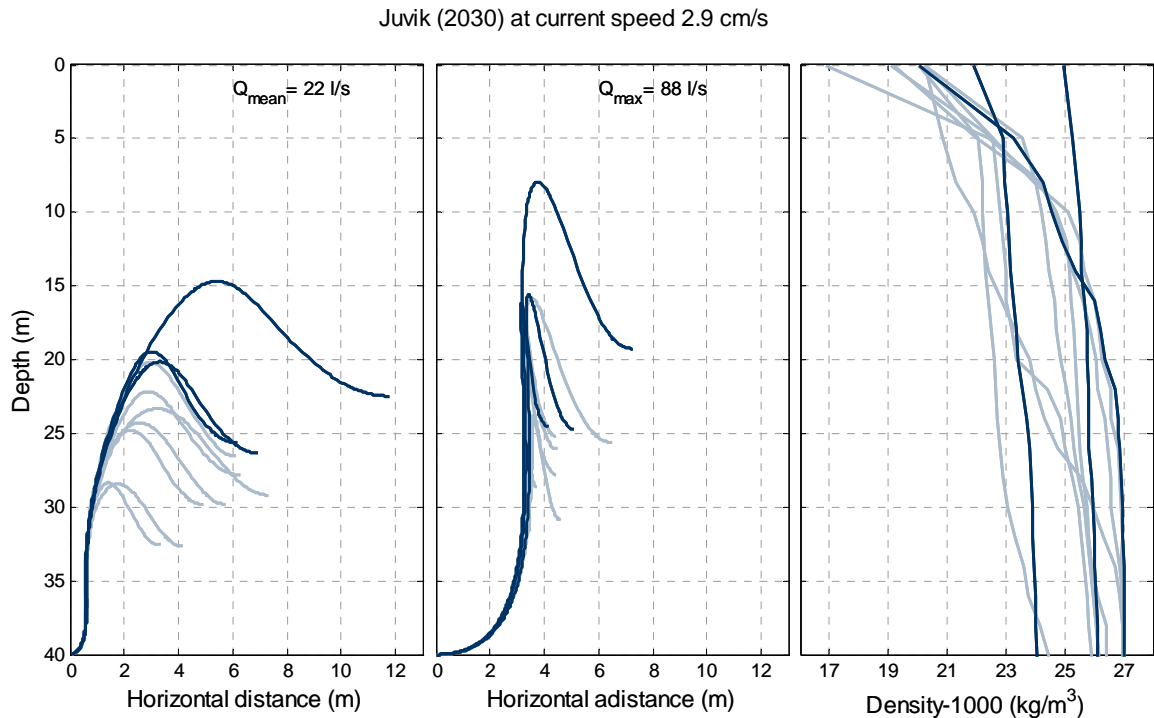
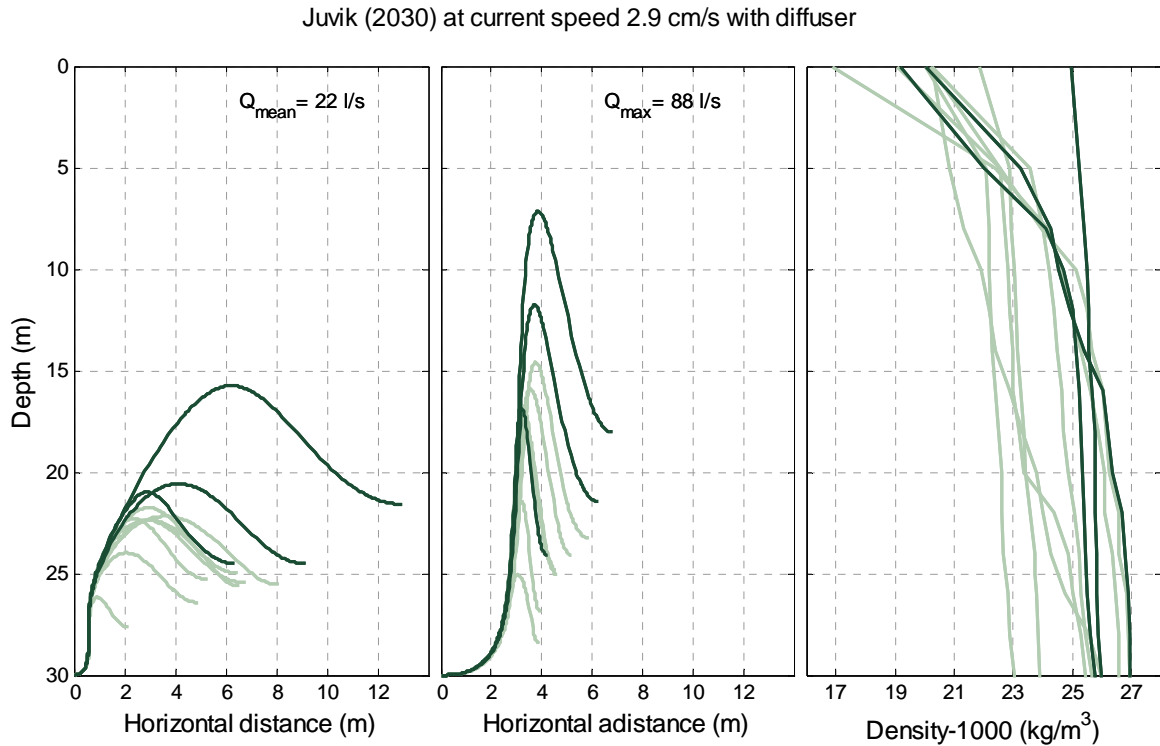
Figure 22. Discharge trapping depth at Juvik calculated for discharge water flows of 22 and 88 l/s in 2030, discharge depth of 40 m, and current speed 2.9 cm/s. Right panel show the different stratification scenarios used. The three situations giving the worst cases are marked with darker colour.

Figure 23. Discharge trapping depth at Juvik calculated for discharge water flows of 22 and 88 l/s in 2030, discharge depth of 30 m, current speed 2.9 cm/s, and use of a diffuser (10 holes, diameter = 8 cm, 3 m between holes). Right panel show the different stratification scenarios used. The three situations giving the worst cases are marked with darker colour.

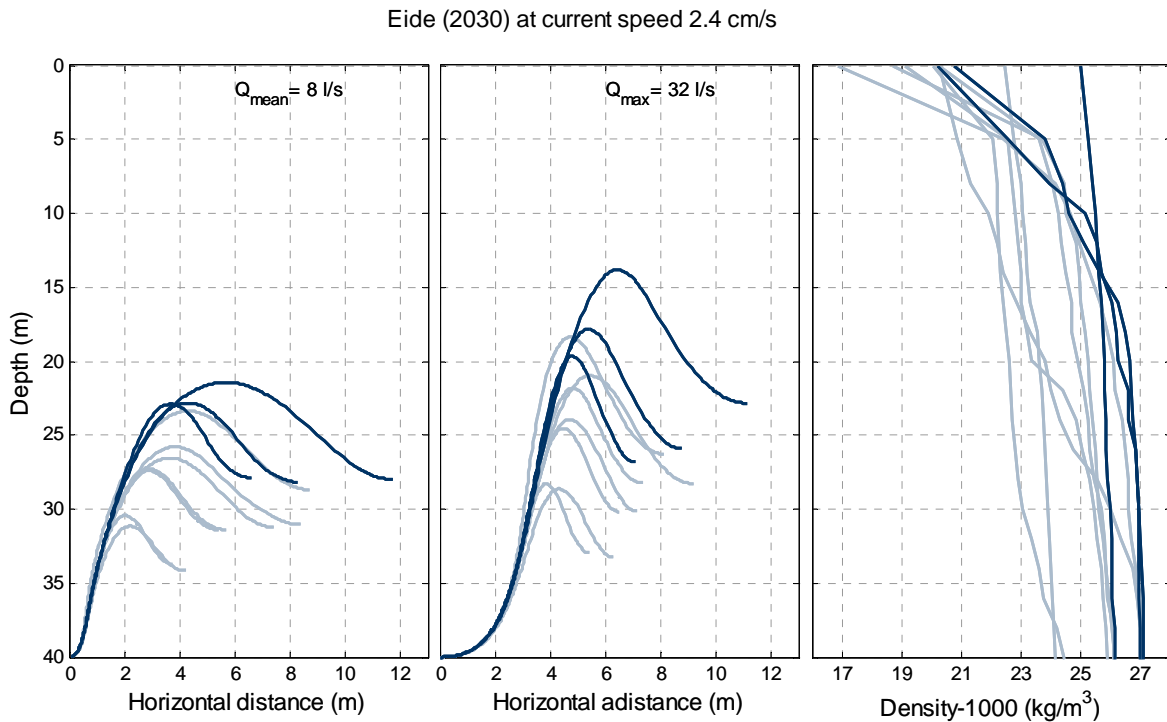
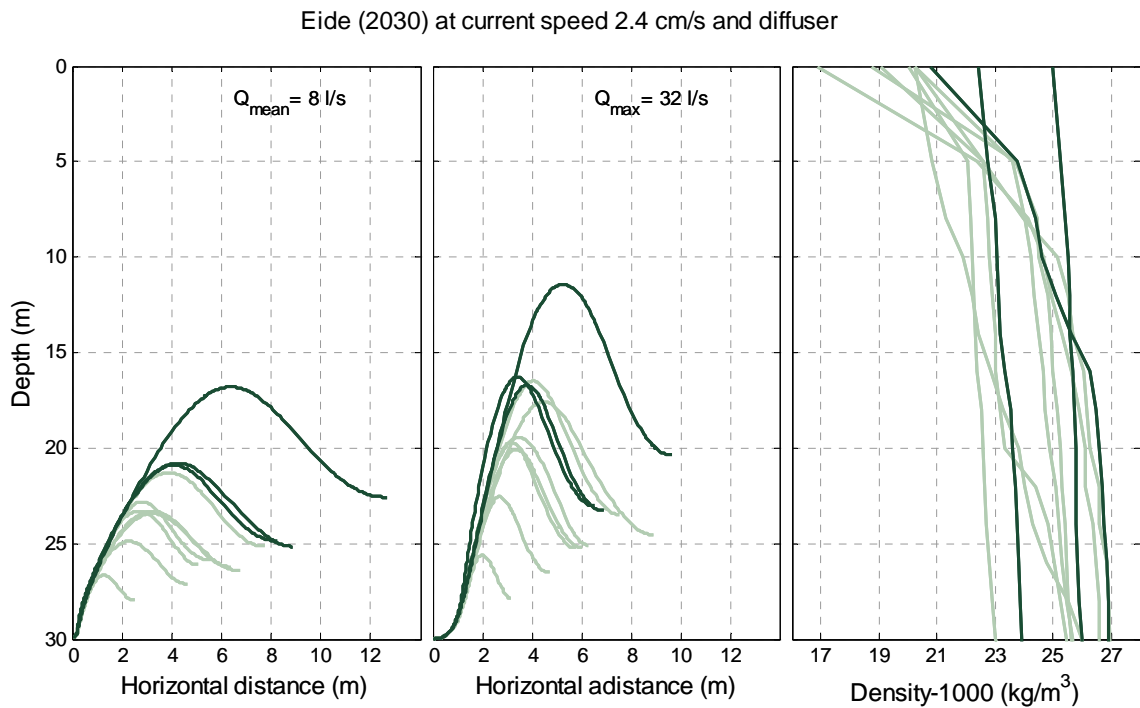
Figure 24. Discharge trapping depth at Eide calculated for discharge water flows of 8 and 32 l/s in 2030, discharge depth of 40 m, and current speed 2.4 cm/s. Right panel show the different stratification scenarios used. The three situations giving the worst cases are marked with darker colour.

Figure 25. Discharge trapping depth at Juvik calculated for discharge water flows of 22 and 88 l/s in 2030, discharge depth of 30 m, current speed 2.4 cm/s, and use of a diffuser (10 holes, diameter = 8 cm, 3 m between holes). Right panel show the different stratification scenarios used. The three situations giving the worst cases are marked with darker colour.

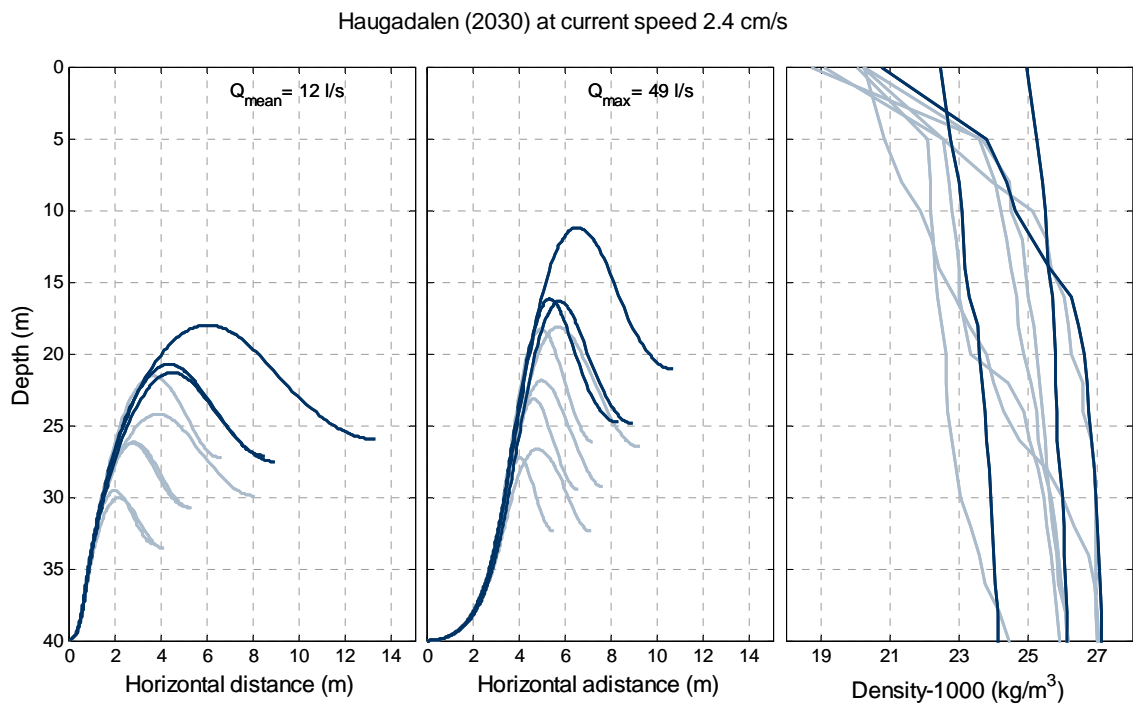
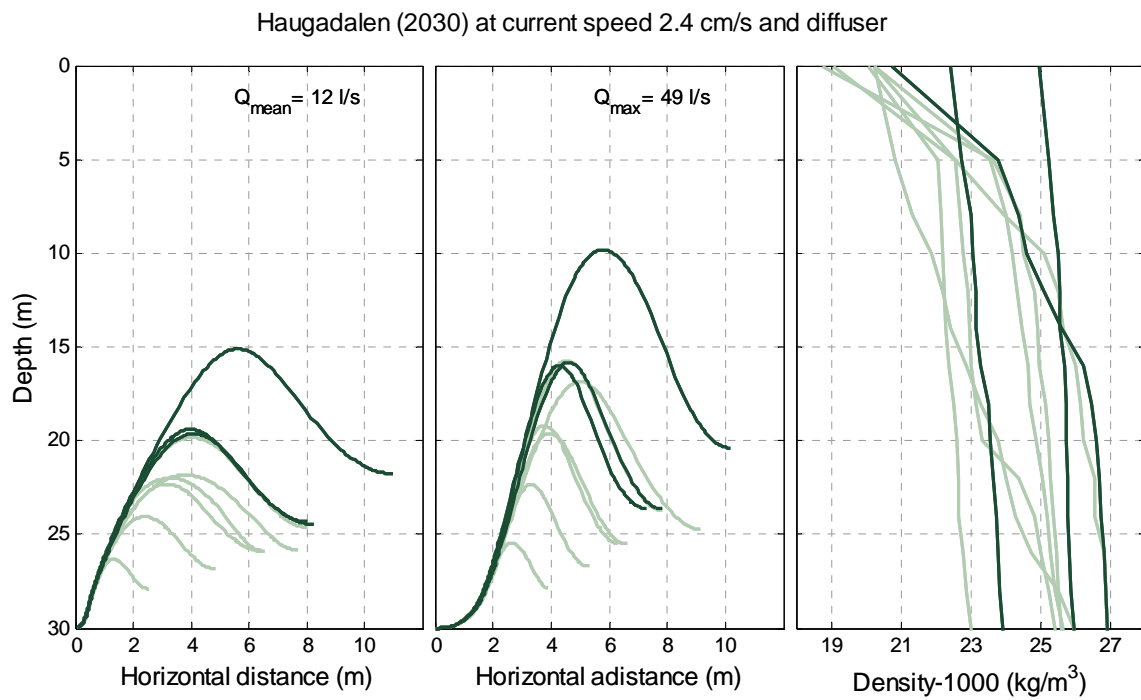
Figure 26. Discharge trapping depth at Haugadalen calculated for discharge water flows of 12 and 49 l/s in 2030, discharge depth of 40 m, and current speed 2.4 cm/s. Right panel show the different stratification scenarios used. The three situations giving the worst cases are marked with darker colour.

Figure 27. Discharge trapping depth at Haugadalen calculated for discharge water flows of 12 and 49 l/s in 2030, discharge depth of 30 m, current speed 2.9 cm/s, and use of a diffuser (10 holes, diameter = 8 cm, 3 m between holes). Right panel show the different stratification scenarios used. The three situations giving the worst cases are marked with darker colour.
