REPORT SNO 4741-2003

Environmental Impact Assessment of the Alto Yuna Multipurpose Project

Topical Report on Water Quality,
Aquatic Life and Fish in the affected
Water Bodies

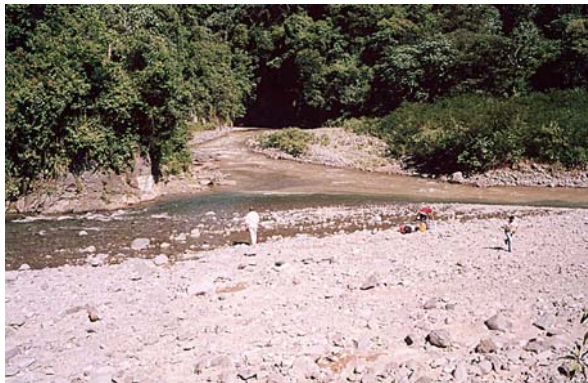
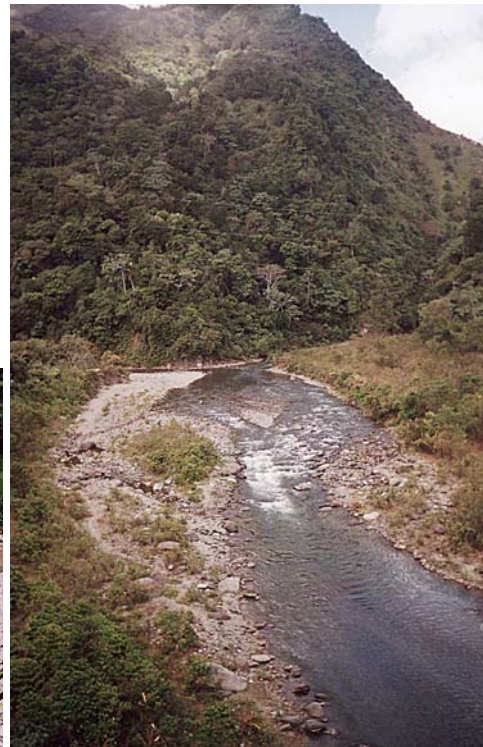
Figure 3.1 Station 1; Rio Yuna (the clear water river from the left) at the confluence with Rio Blanco. In the dry season, Rio Blanco was of the clear water type (right panel).

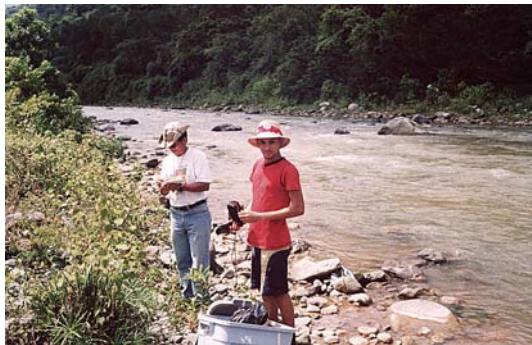
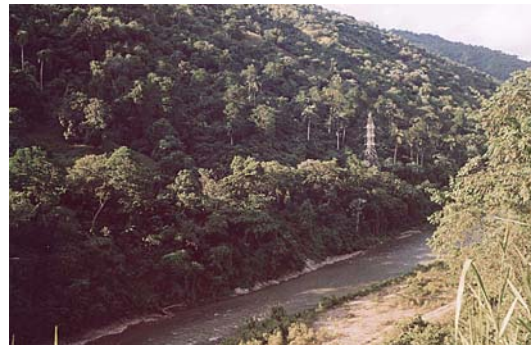
Station/date **2: Rio Yuna at dam site 9/10-02**
Site description Rapids with bottom consisting of stones and gravel (course sand to stones 25 cm in diameter). The water was turbid. The stones were covered by a thin layer of silt. A few patches of filamentous green algae had about 5% coverage. No mosses could be seen. Forest vegetation all the way down to the river.
Samples for: Water chemistry, bacteriology, phytoplankton, periphyton, bottom animals, and fish.
Position: N: 18° 53' 00.7"
 W: 70° 28' 06.9"
Temperature 25 °C
O₂-saturation 96% saturation

Figure 3.2 Station 2; Rio Yuna at the planned dam site

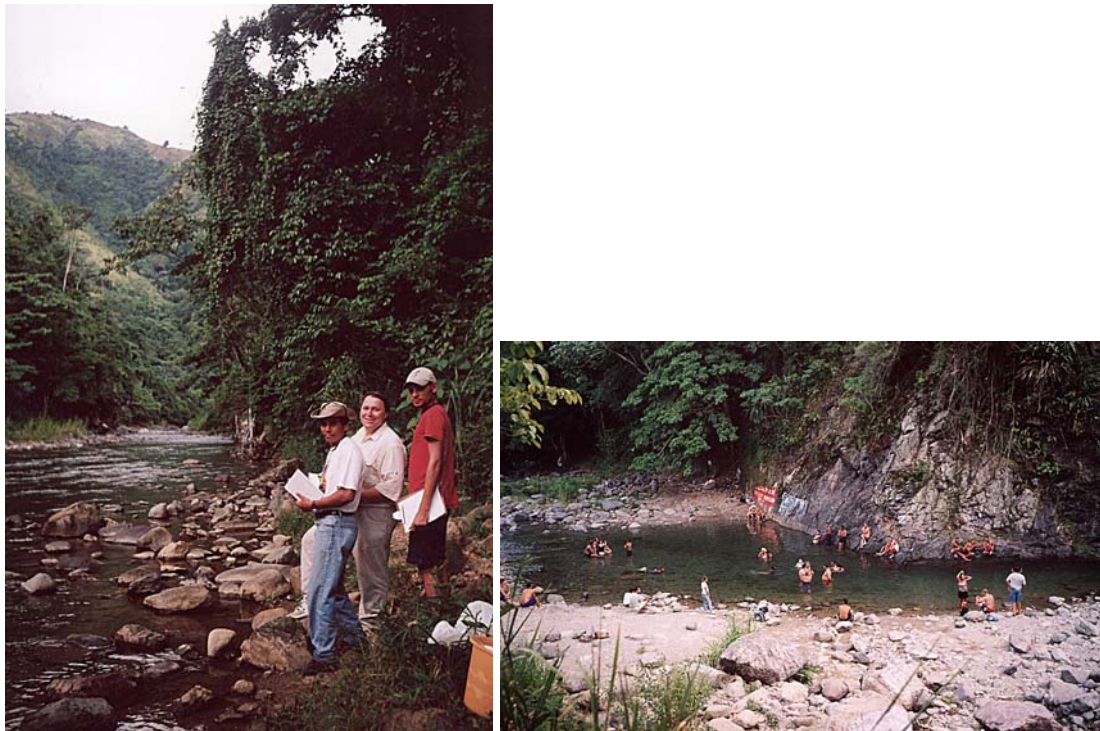
Station/date	3: Rio Masipetro just upstream the Balneario 9/10-02 (50 m upstream of the inlet to the Masipetro irrigation canal)
Site description	Rapids with bottom consisting of stones and gravel (course sand to stones 25 cm in diameter). The water was clear. The stones were clean with a green colour on the downstream side. No mosses could be seen, neither any filamentous algae. Forest vegetation all the way down to the river. The river had little incoming light due to being situated in a narrow valley with overhanging jungle all the way down to the river. Decaying leaves could be seen as part of the river bed substrate. Small fast shrimps could be seen in the shallow water in the shoreline. Also a few small fishes could be seen. 35 people were bathing at the time when the samples were taken.
Samples for:	Water chemistry, bacteriology, phytoplankton, periphyton, bottom animals, and fish.
Position:	N: 18° 58' 33.9" W: 70° 27' 04.1"

Figure 3.3 Station 3; Rio Masipetro just upstream the bathing place at the start of Masipetro canal

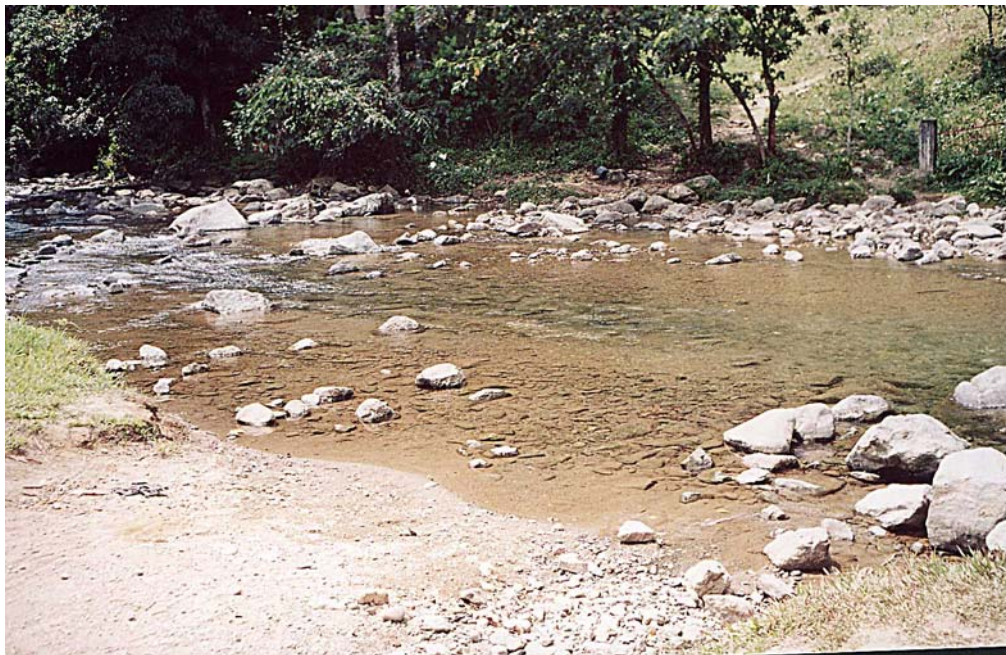
Station/date	4: Rio Jima at tailrace entrance (the bathing place) 9/10-02
Site description	Rapids with bottom consisting of stones and gravel (course sand to stones 35 cm in diameter). The water was clear. The stones were clean. No mosses could be seen, neither any filamentous algae. The river had little incoming light due to overhanging big trees. Decaying leaves could be seen as part of the river bed substrate. Bathing place. Approximately 15 persons were bathing at the time where the samples were taken (ca 1600 hrs).
Samples for:	Water chemistry, bacteriology, phytoplankton, periphyton, bottom animals, and fish.
Position:	N: 18° 59' 59.5" W: 70° 26' 52.4"
Temperature	23.4 °C
O ₂ -saturation	43.6 % saturation, most likely too low due to electrode problems

Figure 3.4 Station 5; Rio Jima at the planned entrance of the tailrace canal from the power station (at bathing place of Caño Piedra).

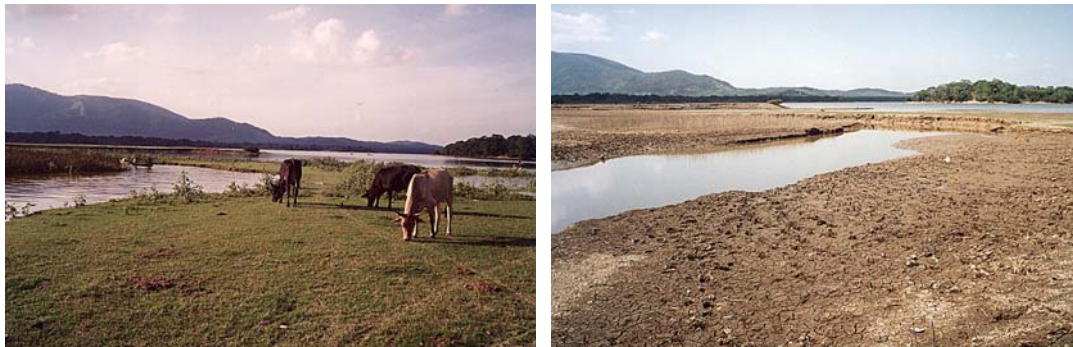
Station/date	5: Rio Jima at the inlet to Rincon Reservoir 10/10-02 (1600 hr)
Site description	Rapids with bottom consisting of stones, sand and also some mud. The water was very turbid due to heavy rain the night before. The station was situated at a wading place in an open pasture landscape with no trees bordering the river. The lower part of Jima (downstream of the Auto Pista) had erosion prone soil materials in the river sides. The water was so turbid that it was impossible to do an evaluation of the periphyton coverage. However, no mosses, neither any filamentous algae could be seen in the sample of bottom dwelling animals, which indicate only minor occurrence of such type of vegetation in the river bed.
Samples for:	Water chemistry, bacteriology, periphyton, bottom animals, and fish.
Position:	N: 19° 03' 09.7" W: 70° 25' 0.2"
Temperature	26.9 °C
O ₂ -saturation	31 % saturation

Figure 3.5 Station 5; Rio Jima at the entrance into Rincon Reservoir close to the village of Cañabon. The right panel shows the same station after flooding.

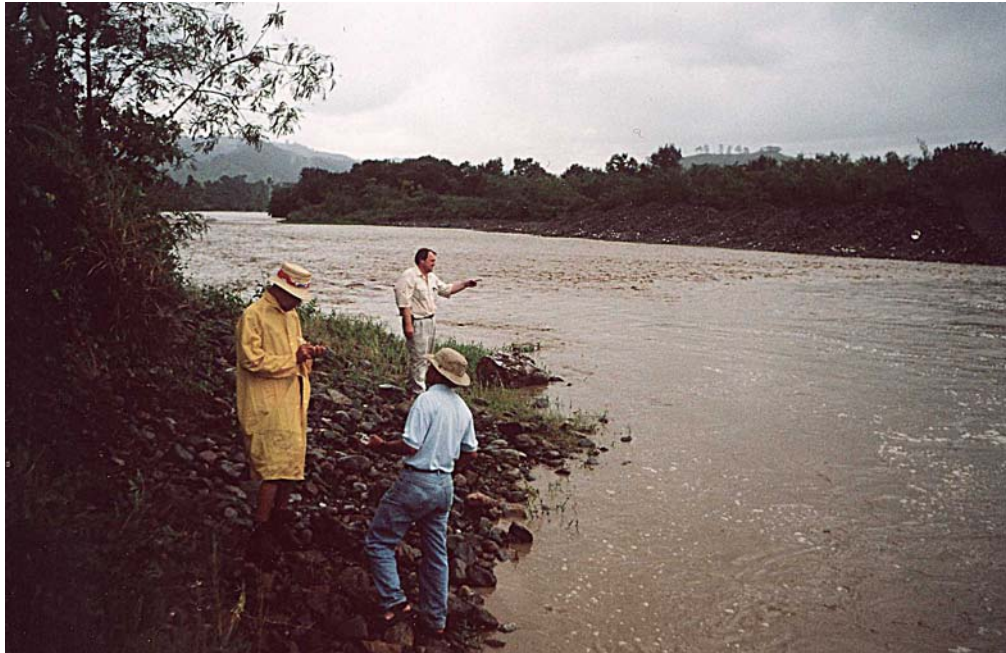
Station/date	6: Rio Yuna downstream of Bona0 City effluents, but upstream of discharges from Falconbridge 10/10-02 (1730 hr)
Site description	Rapids with bottom consisting of stones, sand and also some soil. The water was very turbid due to heavy rain the night before. The riverbed was approximately 200 m wide at this station, and it was water in half of this at the time of sampling. The river had erosion prone soil materials in the river sides. The water was so turbid that it was impossible to do an evaluation of the periphyton coverage. However, no mosses, neither any filamentous algae could be seen in the sample of bottom dwelling animals, which indicate only minor occurrence of such type of vegetation in the river bed.
Samples for:	Water chemistry, bacteriology, periphyton, phytoplankton, and fish.

Figure 3.6 Station 6; Rio Yuna downstream of Bonao City (at the road crosses the river on the way to Falconbridge)

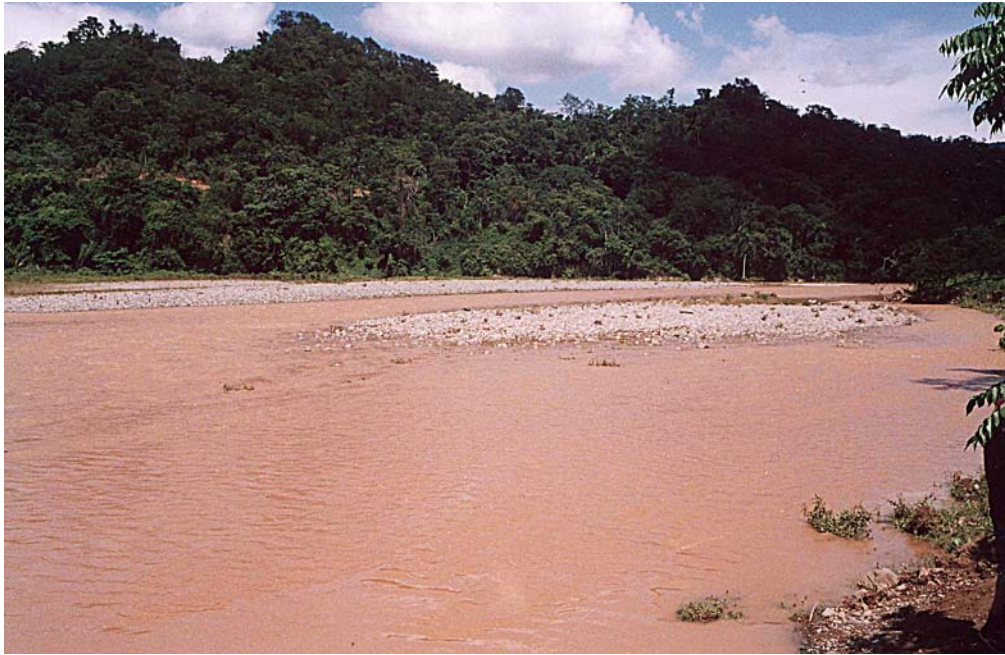
Figure 3.7 Station 7; Rio Yuna downstream the discharges from Falconbridge (entrance of Falconbridge canal)

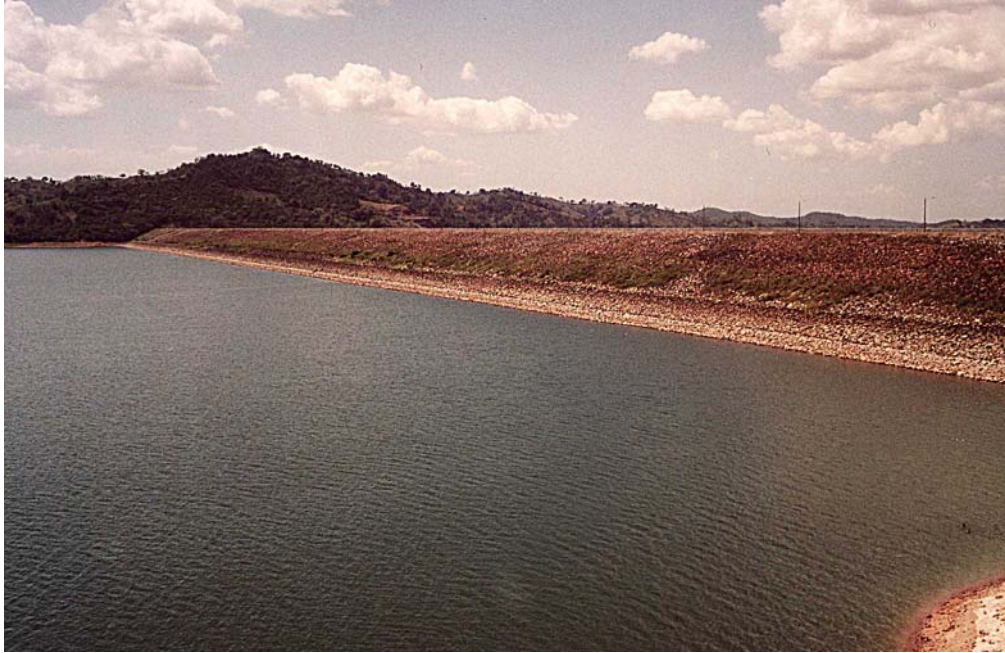
Station/date	Station 9 and station 11: Hatillo reservoir close to the dam
Site description	Station 9 is a shoreline station sampled in October 2002, whereas station 11 was out on the lake over the deepest point at the dam foot, sampled in March 2003. Samples were taken for water chemistry and phytoplankton in the reservoir at the dam site. Oxygen and temperature was measured at several depths to reveal the stratification of the water masses in the reservoir. The water quality seemed good with relatively clear water. The water had a light green appearance. Secchi depth transparency was judged (not measured) to be between 2.5 and 3m.
Samples for: Position:	Water chemistry, phytoplankton and bacteriology.
Temperature O ₂ -saturation

Figure 3.8 Station 9 and station 11; Hatillo reservoir close to the dam. Station 9 is a shoreline sampling station whereas station 11 is out on the lake over the deepest point.

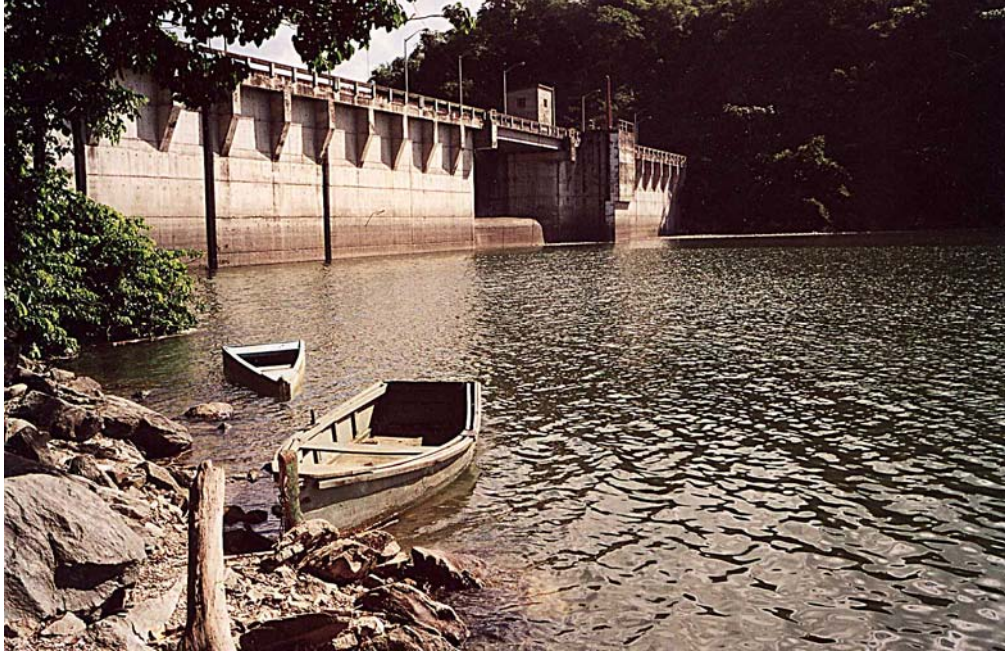
Station/date	Station 8 and station 13: Rincon reservoir close to the dam
Site description	Station 8 is a shoreline station sampled in October 2002, whereas station 13 was out on the lake over the deepest point, sampled in March 2003. Samples were taken for water chemistry and phytoplankton in the reservoir at the dam site. Oxygen and temperature were measured at several depths to reveal the stratification of the water masses in the reservoir. The water quality seemed good with relatively clear water. The water had a light green appearance. Secchi depth transparency was judged (not measured) to be around 2.5 m.
Samples for:	Water chemistry, phytoplankton and bacteriology.
Position:	
Temperature	
O ₂ -saturation

Figure 3.9 Station 8 and 13; Rincon reservoir close to the dam. Station 8 is a shoreline station sampled in October 2002, whereas station 13 is out on the lake over the deepest point.

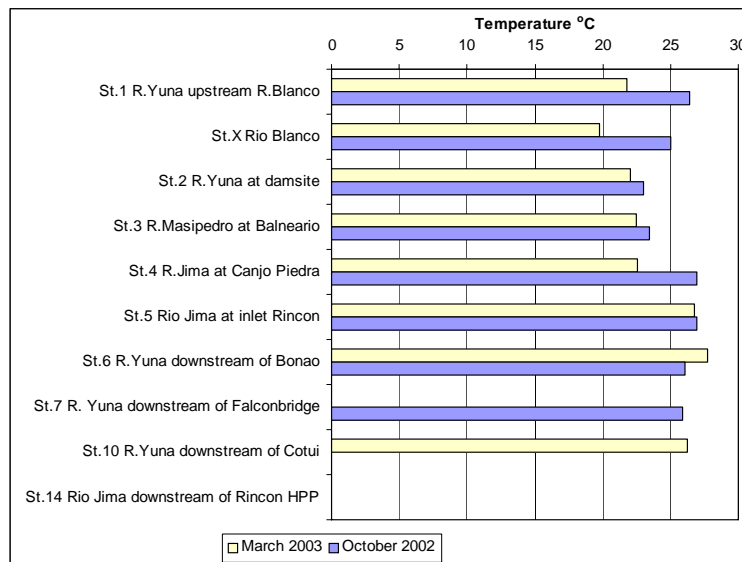
Figure 4.1 Water temperature at the different sampling stations in the rivers

The temperature varied between 20 and 28 °C, and there were only small differences in the temperature between the wet season (October) and dry season (March). In the upper reaches the rivers were slightly colder in winter, whereas in October the differences in altitude did not seem to impact the water temperature significantly.

The water temperature was measured on each station both in October 2002 and in March 2003. The results are given in Figure 4.1.

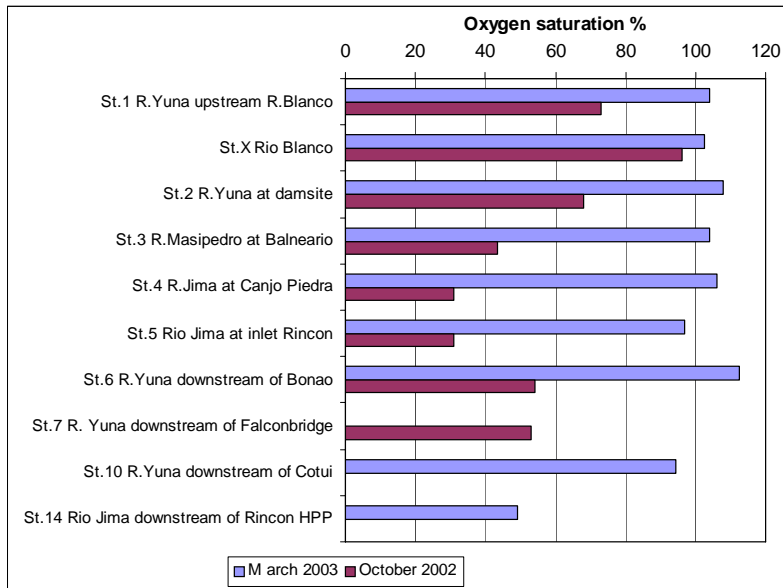
In the measurements from the low flow season the oxygen saturation was around 100% at most river stations. At some stations the saturation was more than 100%, which is a result of the oxygen production from the photosynthesis in the river plants. The oxygen conditions in these rivers were good, and no oxygen problems are likely to occur in near future.

Figure 4.2 Oxygen saturation in the rivers March 2003 (The measurements in October are most likely incorrectly too low, see text.)

The low oxygen concentration downstream of the Rincon Hydropower Plant is due to the deep water intake from the Rincon Reservoir. The deep water of Rincon had very low oxygen, see chapter 4.3. If long periods of anoxic waters are prevailing in the reservoir, it may smell sulphide from the water coming out of the HPP. There was not observed any smell in this case, and people from the area could not remember to have experienced such smell downstream of Rincon HPP.

From Figure 4.2 it can be seen that the oxygen saturation at most stations were much lower in October than in March. There is no rational explanation for such a difference. If it was due to pollution it should have been the other way around. Then the rivers should have lowest oxygen in the low flow season, whereas in fact the opposite was observed. We therefore believe that the measurements from October are wrong.

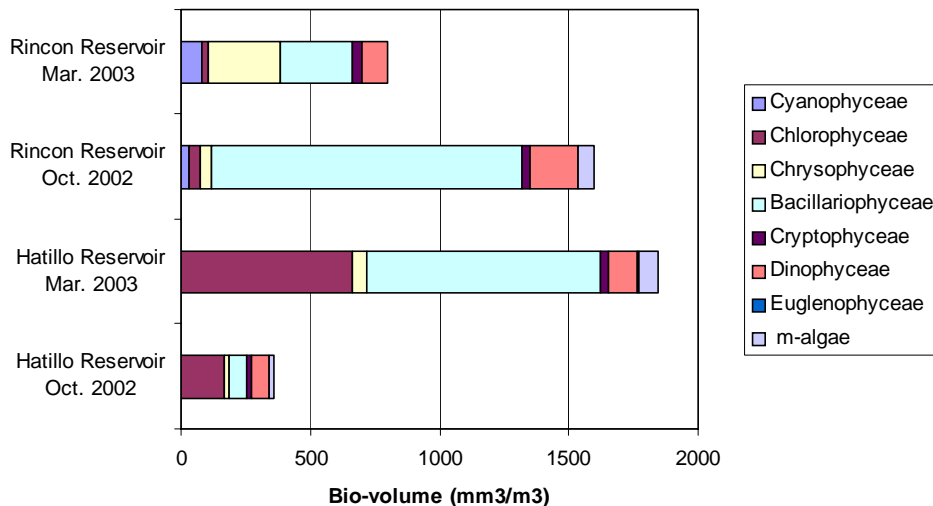
Figure 6.2 Phytoplankton biomass, split into main groups, in the reservoirs Lago de Hatillo and Lago de Rincon.

Phytoplankton was sampled from the reservoirs Hatillo and Rincon both in October 2002 and in March 2003. The results are given in Figure 6.2.

Lake Rincon has an algal biomass which places the lake in the mesotrophic level with respect to productivity. Lake Hatillo had an algal amount of the eutrophic level in March 2003 whereas the amount in October 2002 was in the oligotrophic level. In both lakes Diatoms and Chlorophyceae dominated, which often is the case in mesotrophic lakes. Chrysophyceae and Cryptophyceae, which is characteristic for oligotrophic lakes, did not show any significant amounts in any of the lakes. In Lake Rincon there were present a small biomass of blue green algae in both the sampling periods. Both lakes can be regarded as mesotrophic, with Lake Rincon slightly more impacted by fertilisation effects from nutrient inputs than Lake Hatillo.

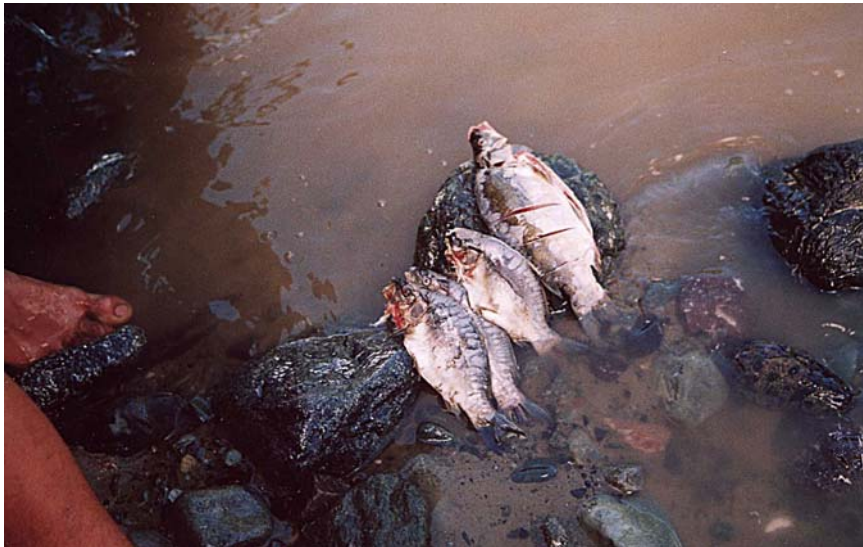
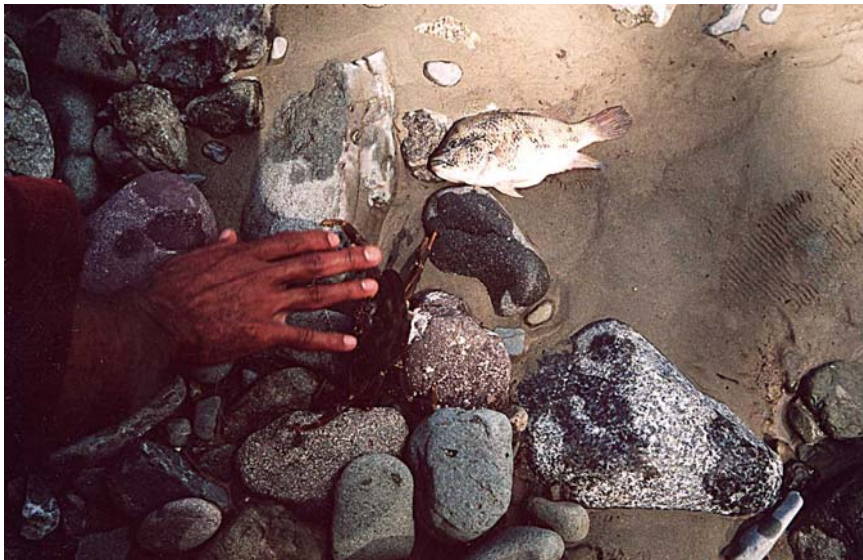
Figure 7.8 Upper panel: Dead specimen of Chinese carps (mirror carps) coming from storm flow release from the Rio Blanco reservoir. Lower panel: One specimen of biajaca and a freshwater crab caught by the fishermen group.

The interviewed fishermen informed that the dam of Rio Blanco was opened the day before (storm flow release due to heavy rain), and because of that they have found some dead Chinese carps that were killed because of the pressure in the released water. These carps were not scientifically identified, but they looked like "Mirror carp" which is a variant of Common carp (*Cyprinus carpio*). Generally this group of five fishermen went fishing together with other fishermen (approximately eight) during the weekends. The catch normally includes individuals of the fish "Biajaca" (*Cichlasoma haytensis*) and crabs "Jaibas".

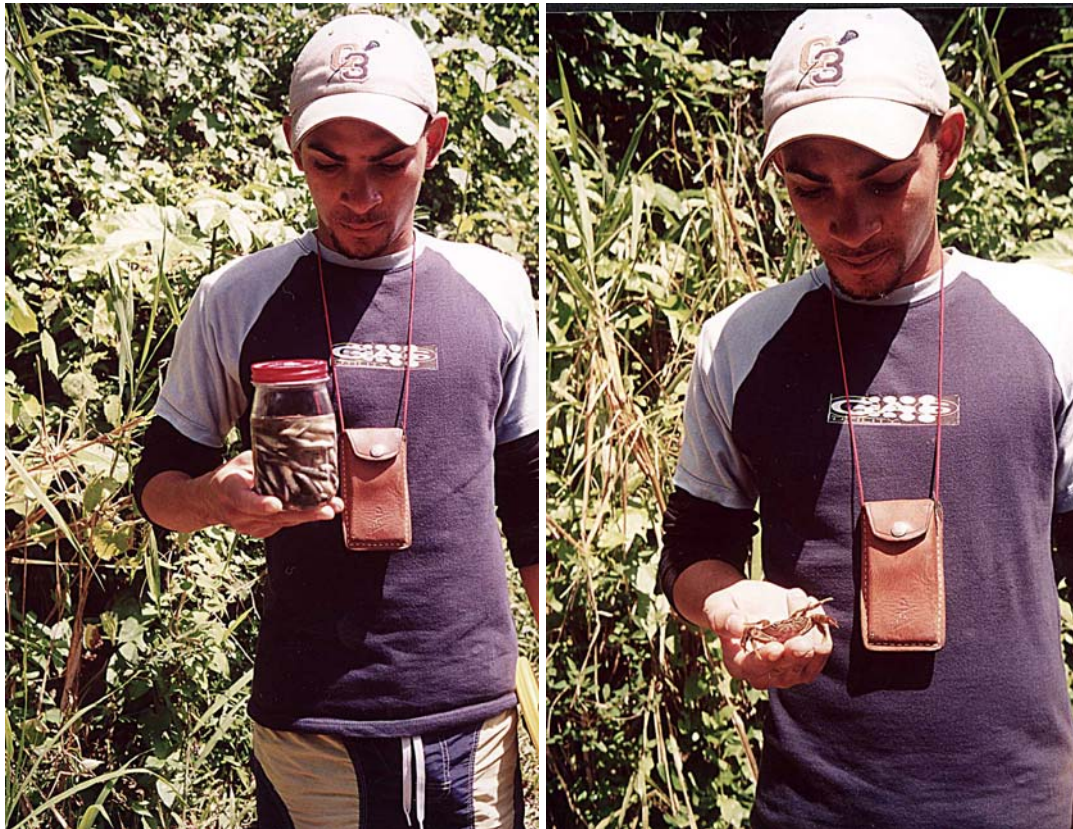
Figure 7.9 Small fish (*Poecilids*) and crab (*Epilobocera haytensis*) caught in the electro fishing in Rio Masipetro just upstream the starting point of Masipetro Canal.

20 minutes of electrofishing gave about 50 small fishes (Poecilids of 3-6cm), and one crab. It was very many small fishes here. The riverbed had stones of many sizes resulting in a great variety of habitats. The rich riparian tree vegetation gives both shadow and food (falling leaves etc) to the river inhabitants. The small fishes were brought to experts in Santa Domingo for identification.
