REPORT SNO 4741-2003

Environmental Impact Assessment of the Alto Yuna Multipurpose Project

Topical Report on Water Quality,
Aquatic Life and Fish in the affected
Water Bodies

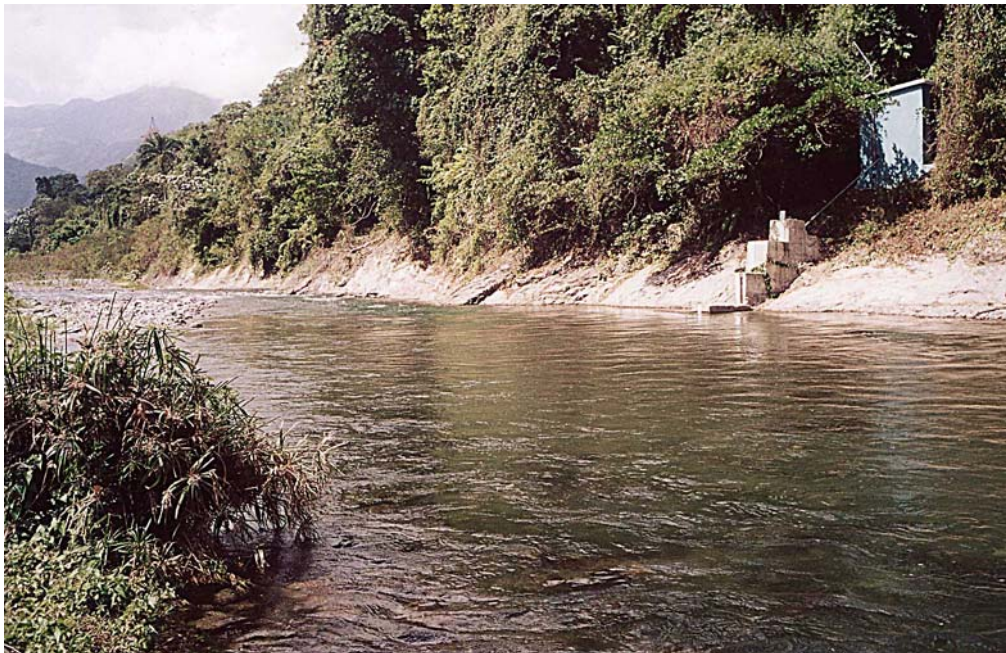
Figure 3.2 Station 2; Rio Yuna at the planned dam site

Station/date	2: Rio Yuna at dam site 9/10-02
Site description	Rapids with bottom consisting of stones and gravel (course sand to stones 25 cm in diameter). The water was turbid. The stones were covered by a thin layer of silt. A few patches of filamentous green algae had about 5% coverage. No mosses could be seen. Forest vegetation all the way down to the river.
Samples for:	Water chemistry, bacteriology, phytoplankton, periphyton, bottom animals, and fish.
Position:	N: 18° 53' 00.7" W: 70° 28' 06.9"
Temperature	25 °C
O ₂ -saturation	96% saturation

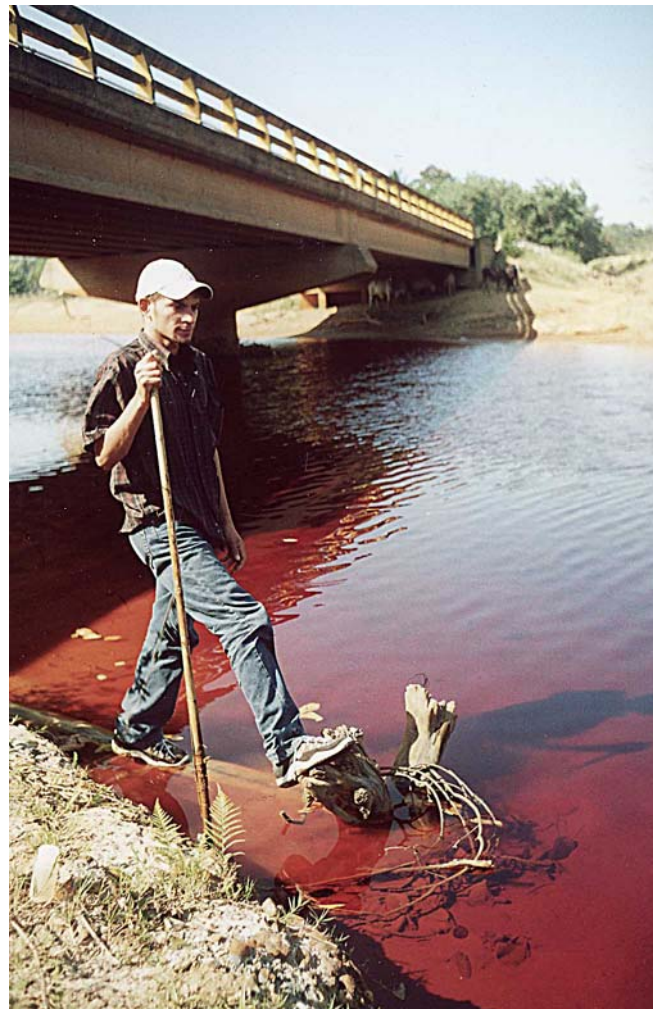
Figure 3.10 Station 12; The mining polluted Arroyo Margajita just upstream where it enters Hatillo. The red colour is due to extremely high content of iron.

Station/date	Station 12: Arroyo Margajita just upstream the entrance into Hatillo reservoir.
Site description	The station is located at the road crossing upstream the entrance in Hatillo. The river was slow flowing, and the bottom consisted of soft mining polluted mud. The water colour was red, most likely due to high content of iron. The river seemed dead due to mining pollution. No living creatures were observed. The locals knew that the river were toxic. It contained “pure poison”, they said.
Samples for: Position:	Water chemistry, and heavy metals
Temperature O ₂ -saturation

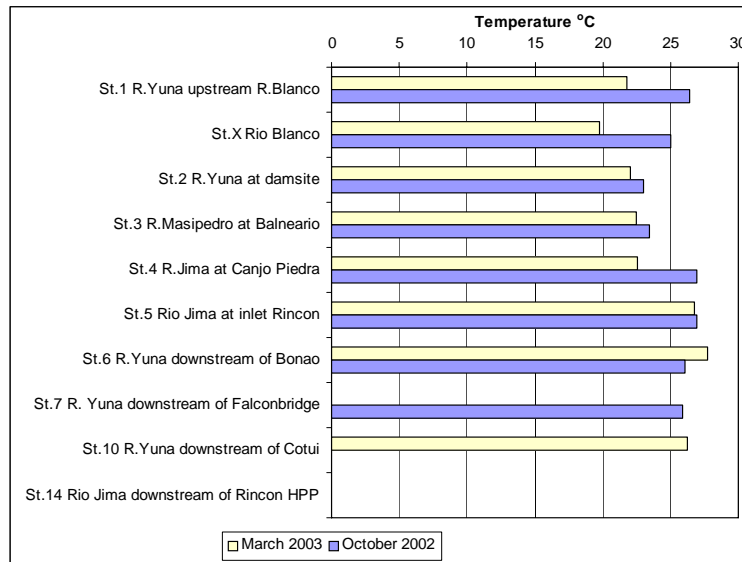
Figure 4.1 Water temperature at the different sampling stations in the rivers

The water temperature was measured on each station both in October 2002 and in March 2003. The results are given in Figure 4.1.

The temperature varied between 20 and 28 °C, and there were only small differences in the temperature between the wet season (October) and dry season (March). In the upper reaches the rivers were slightly colder in winter, whereas in October the differences in altitude did not seem to impact the water temperature significantly.

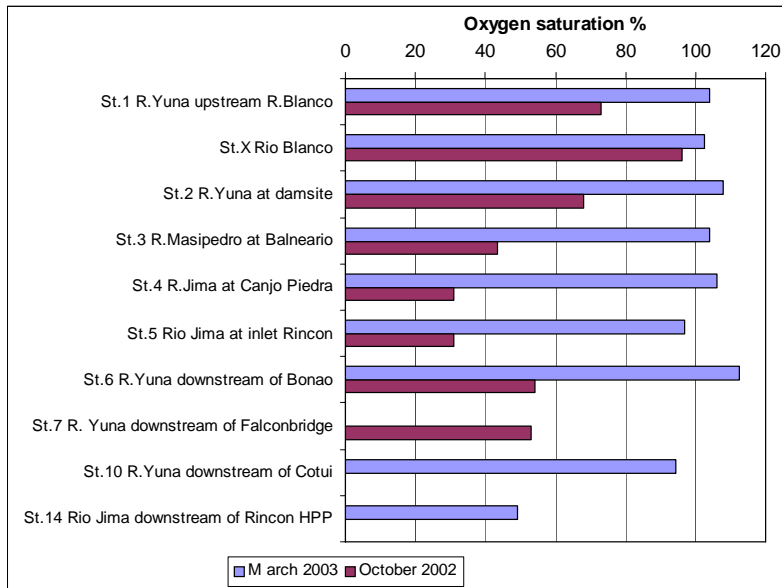
Figure 4.2 Oxygen saturation in the rivers March 2003 (The measurements in October are most likely incorrectly too low, see text.)

From Figure 4.2 it can be seen that the oxygen saturation at most stations were much lower in October than in March. There is no rational explanation for such a difference. If it was due to pollution it should have been the other way around. Then the rivers should have lowest oxygen in the low flow season, whereas in fact the opposite was observed. We therefore believe that the measurements from October are wrong.

In the measurements from the low flow season the oxygen saturation was around 100% at most river stations. At some stations the saturation was more than 100%, which is a result of the oxygen production from the photosynthesis in the river plants. The oxygen conditions in these rivers were good, and no oxygen problems are likely to occur in near future.

The low oxygen concentration downstream of the Rincon Hydropower Plant is due to the deep water intake from the Rincon Reservoir. The deep water of Rincon had very low oxygen, see chapter 4.3. If long periods of anoxic waters are prevailing in the reservoir, it may smell sulphide from the water coming out of the HPP. There was not observed any smell in this case, and people from the area could not remember to have experienced such smell downstream of Rincon HPP.

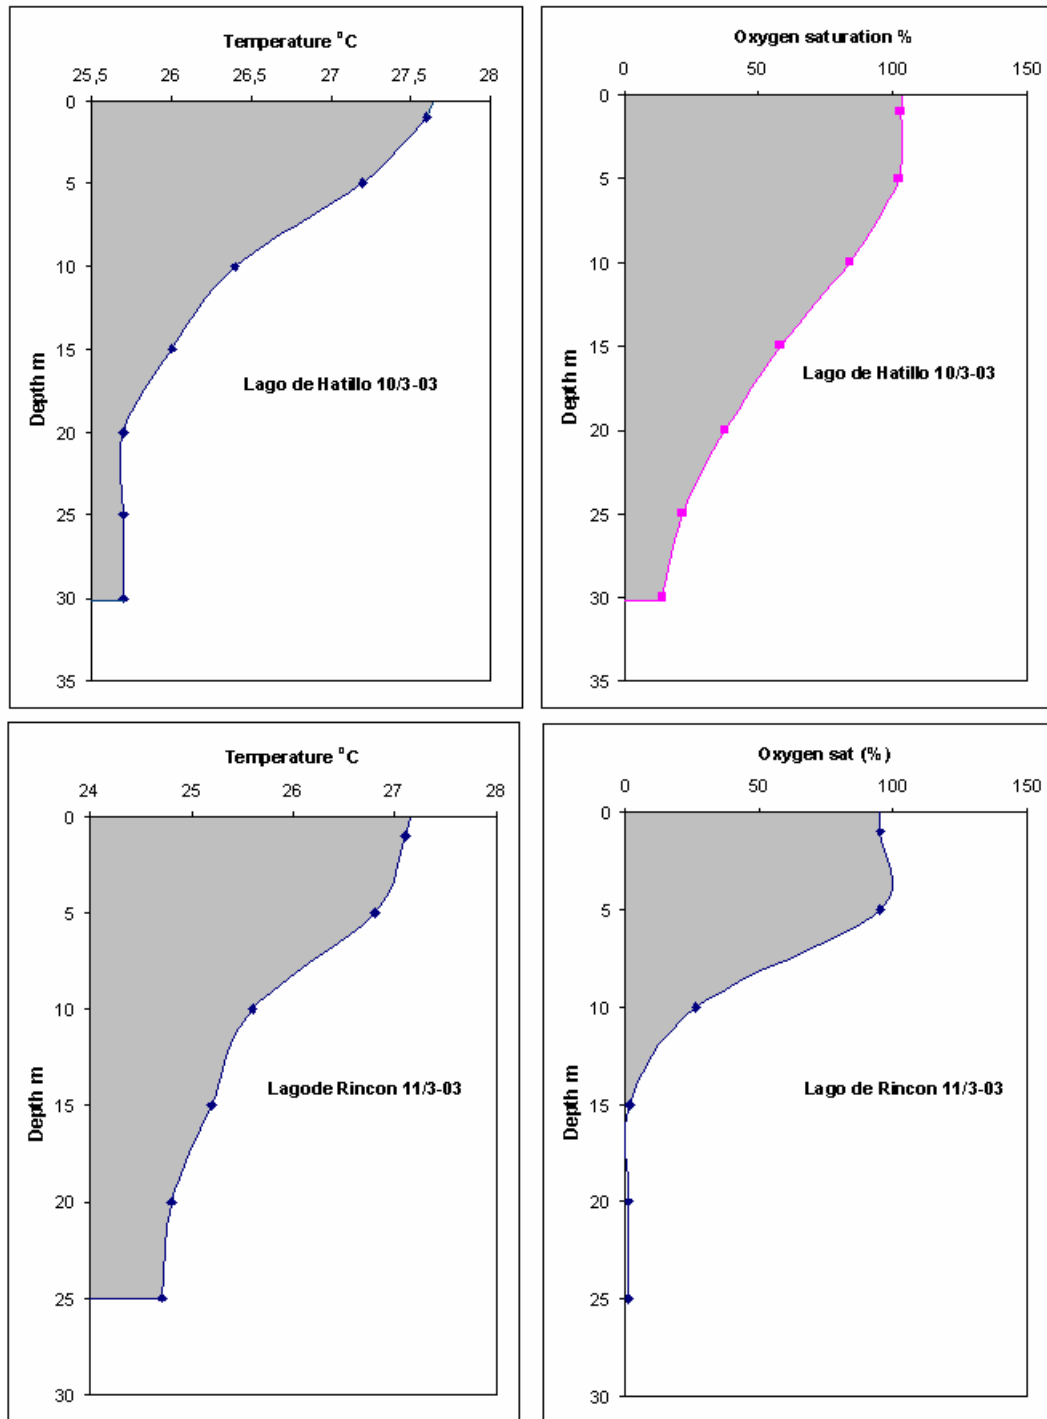
Figure 4.3 Measures of temperature and oxygen in the reservoirs Lago de Hatillo and Lago de Rincon.

Measurements of temperature and oxygen in Hatillo and Rincon Reservoir are given in Figure 4.3.

In both lakes the water masses are stratified with a light top layer of thickness 10-15 m which is lying on above a heavier colder bottom layer of about the same thickness. The bottom layer is prevented from coming in contact with the atmosphere most of the year. Only in periods of cold weather combined with storms the whole water column will circulate recharging the deep water with new oxygen. The dead algae sink through the thermocline and decompose in the deep water consuming the oxygen there, and giving poor conditions for fish and bottom animals. Nutrient discharges enhance the algal growth, which again results in increased sedimentation of dead algae and increased oxygen consumption in the deep water.

In both lakes there is a marked decrease in the oxygen concentration with increasing depth. In Lake Rincon the situation is bad, with total disappearance of oxygen below 15 m depth. Lake Rincon has a eutrophication problem. In Lake Hatillo the situation is somewhat better, but even there the decline in oxygen is significant, which shows that the lake is susceptible to increased nutrient load. A reduction in the water renewal (e.g. by the planned regulation) of the lake gives the same response as an increase in the nutrient load.

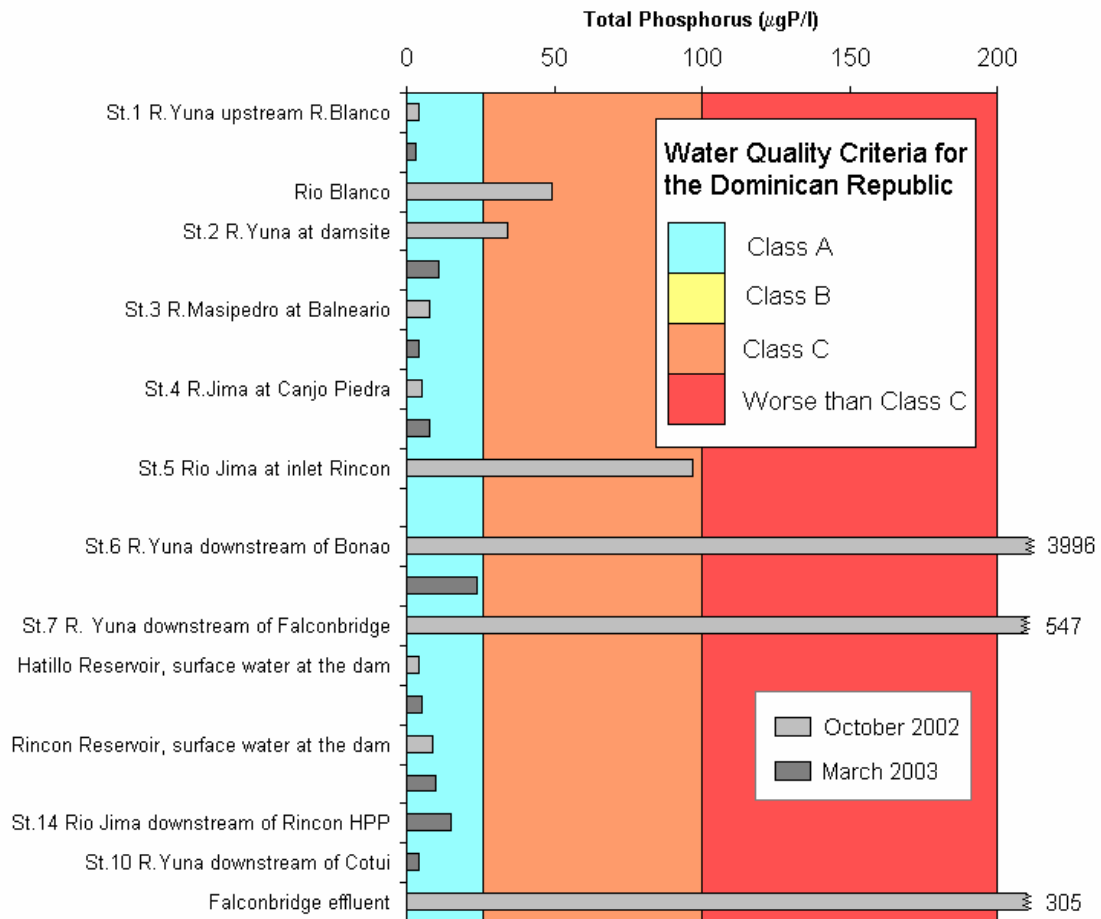
Figure 4.4 Concentration of total phosphorus in the different water bodies. (analysis from NIVA).

Figure 4.4 shows the concentration of total phosphorus at the different sampling stations in the different water bodies of the study, results from the October visit and March visit respectively. The results are compared with the water quality guidelines for the Dominican Republic. For total P the guidelines merge class A and B.

Most of the stations have P concentration that lies inside the best water quality class, both in the wet season (October) and in the dry season. At some of the stations, however, the water quality is susceptible to erosion, and these stations show high P-concentration in the wet season. This applies to Rio Blanco, Rio Jima from Cano Piedra to Rincon inlet, and most of all, Rio Yuna from Los Quemados and downwards. Downstream of Bonao the P-concentration was as high as 3,9 mg P/l, which is a very high value for freshwater. The sample was taken during a heavy rain shower, and during such showers the river receives both erosion material as well as pollution from Bonao City. During the same shower the turbidity increased to above 3000 FNU indicating large amounts of erosion material. The concentration of faecal coliform bacteria increased also considerably during such periods, which indicates overflow in the sewer systems.

The reservoirs, Lake Hatillo and Lake Rincon had both low levels of total phosphorus in the surface waters, being in the oligotrophic to mesotrophic level. Rincon seem to be slightly more nutrient rich than Lake Hatillo.

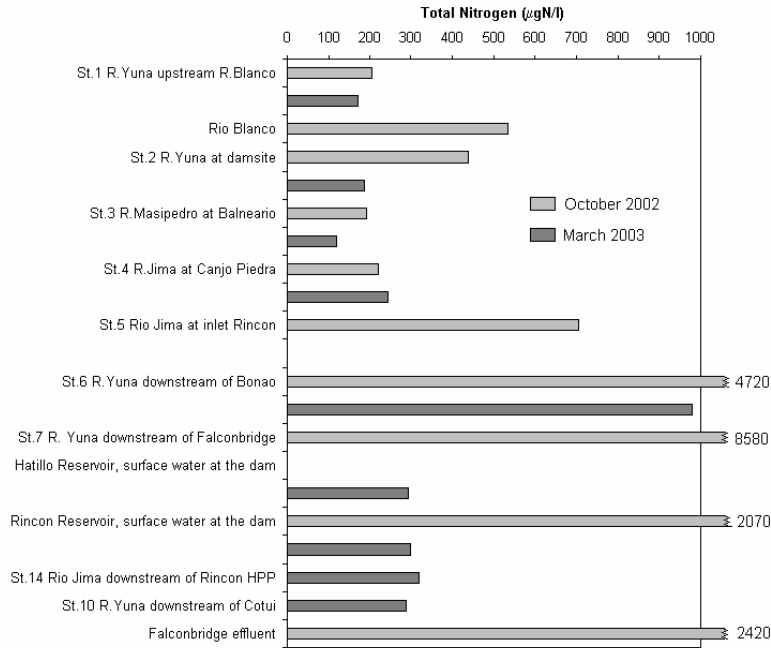
Figure 4.5 Concentration of total nitrogen in the different water bodies affected by the project

The Dominican Republic has not yet developed water quality guidelines for total nitrogen, and Figure 4.5 is therefore given without coloured background. The nitrogen concentrations were high downstream of Bonao and the Falconbridge area. Nitrogen has no geological sources, and does not increase due to erosion as is the case for phosphorus. Therefore the observed high values are discharges from human sanitary systems or runoff from agricultural land.

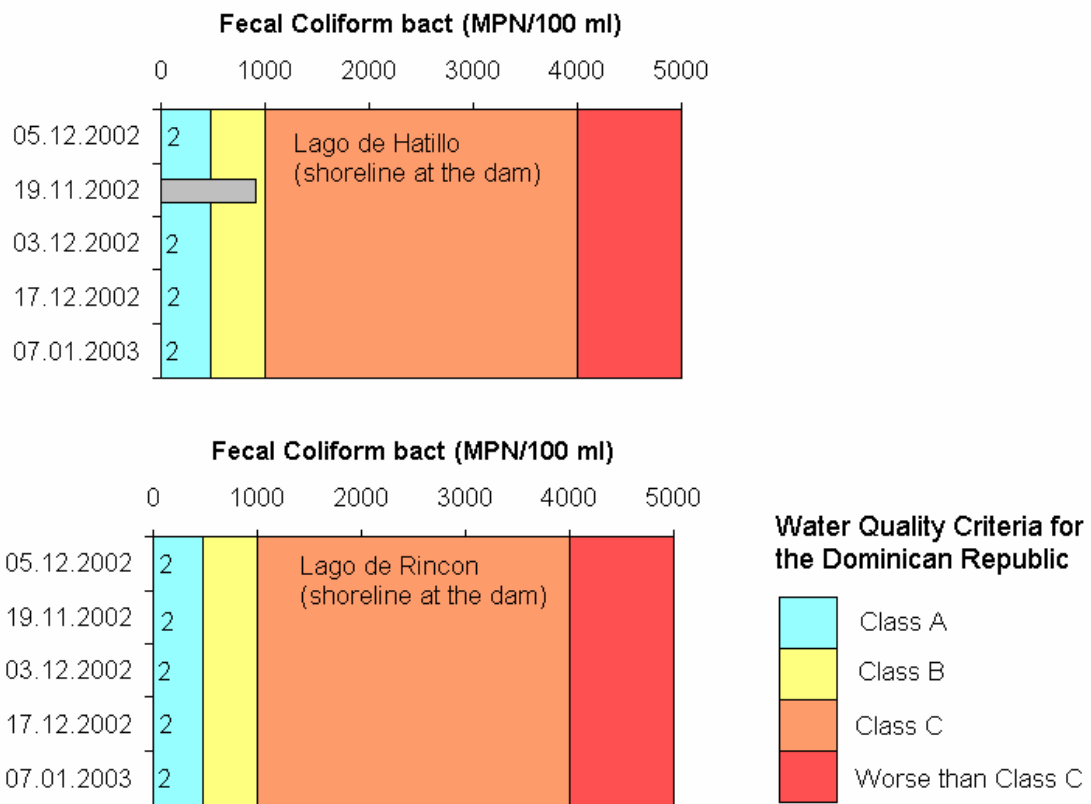
Figure 4.7 Coliforme bacteria (44 °C) in the surface water of the reservoirs Hatillo and Rincon.

The results are given in Figure 4.7 and show that the surface water quality in these lakes are in most instances in class A. The long water residence time, and exposure to UV-sun radiation of the surface water are the two main factors purifying the lake water for bacteria.

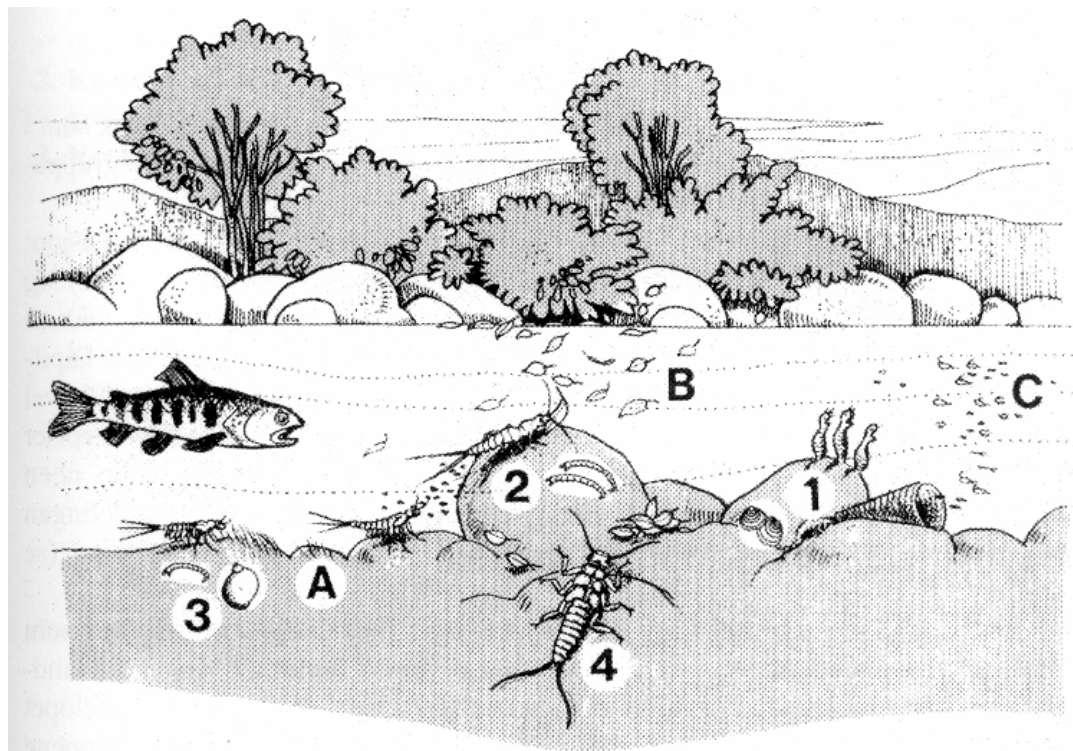
Figure 6.1 The life of rapids in rivers. A=periphyton which is tiny plants growing on stones etc. B is leaves and debris falling in from the riparian vegetation. C is drift, i.e. edible organic particles (both living and dead) coming with the current. 3 are organisms eating periphyton, 2-and 4 are organisms eating dead leaves and terrestrial debris, and 1 is filter-feeding organisms. The fish is mainly feeding on bottom animals in these reaches. (From Lillehammer et al 1980).

The rapids are shallow and the whole bottom surface receives the life-giving sunlight. On all substrates, stones etc., there are tiny layers of algae. These are the “pastures” of the river bottom, and are the most important starting point of the river food chain. Another important source of nutrients to a river is the falling of leaves and other debris from the riparian vegetation. Overhanging big trees are very important in this respect. A third group of energy input is what is called “drift”. These are edible organic particles coming with the current. The drift may come from the river itself, from the catchment, or from upstream lakes. Figure 6.1 gives a general picture of the life in rapid flowing rivers.

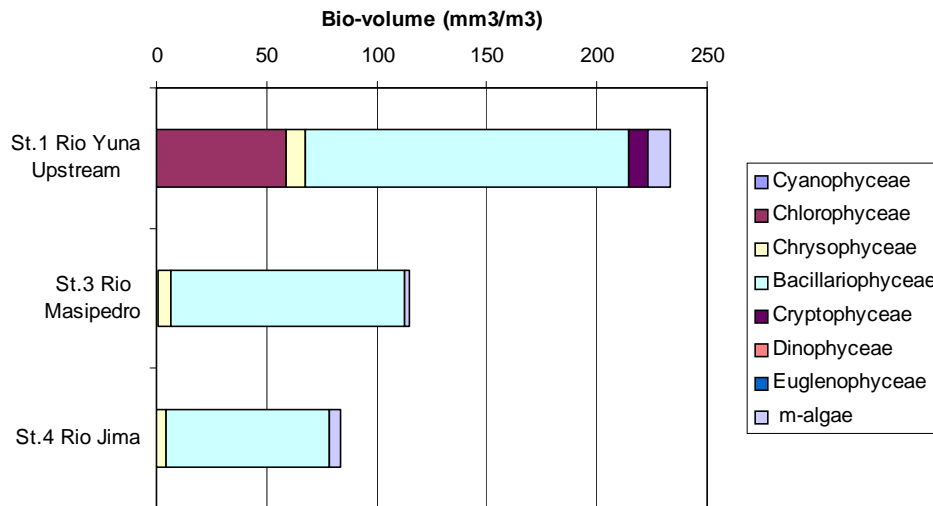
Figure 6.3 Phytoplankton biomass, split into main groups, at the different river stations.

Samples are taken from the stations upstream in the three river Rio Yuna, Rio Masipetro and Rio Jima. The results are given in Figure 6.3. The rivers are fast flowing with turbulent waters, which is not a good environment for phytoplankton production. Most of the species found in the free water masses were periphyton species that were loosened by the strong current. Bacillariophyceae (diatoms) were the dominant group.

All the rivers had low bio-volume of phytoplankton which indicates oligotrophic waters at these three upstream stations of R. Yuna, R. Masipetro, and R. Jima.

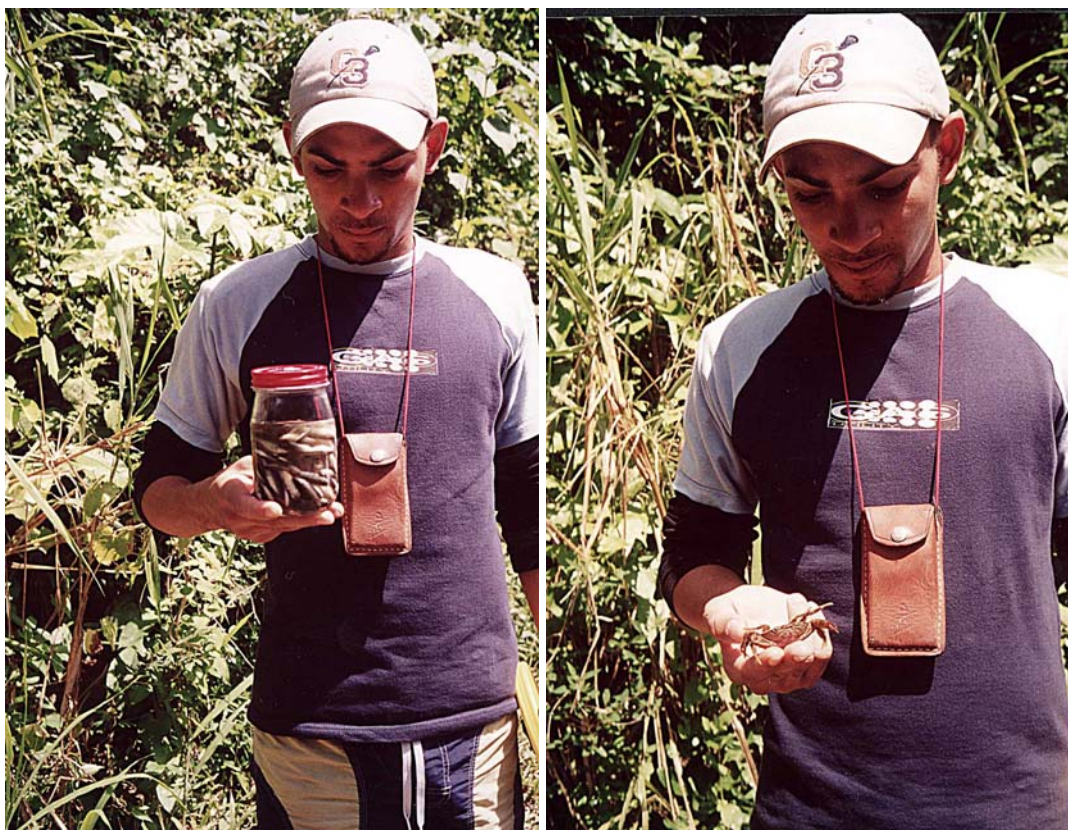
Figure 7.9 Small fish (*Poecilids*) and crab (*Epilobocera haytensis*) caught in the electro fishing in Rio Masipetro just upstream the starting point of Masipetro Canal.

20 minutes of electrofishing gave about 50 small fishes (Poecilids of 3-6cm), and one crab. It was very many small fishes here. The riverbed had stones of many sizes resulting in a great variety of habitats. The rich riparian tree vegetation gives both shadow and food (falling leaves etc) to the river inhabitants. The small fishes were brought to experts in Santa Domingo for identification.

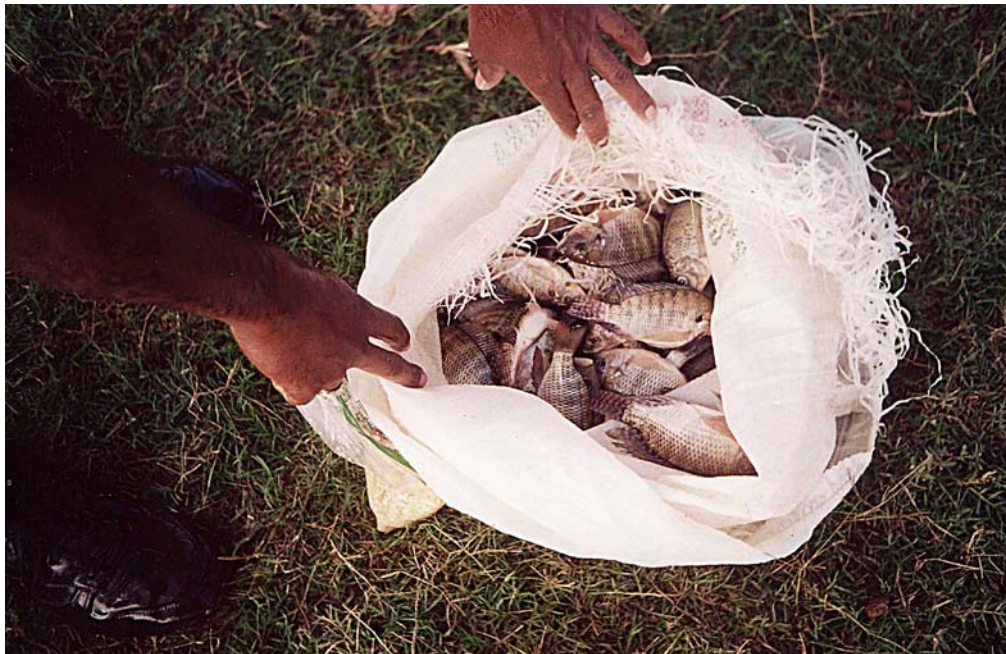
Figure 7.10 Catch during two hours fishing with throw-net in the river mouth area where Rio Jima enters Rincon reservoir. The dark fish is Mozambique-tilapia and the light coloured is Nile-tilapia.

The water level of the reservoir was approximately 1,5 m higher than before the weekend. This is partly due to heavy rain and less discharge from Rincon. The river mouth of Rio Jima was flooded. In such periods, fishes from Rincon migrate into the river mouth area, which creates good conditions for fishing. 10 groups of fishermen were fishing in the river mouth area at the day of test-fishing. 3 groups used throw-net from land, 6 groups used boat and traditional nets, and 1 group used rod (partly with earthworm-bate and partly with artificial lures). All groups did good catches (estimated to 2-15 kg in 2-4 hrs of fishing depending on the method). Figure 7.10 shows a catch from 2 hours fishing with throw-net operated from land, mostly tilapias.

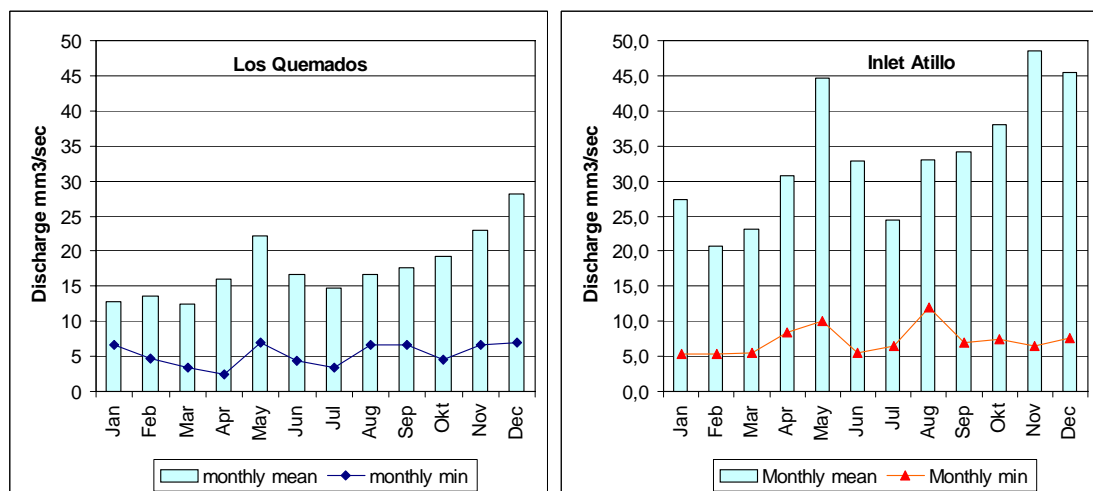
Figure 9.1 Water discharge in Rio Yuna at Los Quemados and at the inlet to Lago de Hatillo.

The average flow in Rio Yuna at Los Quemados to day is approximately 18 m³/s, while at the inlet to Lake Hatillo the mean flow is 33 m³/s, see Figure 9.1. According to the preliminary plans 14-15 m³/s are going to be transferred to Rio Jima with an underground hydropower plant in the Masipedro area. In addition, the Rio Masipedro is planned to be taken almost entirely into the diversion tunnel (3-4 m³/s) and contribute to the hydropower production. The flow in Rio Yuna will be reduced considerably, and the renewal of water in Lake Hatillo will decrease, and the water residence time will increase. Very little, if any, water will be back in Rio Masipedro. The flow in Rio Jima will increase, the water residence time in Lake Rincon be reduced.
