ALUSCAN AS

Marine environmental impact
from the discharge water

Report from a survey in October 1993

O-93225

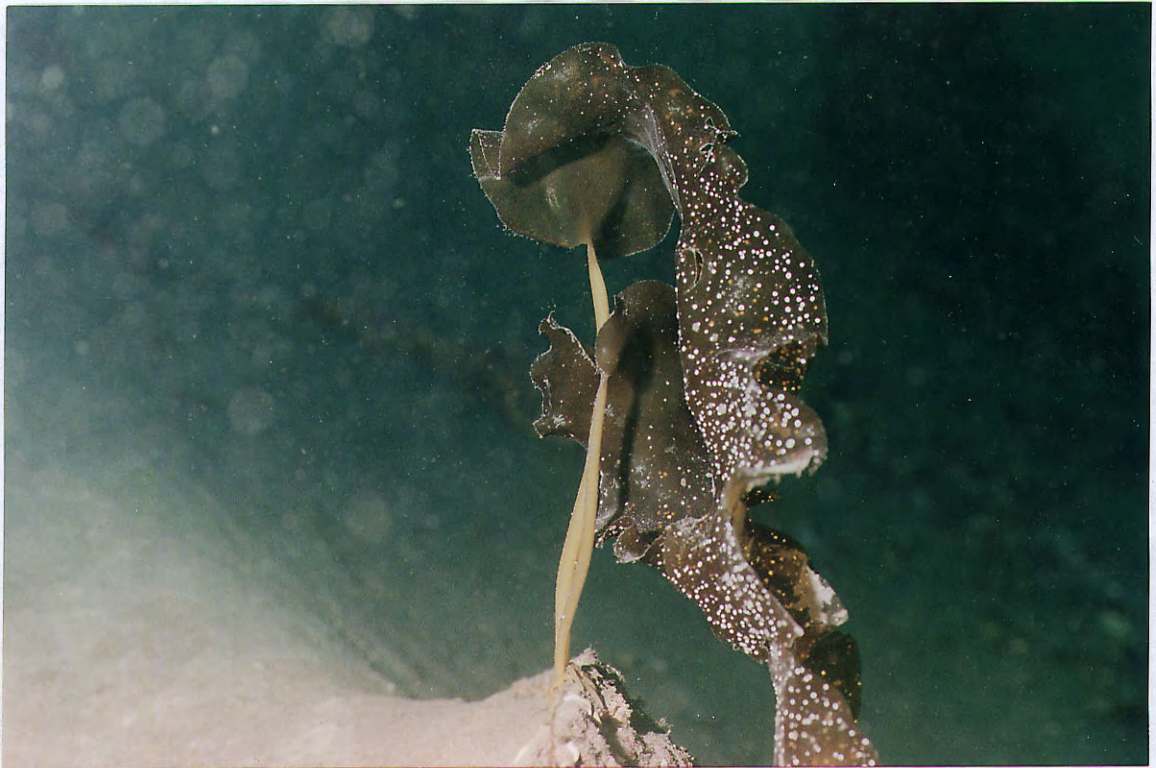
Within a distance of 2-3m from the old pipeline outlet, no hard bottom organisms were found. In this area large deposits of salt aggregates were observed. Further away at 3-4m distance small kelp plants were observed (Fig. 7.). 5m from the old outlet at suitable substrates, several organisms were observed (Tab.3 in Appendix 1).

Figure 7. Kelp (*Laminaria saccharina*) found at station R01, R02 and R03. Small tube worms (*Spirorbis sp.*) grow on the blade (*lamina*). Picture taken on station R02.

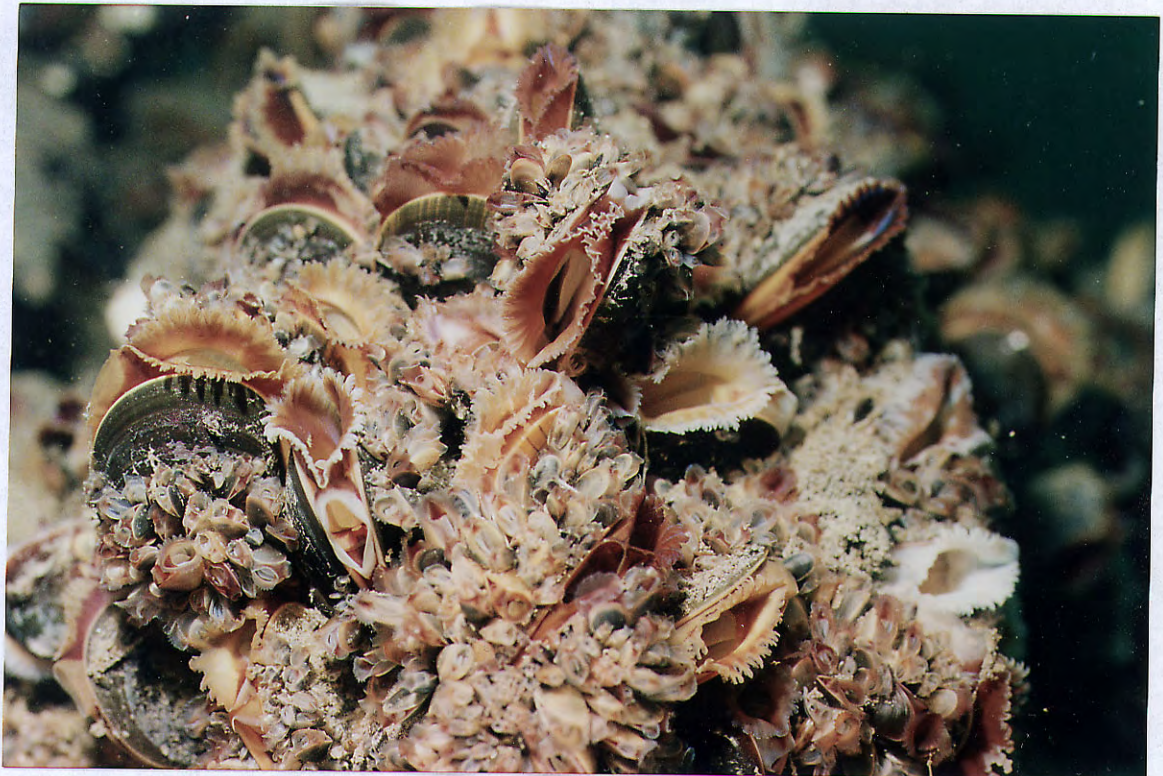
Large quantities of mussels (*Mytilus edulis*) (Fig. 8) were found as deep as 18m with the main occurrence at 4-5m depth. Usually these mussels are predated by starfish (mainly *Asterias rubens*) (Fig. 9) and one will find very few older mussels. The population of starfish at the station was scarce considering the amount of available food in the area. Starfish and sea urchins are also sensitive to changes in the water quality especially salinity and heavy sedimentation. The sedimentation at the station was significant and caused an additional stress to the attached hard bottom organisms. Below 10m depth where the sedimentation was heaviest, sensitive organisms as tubeworms (*Pomatoceros triqueter* & *Serpula vermicularis*) and barnacles (*Balanus balanus*) seem to prefer overhanging substrate (Fig. 10).

Figur 8. Mussels (*Mytilus edulis*) found at 5m at station R01 in large quantities.

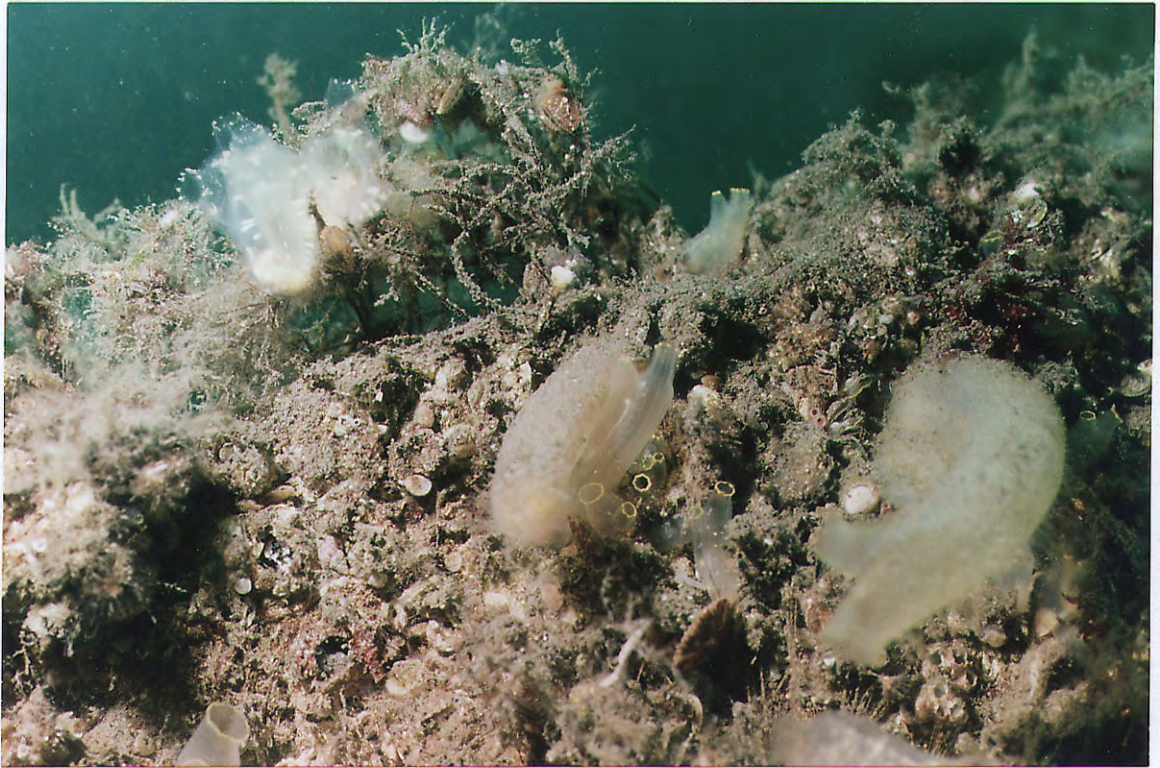
Other characteristics for this station were the large amount of hydroid (*Laomedea spp.*) (Fig. 11). These are opportunistic species which will colonize available space whenever the conditions are favourable. They usually reproduce at spring. After some months most of the hydroids will be predated on by seaslugs (cf. *Dendronotus frondosus*) (Fig. 12) and only their stolon (stems) will be found.

Figure 11. Hydroids (*Laomedea* spp), tunicates (*Ciona intestinalis*), clams (*Chlamys* sp), barnacles (*Balanus balanus*) in a mixture of other organisms at station R02.

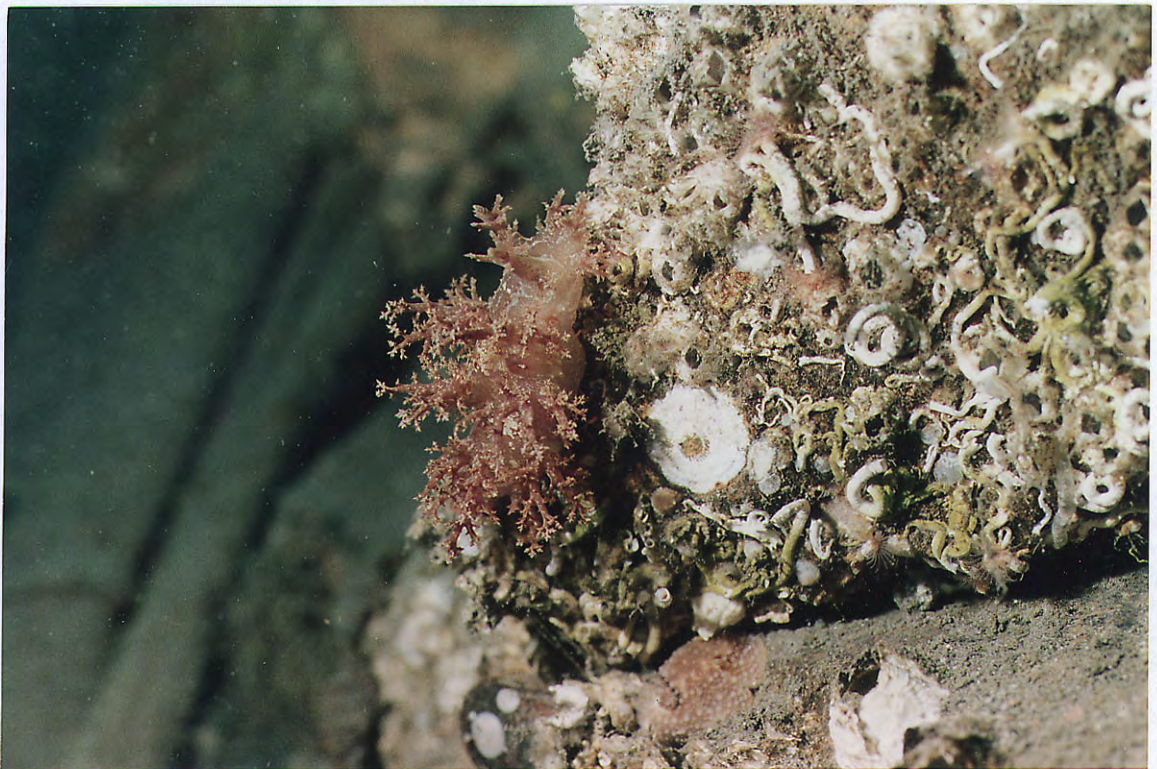
Figure 12. Sea slug (cf. *Dendronotus frondosus*) feeding on hydroids at station R01. Different tube worms (*Pomatoceros triqueter*, *Serpula vermicularis*, *Chaetopterus variopedatus*) and barnacles (*Balanus balanus*) can also be seen.

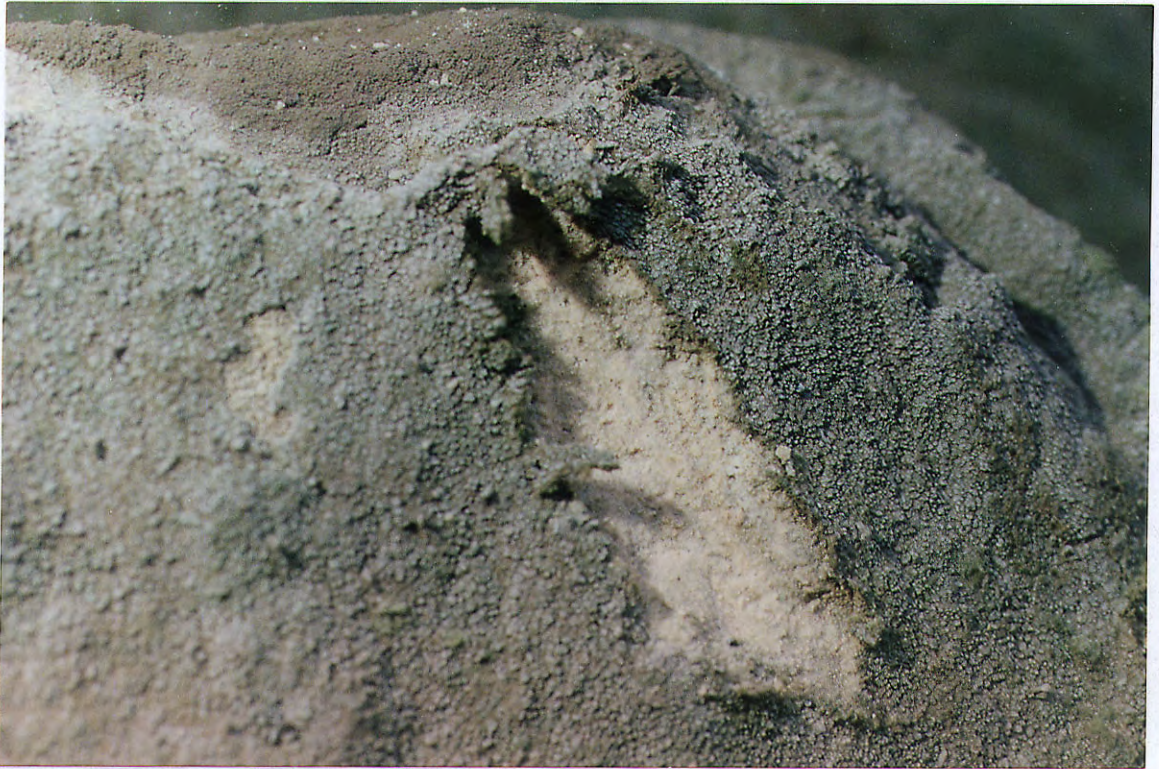
The station did not have a normal littoral belt of seaweeds. The rock surface in the upper 2m was also covered with salt deposits 5mm thick (Fig. 13). Some mussels and green seaweed (*Enteromorpha sp*) (Fig. 14) grew in/on this indicating low toxicity of the salt (not tested). The top of the salt was covered with a layer of cyanobacteria.

Figure 13. Salt aggregating on the surface of rock in the upper 2 meters at station R01. The surface was covered with cyanobacteria and probably diatoms.

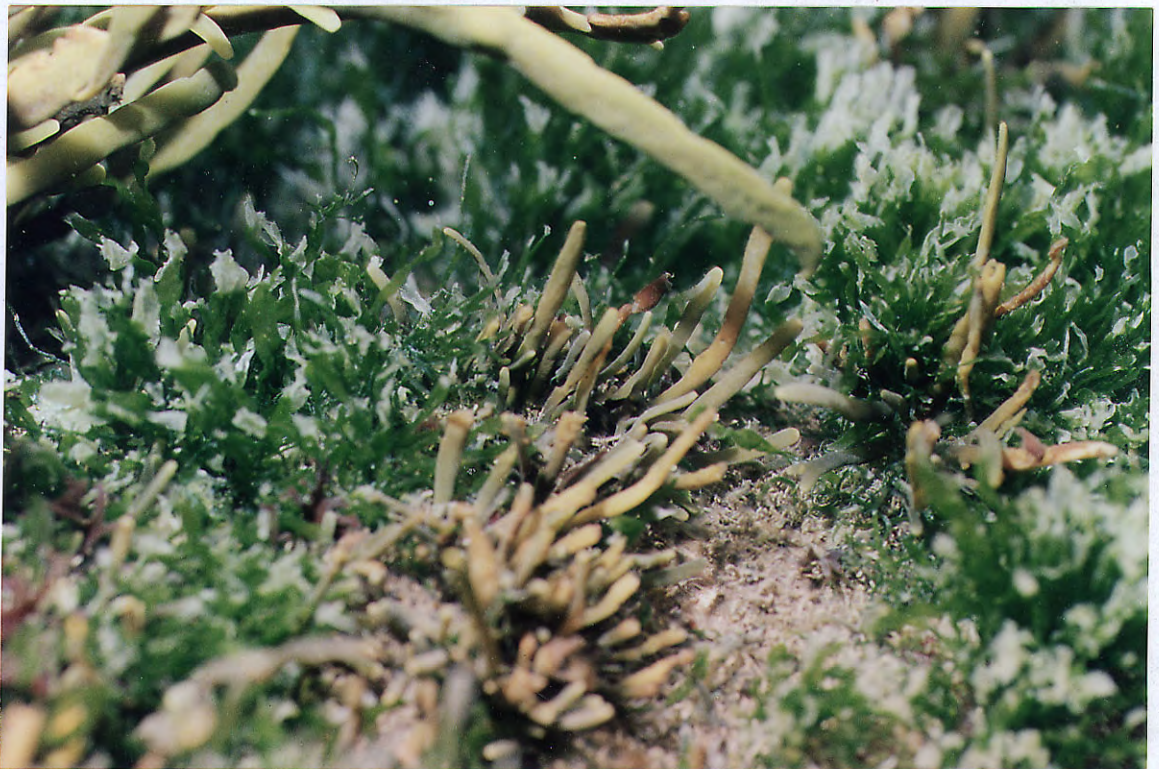
The station also showed definite sign of eutrophication with a well developed belt of green seaweeds (*Enteromorpha spp.* & *Ulva /Ulvaria.*) (Fig. 14). Pedersen (1990) did, however, not find any signs of eutrophication in the Sunndalsfjord except for in the innermost 1km of the fjord and at one site near Tingvoll due to a local farm.

Figure 14. Green seaweeds (mainly different *Enteromorpha* spp) among young and older bladdered wrack (brown important seaweed *Ascophyllum nodosum*) at station R02 and R03. Picture from station R02.

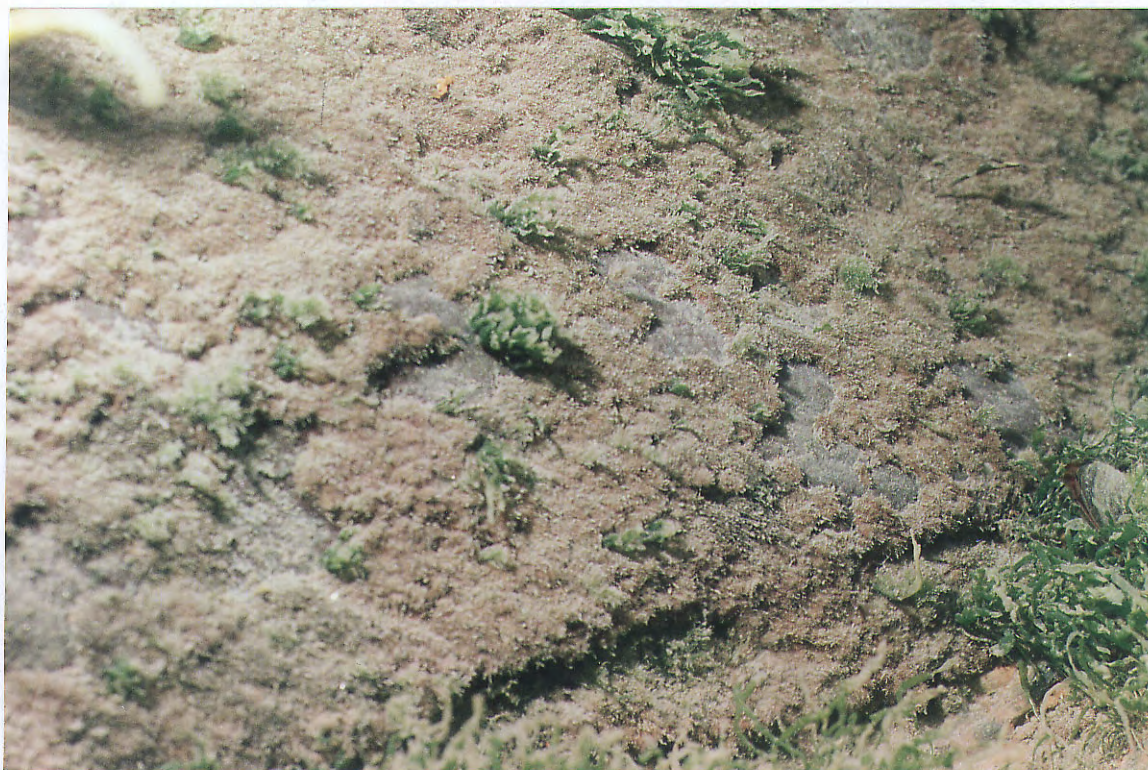
Figur 15. A small brown algae (*Sphacelaria cf. radicans*) growing in sediment mats together with a very fine red algae (*Audoniella cf. floridula*). Picture taken at station R03 at 2m depth.

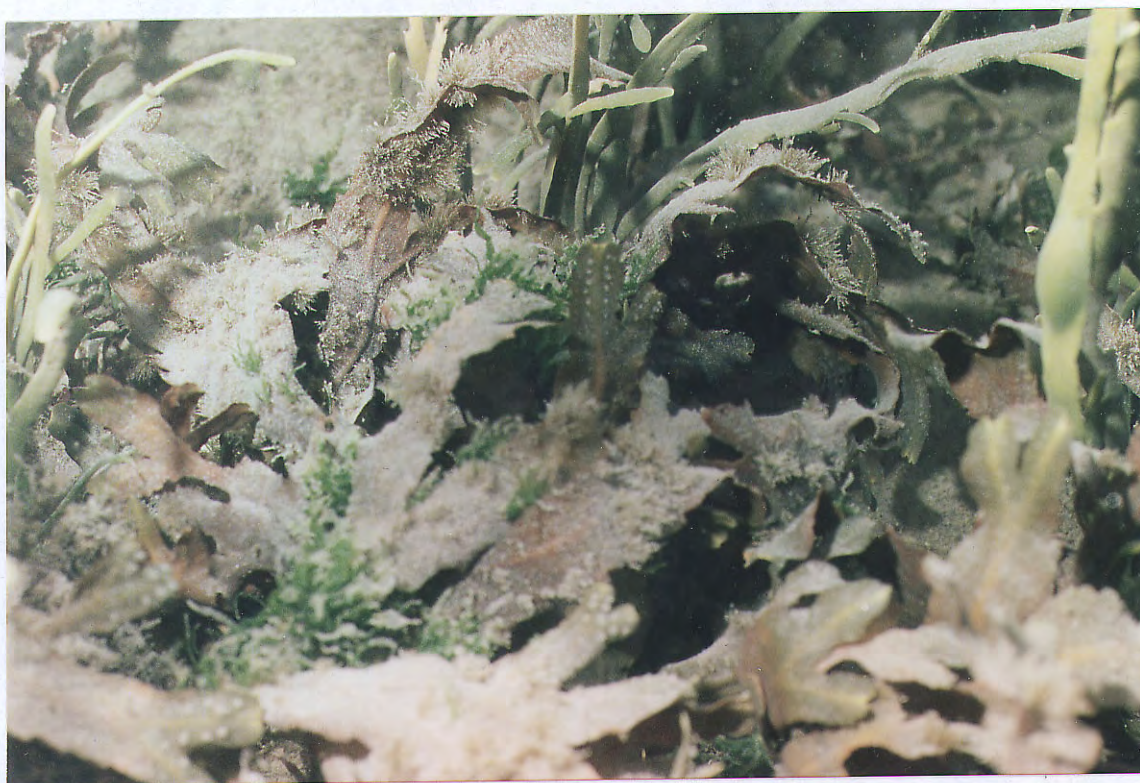
Figur 16. An ecological important brown algae - *Fucus serratus*, being overgrown by small epiphytes and partly covered with fine sediments. Picture taken at station R03.
