REPORT SNO 4263-2000

# **An** evaluation of a novel test method for anti-scale devices

A case study from Sauherad,  
Norway

Title An evaluation of a novel test method for anti-scale devices. – A case study from Sauherad, Norway	Serial No. 4263-2000	Date 11.08.2000
	Report No. Sub-No. O-99039	Pages Price 14
Author(s) Henning Mohn and Svein Stene-Johansen	Topic group 41	Distribution
	Geographical area TEL	Printed NIVA

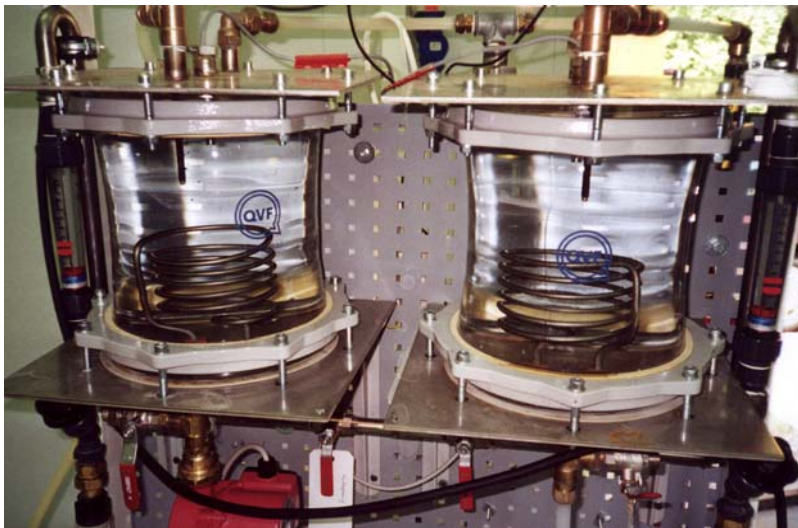
Figure 4. Hot water tanks after cleaning with acid

After 20 days of operation influent and effluent water samples were taken from the test rig. Thereafter 50 ml of concentrated HCl was added to the two water circuits, the influent water was shut off and the re-circulation pumps were started to dissolve all particulate matter in the systems. After one hour of re-circulation no particulate matter could be observed and new samples were taken from the liquid for analyses. Based on these analyses mass balances were set up and scaling capacity was determined. The results are presented in Table 3. After each acid wash the water circuits were thoroughly rinsed with cold water.

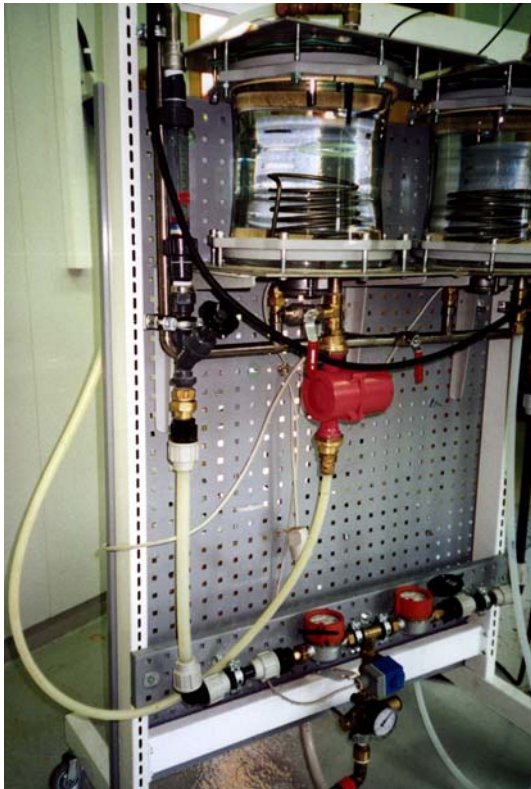
Figure 6: Left re-circulation loop without anti-scale device (front)

Prior to the second test the water circuits were washed with diluted hydrochloric acid in the same manner as described in section 3.1. Thereafter the old anti-scale device was substituted with a by-pass pipe. The new anti-scale device was attached to the recycle loop of the right water circuit before its recycle pump, while the left water circuit was a control unit without any anti-scale device. The arrangements are presented in Figures 6 and 7. The anti-scale device is hidden behind the blue field in Figure 7. The recycle pumps pumped water continuously from the hot water tank through the anti-scale device and back into the heater again.

The rig was operated with the same fill pattern as in the first test; the only differences were the continuous re-circulation pumping and a different anti-scale device. The recycle flow rate was 2 litres per minute, giving a 5 minutes theoretical water retention time of the hot water tanks (based on a plug flow pattern).
