REPORT SNO 5283-2006

## Mercury and water quality study

Impact of Gold Mining in the Song Bung 4  
Project Area, Central Vietnam

FINAL REPORT

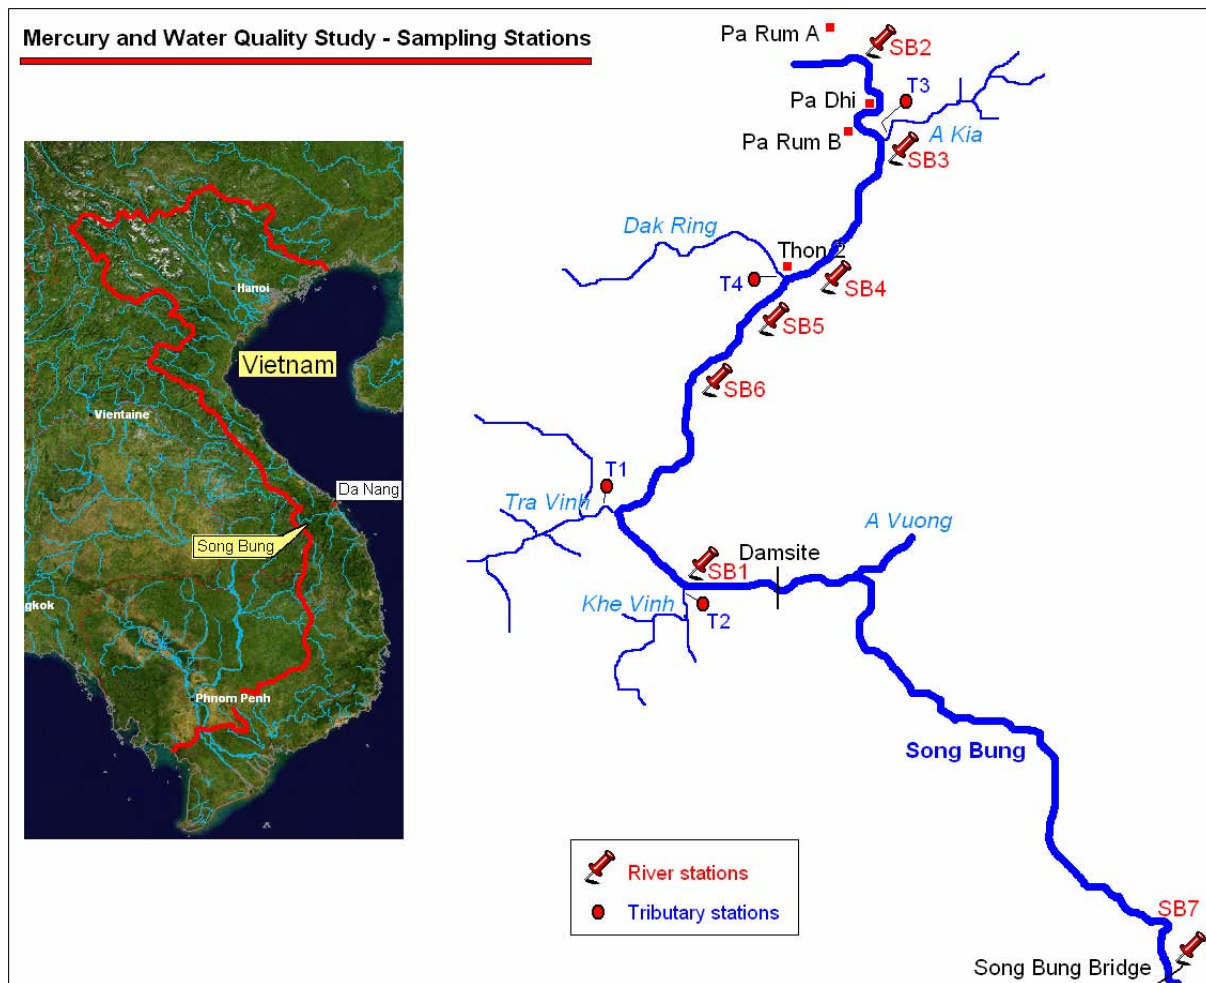
Figure 1. The Samplings sites for the mercury and water quality study March 19-26 in the Song Bung 4 Hydropower Project Area.

According to the Terms of Reference, 6 stations in the main stream Song Bung and 6 tributaries should be sampled. However, two of the tributaries were dry, so more stations in main stream river were sampled instead, as well as 4 tributaries suspected to be impacted by gold mining. Two of the tributaries were impacted by gold dredging, and some by hard rock mining in the upstream areas. The sampling stations are shown in Figure 1.

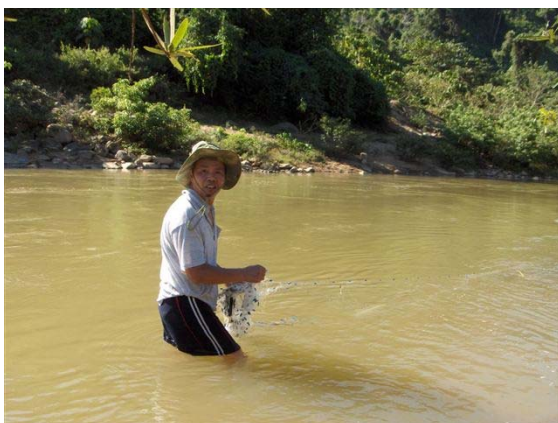
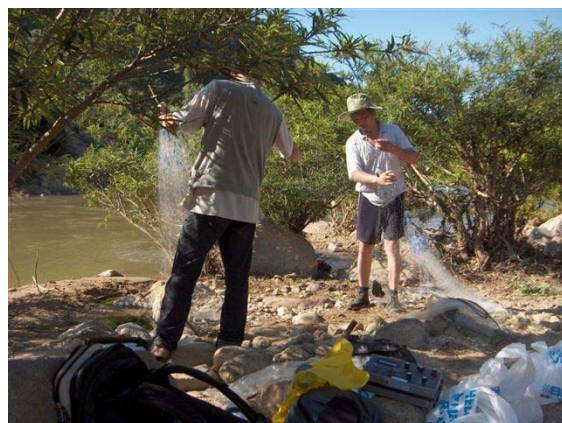
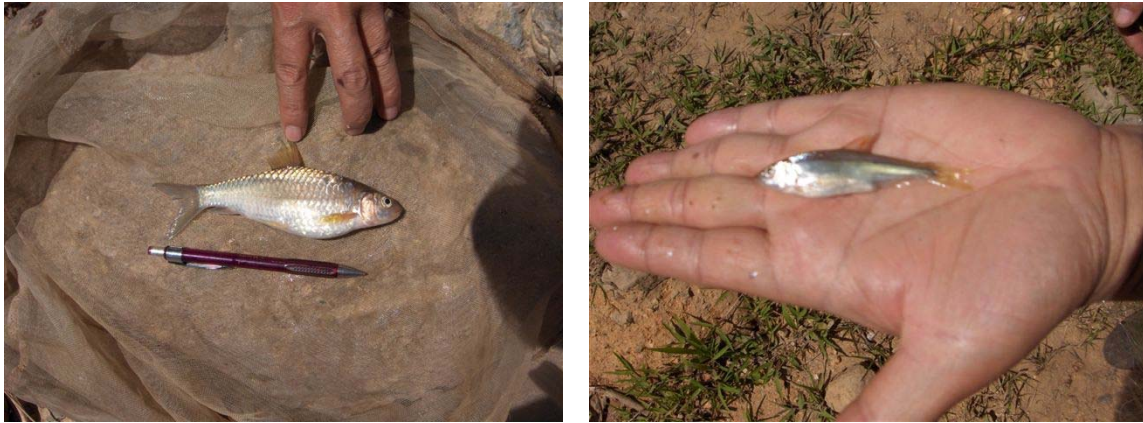
Figure 2. Fishing ourselves during the field trip (day time) gave only small fishes. Here young stages of *Spirobarbichthys denticulatus* to the left and *Hainania serrata* to the right. The first of these species can grow to 8-10 kilos in Song Bung.

To be sure that the fish really was caught in Song Bung River, we initially tried to carry out the fishing ourselves. However, it turned out that we only were able to catch small fish during day time, see **Figure 2**. We therefore, on our way upstream, arranged with professional fishermen to try to catch big fish for us, so we could buy from them on our way back. In this way we managed to get samples from large specimen of fish that people normally use for food along the Song Bung River, see **Figure 3**.

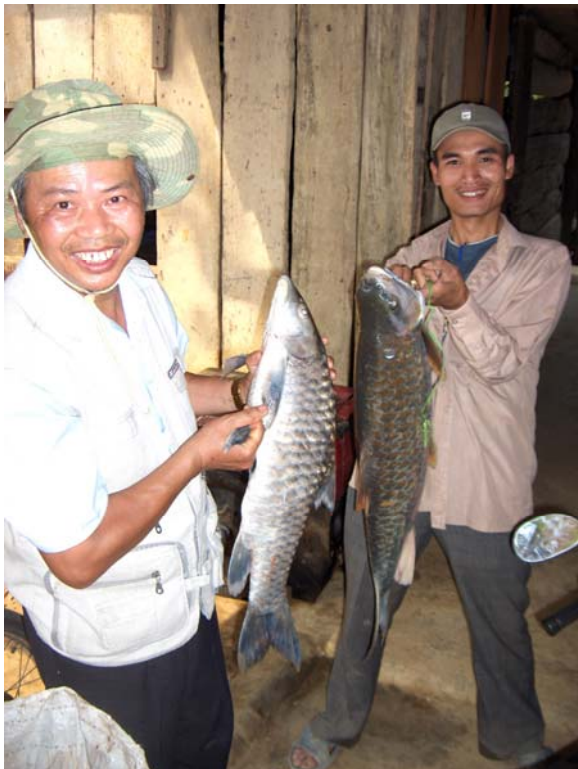
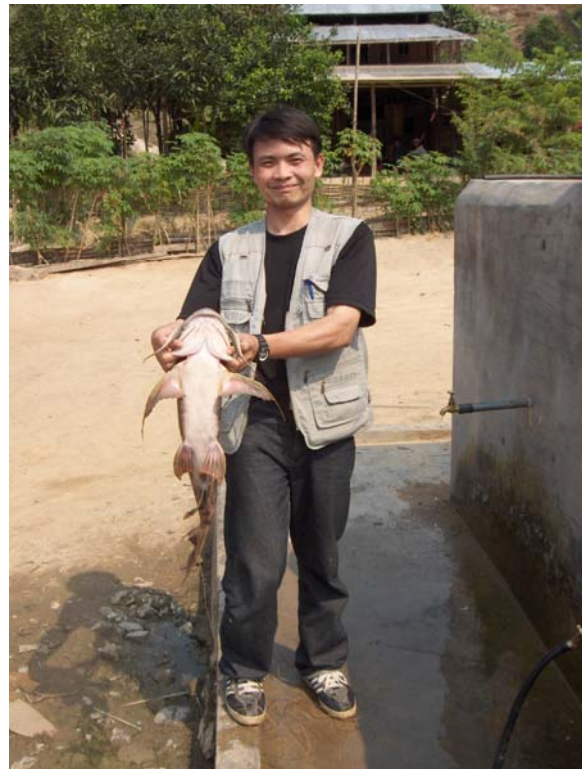
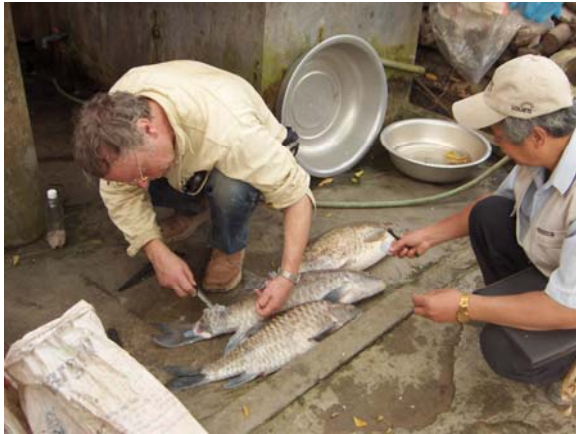
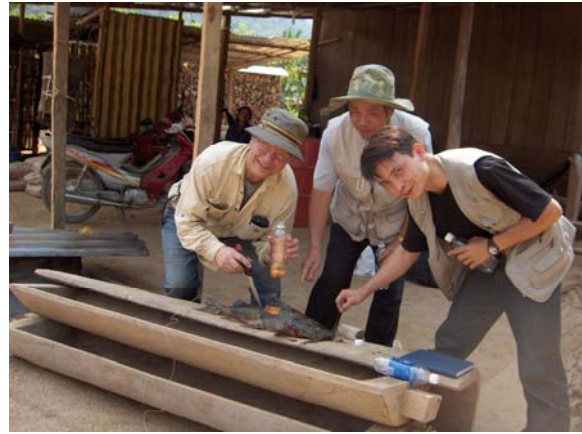
**Figure 3.** When we let local fishermen do the fishing, large fishes were caught.

Large representatives for the same species as above, *Tor Strachey* (4 kg) to the left and *Spinibarbichthys denticulatus* (7 kg) to the right

*Bagarius yarelli* (3 kg)

*Samples for mercury and heavy metal analysis were taken from the fish filets*

*And conserved in 70 % ethanol prior to analysis*

The fish samples were taken from the filets and conserved in 70 % ethanol prior to the analysis.

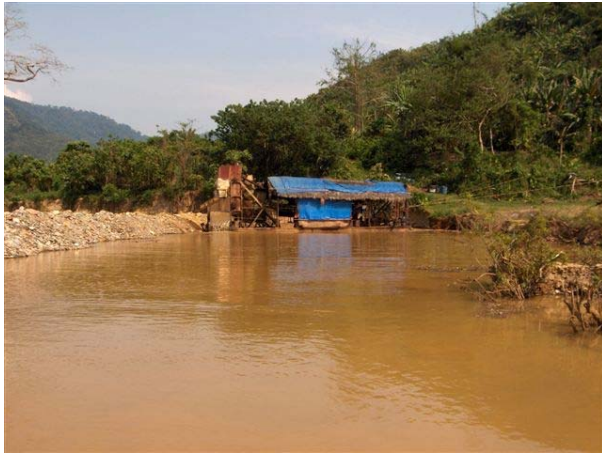
1. The gold mining barges eat their way sideways into the river banks

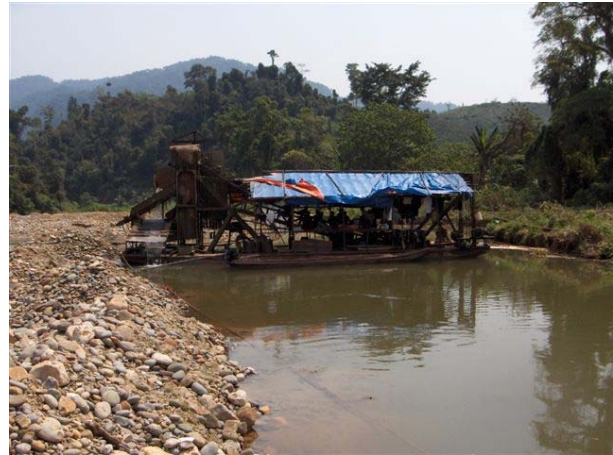
2. Eating old grass-covered banks in the front end, washing the material and spitting it out in the rear end

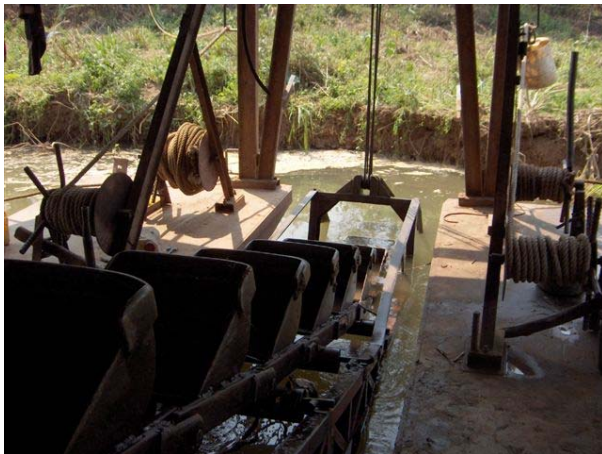
3. A continuous excavator belt with half a meter between the grabs is fairly efficient.

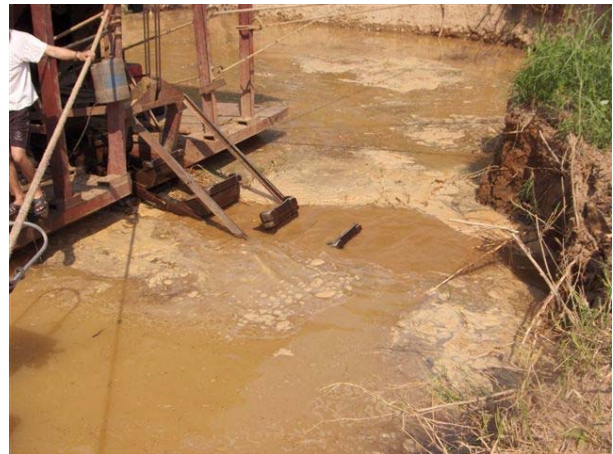
4. Digging down to 1.5 m below the water surface, and 1 m above the water surface

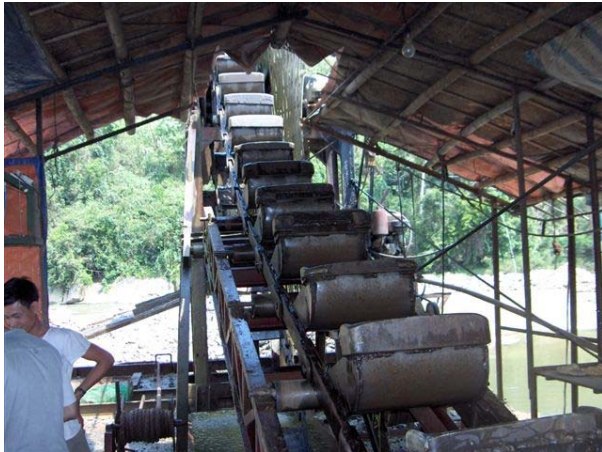
5. The material is transported up to a washing tower at the rear end of the barge

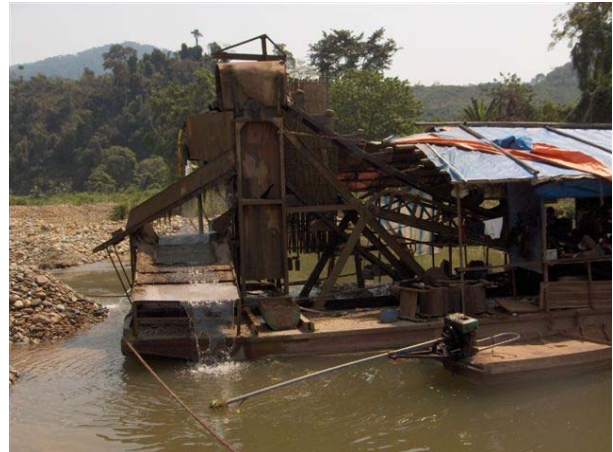
6. Here the material is separated, the stones and gravels are dumped backwards, while the sand and fine material go to both sides.

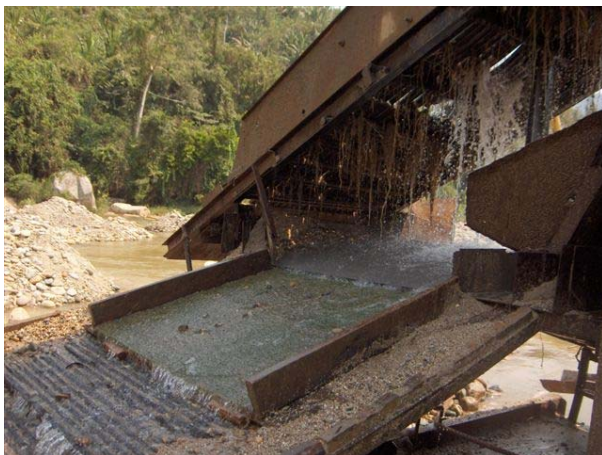
7. The gold and some sand are retained between the fibres in a nylon carpet, like the door mats used to clean dirty shoes.

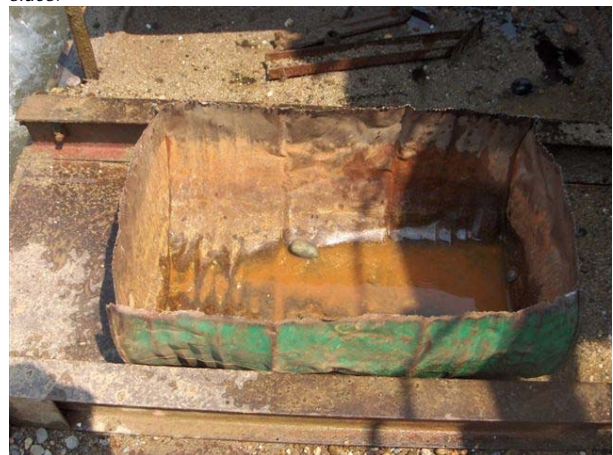
8. After some hours of operation the mats are thoroughly washed in a half barrel filled with water. The water is thereafter carefully decanted off.

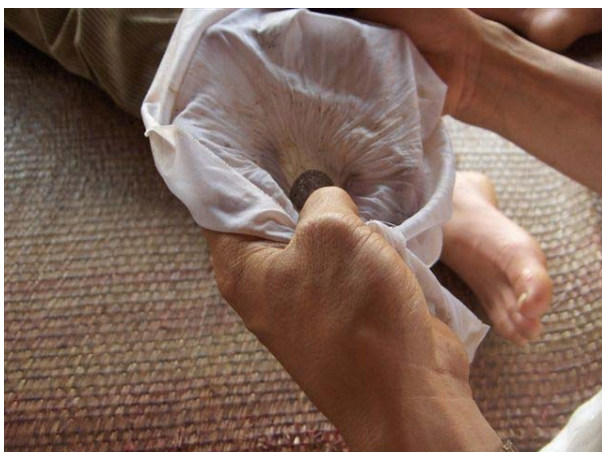
9. After a last mechanical separation where some coarse sand and debris are taken out, the remaining material is mixed with mercury and moulded in a cloth. The mercury reacts with the gold forming amalgam, the sand does not react. The surplus of mercury is squeezed through the cloth and collected.

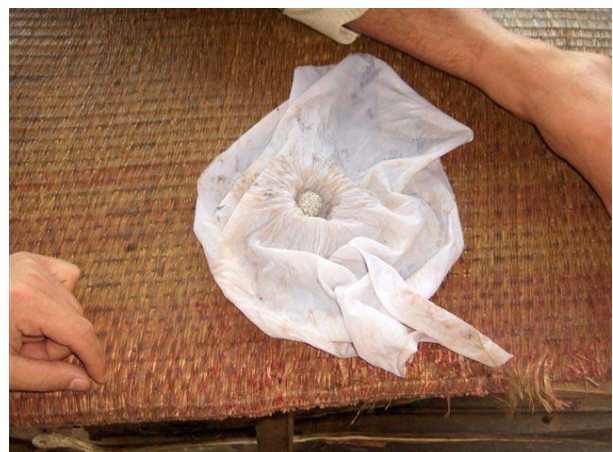
10. The result of four days and nights of gold washing. A lump of amalgam of the size of a ping pong ball. This is heated and the mercury vaporizes off, and the pure gold and some silver are left back. This last extraction is not performed on board the barge, but in town, we were told.

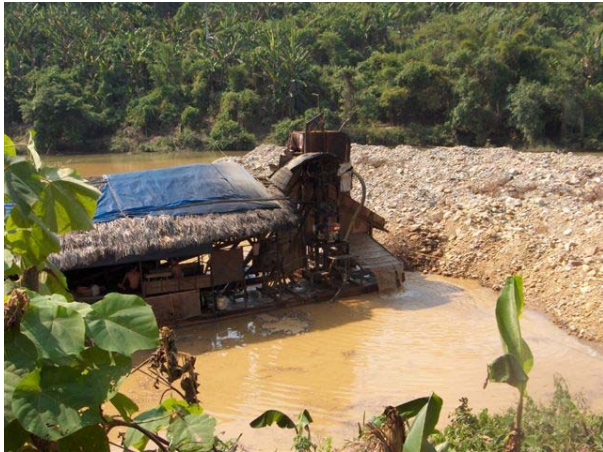
11. In addition to potential pollution, the gold dredging makes large physical and ecological impacts on the river bed, as well as making the river water turbid

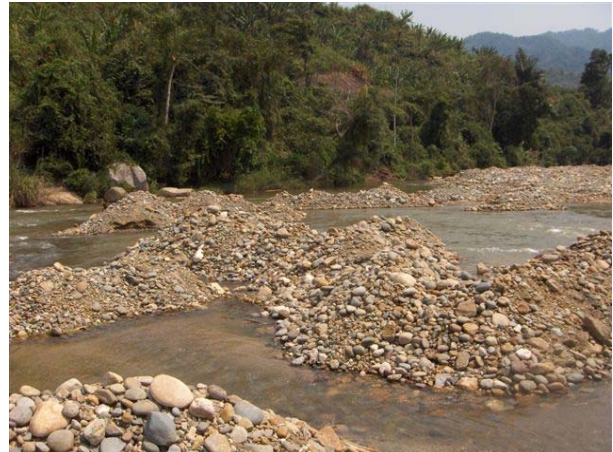
12. Here it is not easy to go boating, nor for the fish to find back to its old living places.

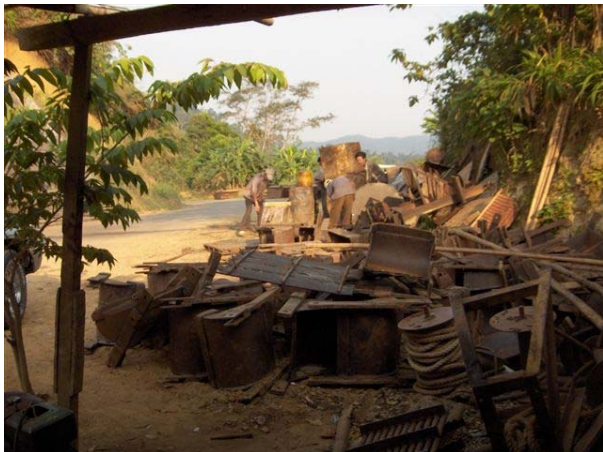
13. The dredging machines are pre-built in sections at small workshops in the forest.

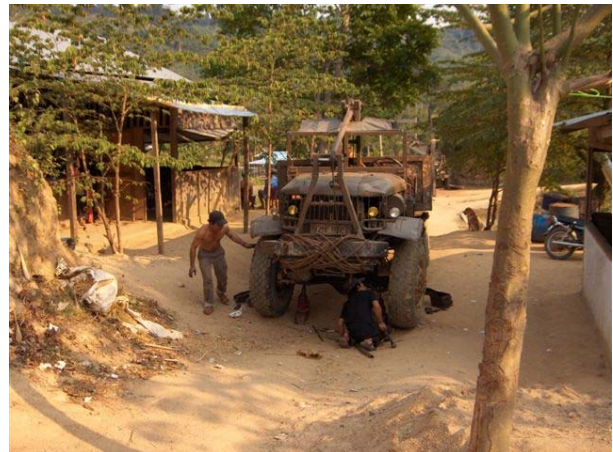
14. Thereafter transported to the site on old military terrain vehicles.

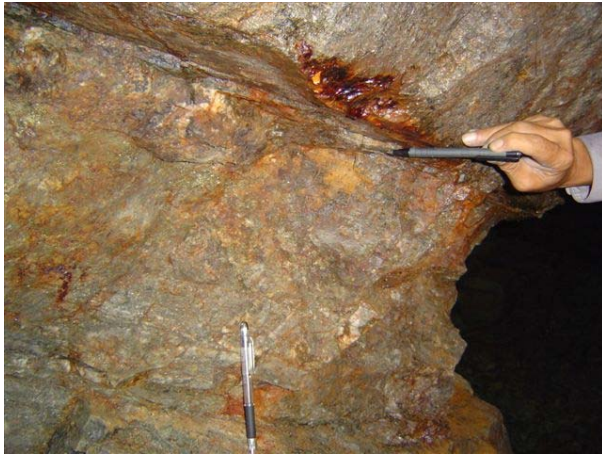
1. Gold bearing ore are taken out by blasting (tunnel mining)

**Figure 4.** From the hard rock mining in the Song Bung catchment

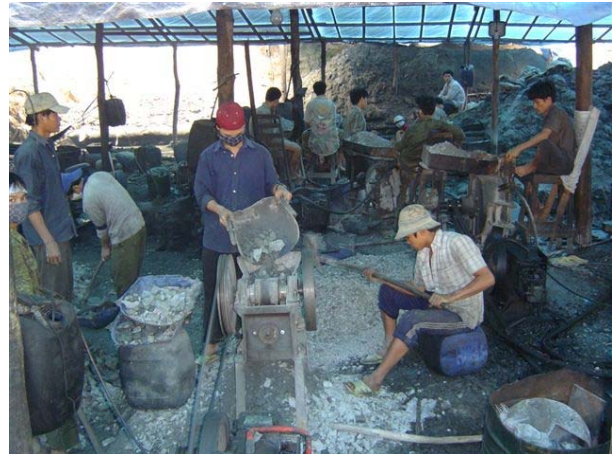
2. The ore is crushed to a particle size of fine sand and finer

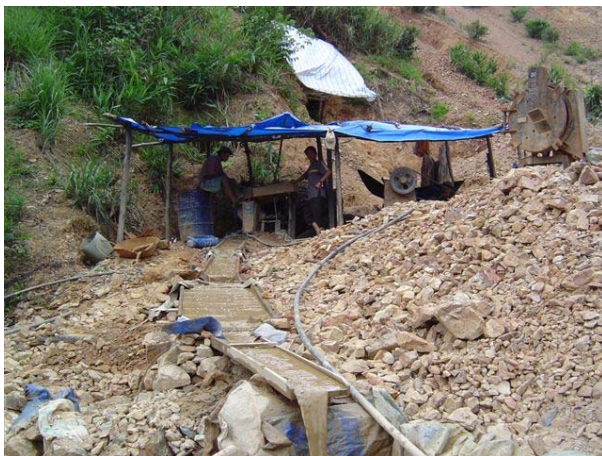
3. The crushed material is mixed with water, forming a slurry, which is led down a gentle sloping canal with a transverse rib system in the bottom. Heavy particles are retained between the ribs, while the lighter particles follow the water. The rib system is cleared for gold bearing particles at certain intervals.

In the heavy particulate material taken out by gravity in the way described in **Figure 4** the gold is still sticking to the mineral particles. This material is now put into a plastic lined pond of a typical size of approximately 2x2m wide and 1 m deep and treated with cyanide. The miners would not tell us how this process was done (business secret), but here we cite the most common way of using cyanide-extraction in small scale gold mining. In addition to the gold containing sediment the pond is filled with water and a small amount of sodium cyanide is added. The pond is stirred thoroughly by blowing in compressed air (oxygen is necessary for the process). The gold is now dissolved from the mineral particles and goes into aqueous solution. This process takes a couple of days. The solution is then led into another plastic lined pond and zinc shavings (or zinc powder) are added. The gold, some silver and copper will be precipitated onto the zinc particles (like in plating) and will settle to the bottom of the pond. The metals in this precipitate can be separated by heating according to the different melting points they have. In some systems a step using activated charcoal is also used (but not here we were told).

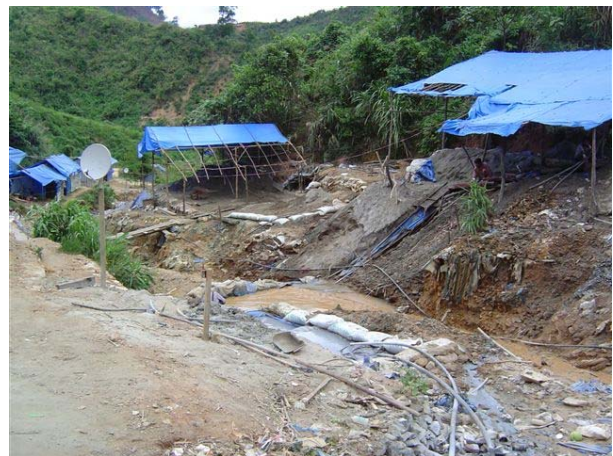
4. The water that escapes the rib settling system is led through ponds where more material settles out. The sediments here are taken up and led over the rib canal system once more for collecting more material.

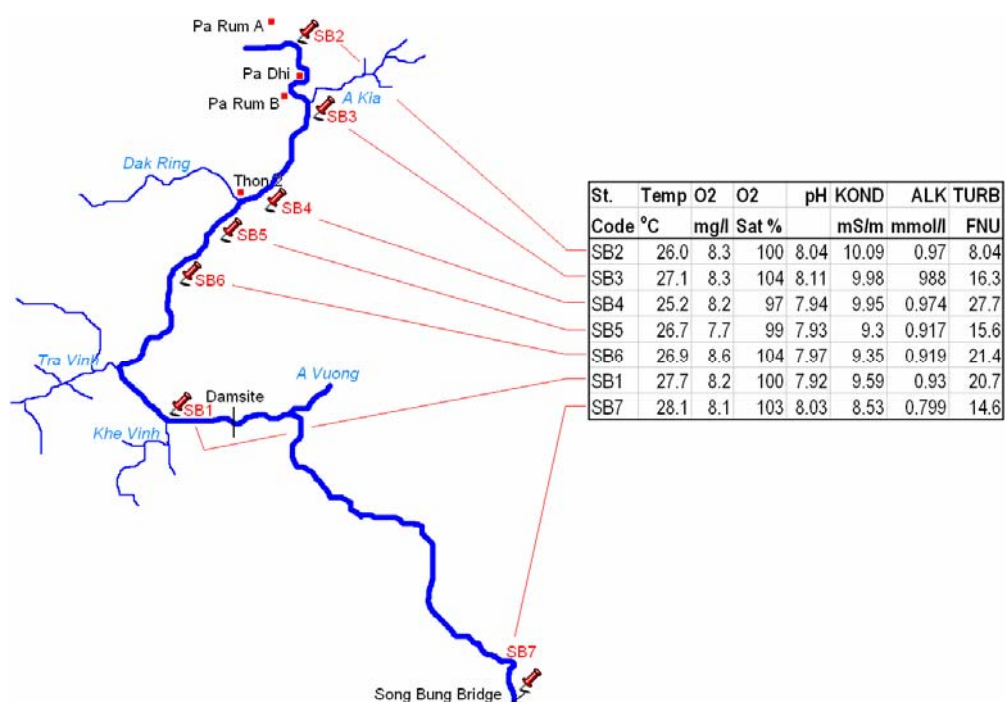
**Figure 5.** Some parameters of general water quality at different sites in the Song Bung River, March 19-26 2006.

Some general water quality parameters from Song Bung mainstream are given in **Figure 5** while those from the tributaries are given in **Figure 6**. Temperature varied from 26 to 28 degrees Centigrade. The water was saturated with oxygen at all stations, also in the tributaries. The PECC3 found that the water had only around 60 % oxygen saturation, which most likely was wrong due to the fact that they brought the water samples to the lab without conserving the oxygen in the field. The oxygen will then be consumed by micro organisms on the way to the lab. The pH was slightly alkaline from 7.8 to 8.1. The water was relatively soft with conductivity values around 9-10 mS/m, and alkalinity of 0.9 mmol/l. The turbidity was moderate at all stations during the days of sampling and showed values from 8-35 FNU, including in the tributaries. As the relationship between turbidity measured as FNU and suspended particulate matter measured as mg/l is not far from 1:1 (Berge et al 1995), this indicates that the concentration of particulate matter was in the range of 10-30 mg/l. These represent normal values in the region for the dry season of the year, with low erosion activity. According to the PECC3 study and the hydrodynamic modelling study the concentration can increase to 200 mg/l during rainy weather (Basberg 2006). During the period we were sampling, the gold mining barges were operating at full speed (11 only in the Song Bung between Pa Dhi and Ta Vinh), but this did not cause any large increase in the turbidity of the river water, and much lower than is known to cause any problems for aquatic life. According to water quality criteria of the European Inland Fishery Commission (EIFAC, see Alabaster & Lloyd 1980), no damage is proven to occur to aquatic life below 35 mg/l of particulate matter. On the other hand they state that it is impossible to have good fish productivity in a river if the concentration of suspended sediments is above 100 mg/l.

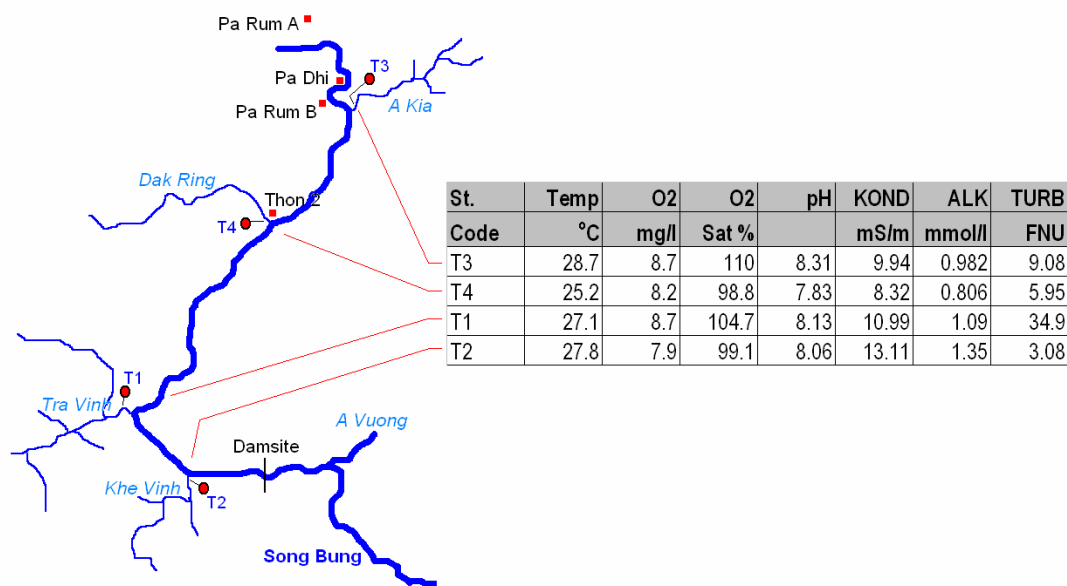
Figure 6. Some parameters of general water quality in different tributaries of Bung River, March 19-26 2006.

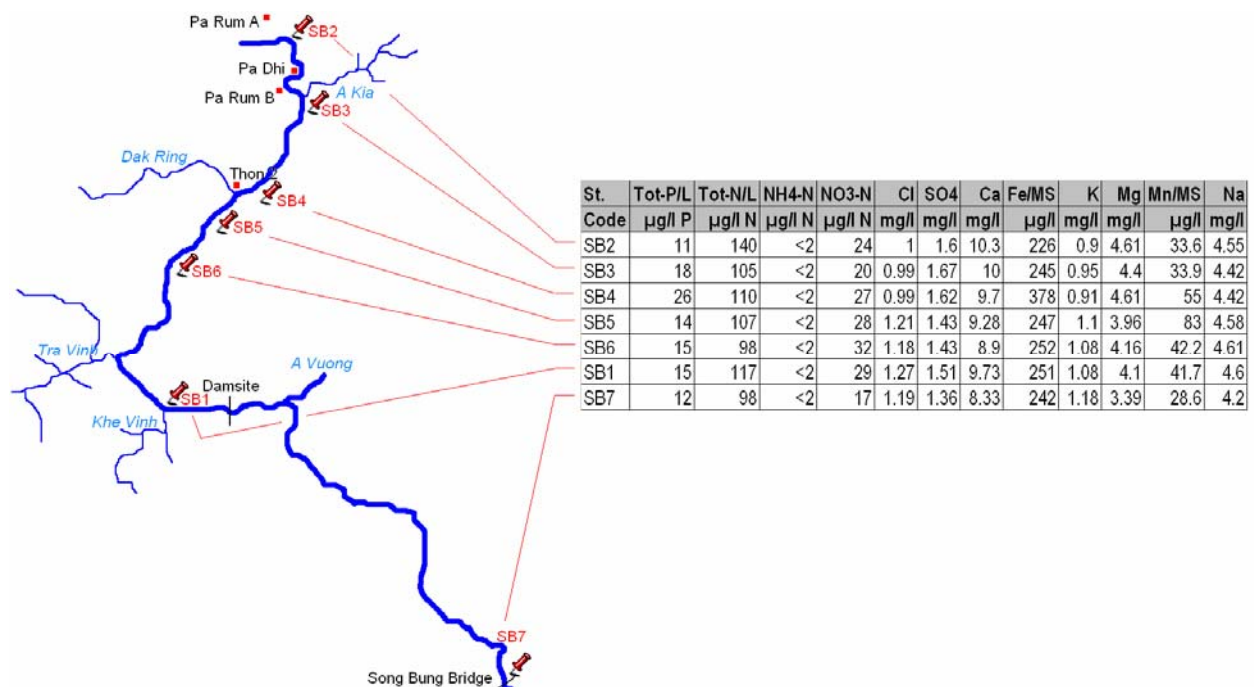
Figure 7. Nutrients and main ion composition at different sites in Sung Bung River March 19-26 2006.

The results from the analyses of nutrients (nitrogen and phosphorus components) and major ions, are given for Song Bung mainstream in Figure 7, and for the tributaries in Figure 8.

The concentration of both phosphorus and nitrogen is low. The P shows the same variations between stations as the turbidity, which indicates that it is P adsorbed to particulate matter that constitutes the concentration and not discharges from human activity. The concentration of total nitrogen and other N fractions are very low, and indicate almost pristine natural values, and no use of chemical fertilizer in the catchment. The concentrations of the main ions seem very natural. There are relatively high concentrations of iron and manganese, which however, is also normal in this type of soils which is dominating in the catchment (Ferrallite soils and Ferralic Acrisols, cf NHP 2005).

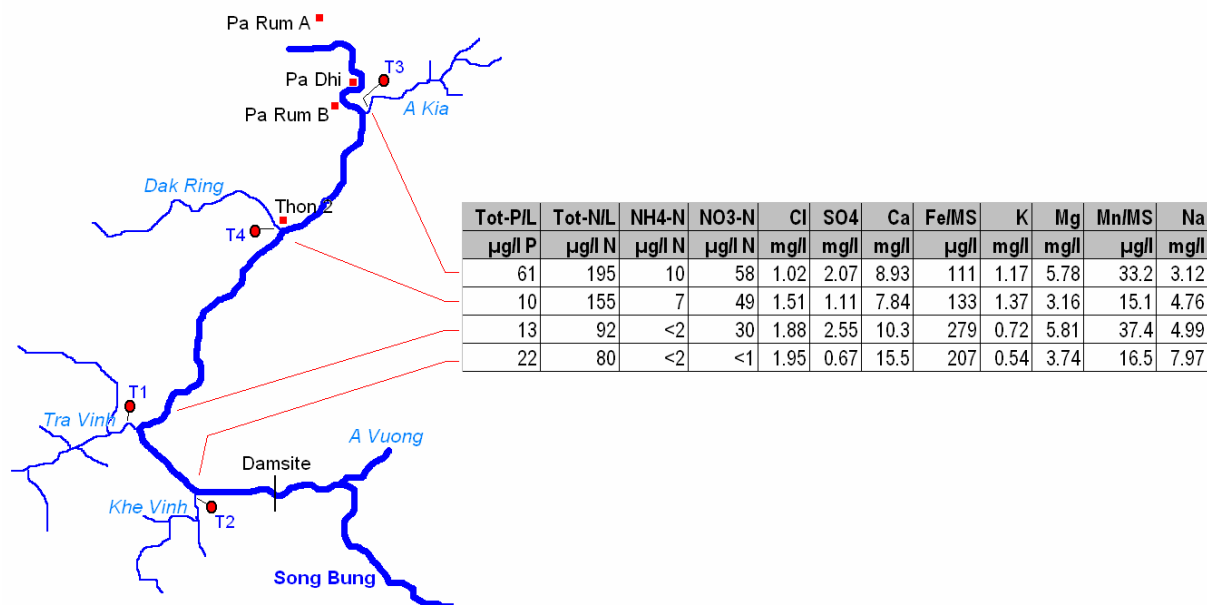
Figure 8. Nutrients and main ion composition in different tributaries of Song Bung River March 19-26 2006.

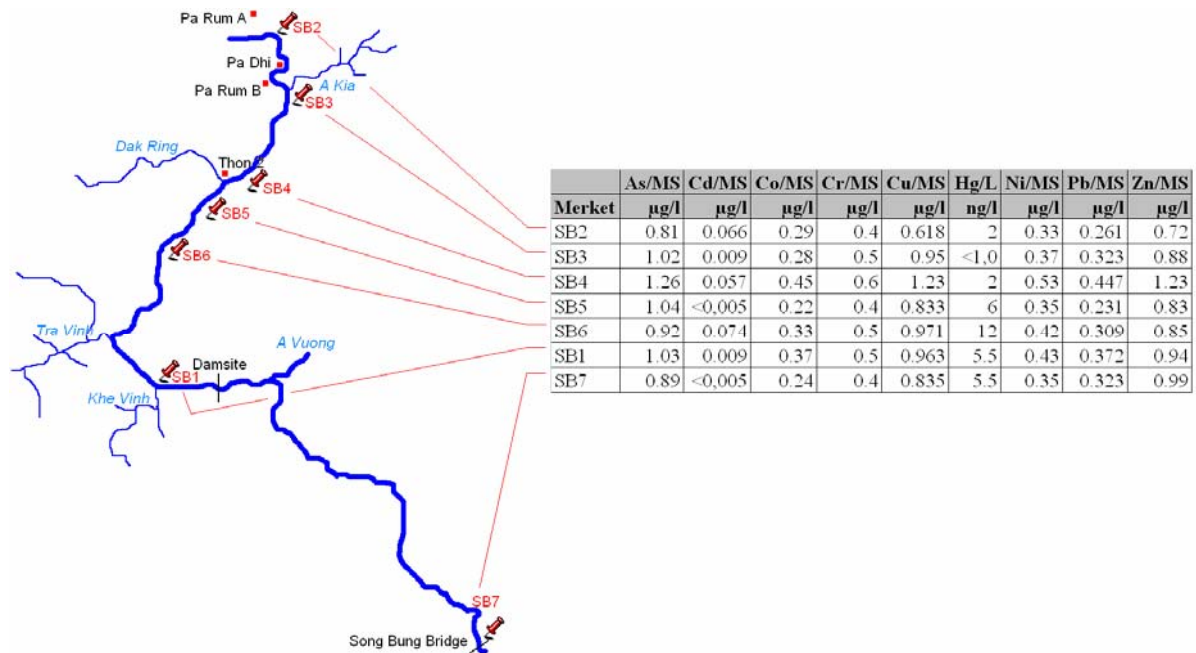
Figure 9. Concentrations of mercury and other heavy metals in the water at different sites of Song Bung main-stream, March 19-26 2006

The results from the water analyses of mainstream Song Bung River is given in **Figure 9** while the values for tributaries are given in **Figure 10**. For arsenic the highest concentration in Song Bung was from 0.8-1.2 µg As/l. In the tributaries, the highest concentration is found in Ta Vinh (2.3 µg/l). The values are well below the limit that WHO set for safe dinking water (10 µg/l). The Vietnamese standards set a limit of 50 µg/l. Several places in Northern Vietnam high content of arsenic in ground water is a problem for dinking water. For example in the raw drinking water wells for Hanoi City the arsenic content is from 240-320 µg/l, and after treatment it is varying from 25-91 µg As/l (Berg et al 2001).

For mercury, which is used to extract gold from the river sediments, the concentration in the water was also found to be low at all stations. The highest concentration in Bung River was 12 ng/l and was found at the downstream end of the gold mining impacted reach. There was a gradually increase from 2 ng/l upstream of Pa Dhi, which is upstream of the gold dredging area, and to the Ta Vinh area. At the 2 lowermost stations (Khe Vinh and Song Bung Bridge) the concentrations were lower. The Ta Vinh tributary had the highest observed Hg concentration of 21 ng/l. In this river there are going on several gold panning activities in the upstream reaches, and metallic mercury is used in the extraction. The other tributaries had values about as in Bung River upstream Pa Dhi, which can be regarded as natural background levels.

In the Bung River from Pa Dhi to Ta Vinh tributary, as well as in Ta Vinh it self, the water had enhanced mercury concentrations clearly above natural background levels. The levels were, however, low compared to what is regarded as safe water both in national and international water quality standards. The Vietnamese water quality criteria advices that the concentration should be below 1000 ng Hg/l, the US EPA says that no damage to

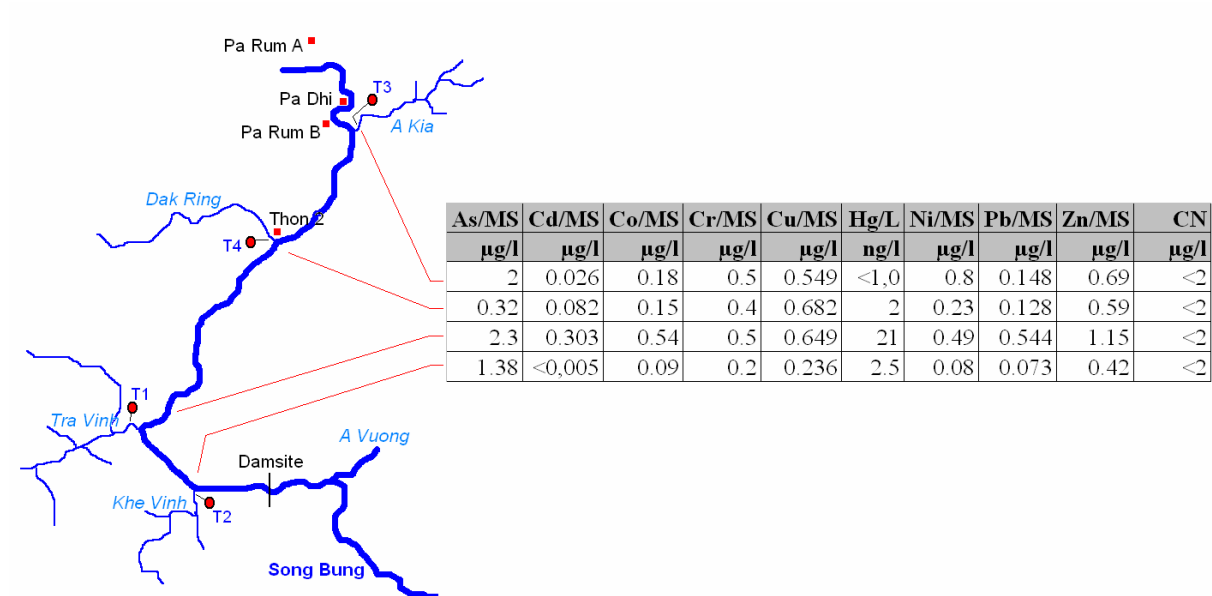
Figure 10. Concentrations of mercury and other heavy metals, and cyanide in the water of different tributaries of Song Bung, March 19-26 2006

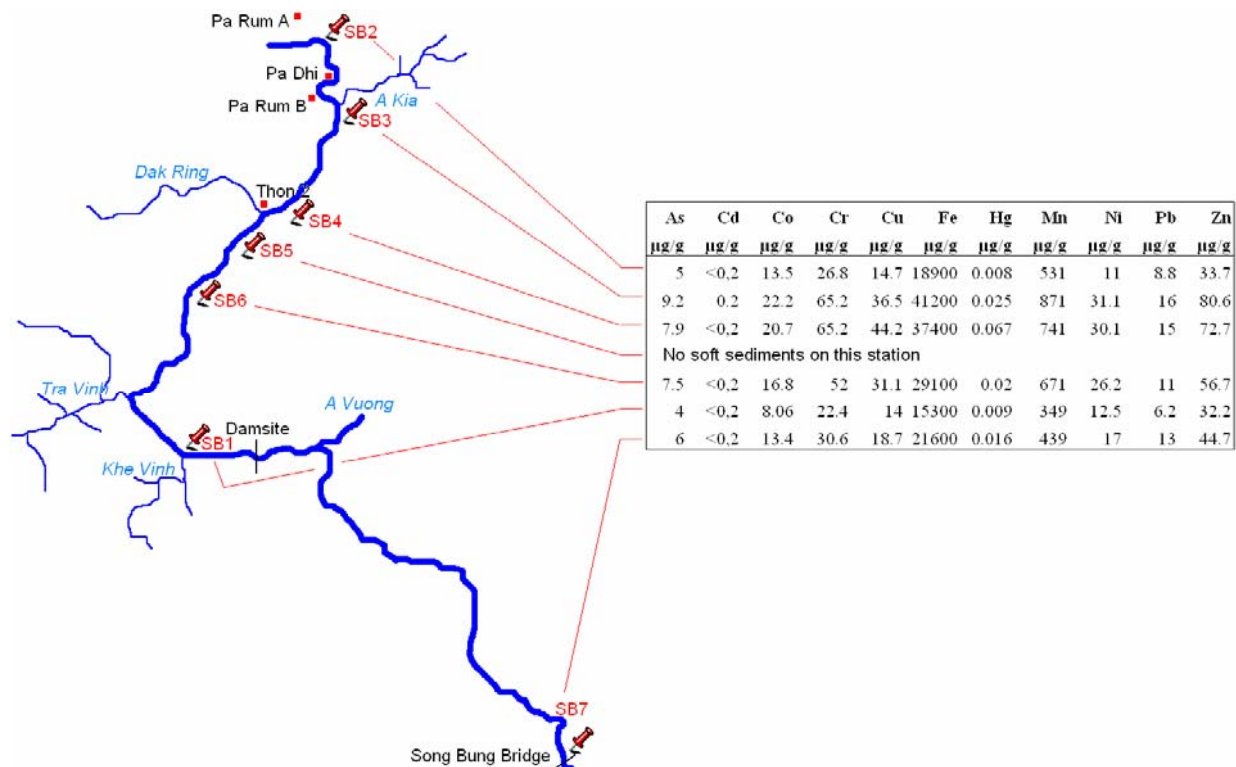
**Figure 11.** Concentrations of mercury and other heavy metals in the bottom sediments at different sites of Song Bung mainstream, March 19-26 2006

The analytical results from the sediment samples from the Bung River itself are given in **Figure 11**, whereas the results from tributary sediments are given in **Figure 12**.

Only a few nations have adopted quality guidelines for sediments. Vietnam has not. Canada has adopted a set of sediment quality guidelines where they operate with 2 limiting levels. They give one level above which possible environmental impacts can occur, and based on that, they give a recommended level well below this as a guideline for water managers to try to keep the water recipients below. The Canadian Environmental Guidelines are among the strictest in the world. With respect to mercury, which is the most dangerous heavy metal, the Canadian Environmental Quality Guidelines gives a recommended guideline of 0.170 µg/g, and a value of possible environmental effects of 0.486 µg/g sediment. In Bung River the highest sediment concentration of 0.067 µg/g was recorded in the middle of the gold dredging area at Thon 2. This is well below the Canadian guidelines.

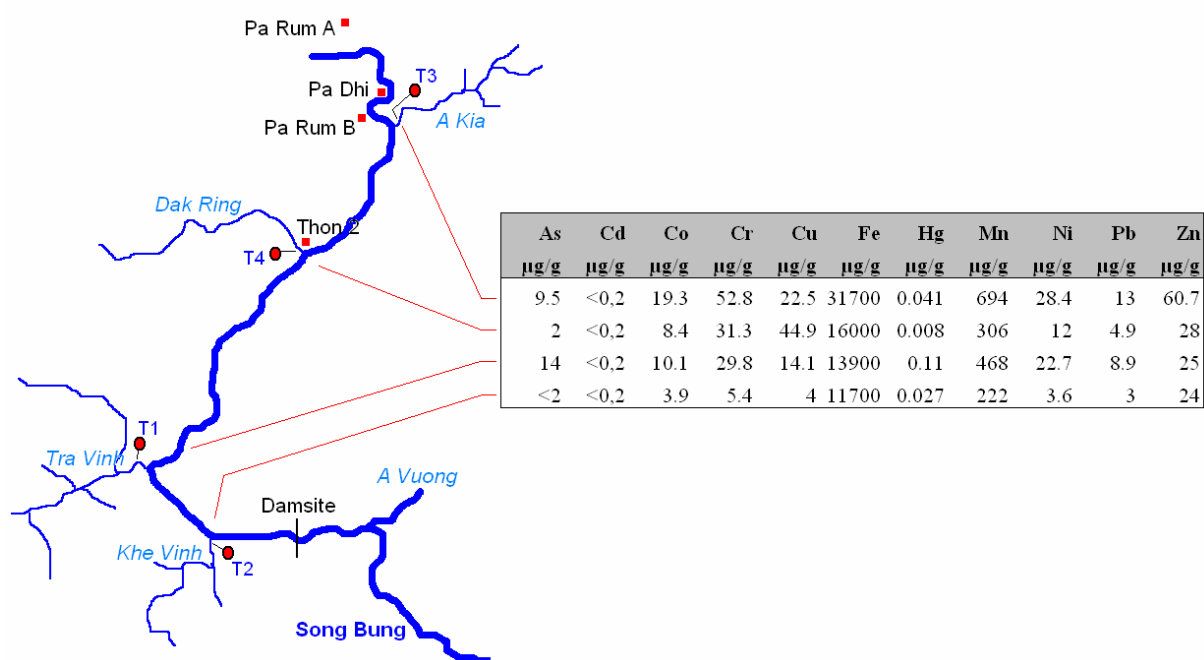
**Figure 12.** Concentration of mercury and other heavy metals in the bottom sediments in different tributaries of Song Bung March 19-26 2006

Among the tributaries, the highest concentration of mercury was found in the sediments from Ta Vinh (0.110 µg/g). This is approaching the Canadian guideline, but is still well below the limits of observed environmental impacts given in the Canadian Environmental Guideline system.
