Investigations of mercury during a survey near submarine U-864 outside Fedje in 2013

Title Investigations of mercury during a survey near submarine U-864 outside Fedje in 2013	Report No.. 6499-2013	Date 2.4.2013
	Project No. O-12365	Pages 24
Author(s) Sigurd Øxnevad Bjørnar Beylich	Topic group Contaminants in marine environments	Distribution
	Geographical area Fedje	Printed NIVA

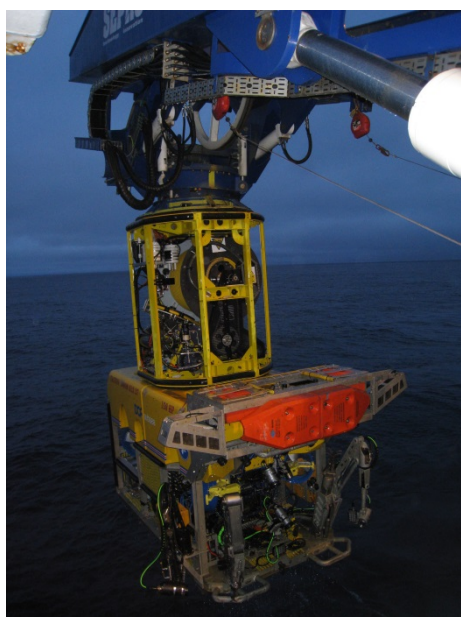
Picture A and B. The ROV (A) and the Vibro corer (B) used for taking the sediment samples near U-864 at Fedje (Photos: Sigurd Øxnevad).

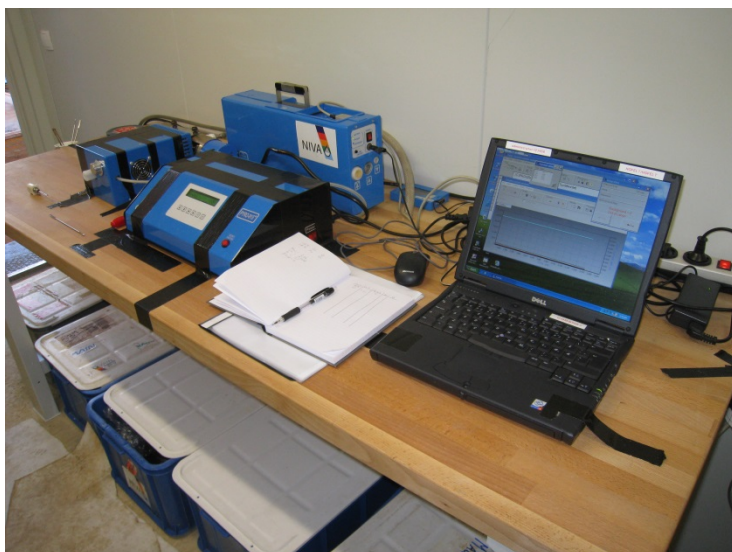
Picture C. The Lumex Mercury Analyzer with pyrolyzer unit (Photo: Sigurd Øxnevad).

The RA-915+ Mercury Analyzer is a portable multifunctional atomic absorption spectrometer with Zeeman background correction, which eliminates the effect of interfering impurities. It does not require gold amalgam pre-concentration and subsequent regeneration steps. This enables the user to conduct real time monitoring and detection of a mercury vapour. Combined with a two-chamber atomizer (PYRO-915+), the instrument can determine mercury content in solid samples such as sediment. The detection limit is 1.0 µg/kg in solid samples. A certified marine sediment reference material (MESS-3) was used as standard for the analysis of sediment samples.

Sediment samples were analysed roughly on board, and more accurately in the NIVA laboratory after the cruise. A Lumex RA-915+ Mercury Analyzer with pyrolyzer PYRO-915+ was used for the analysis (picture C).

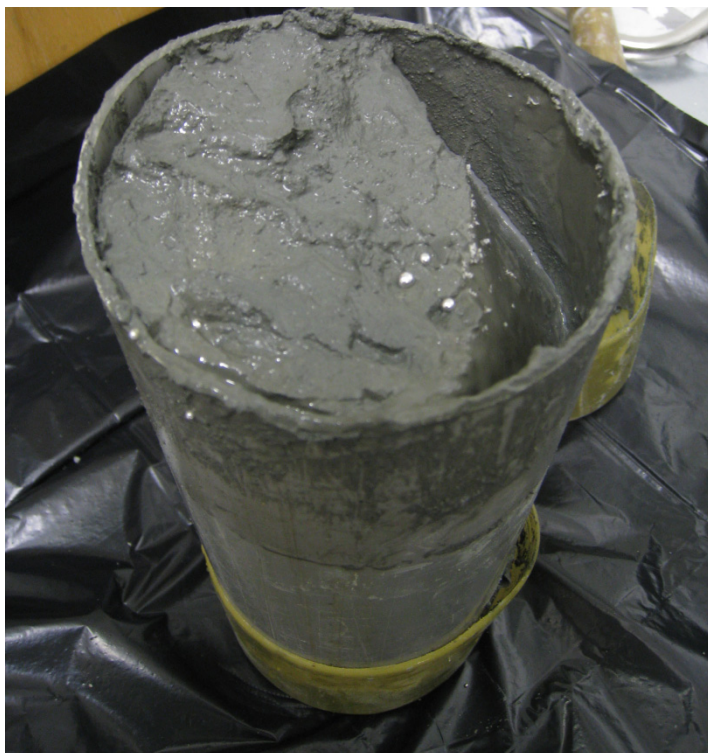
In cores 406 and 407 liquid mercury were found (picture D). Sections of the sediment cores with visible liquid mercury were not analysed for mercury. In the cores from station 405 and 407 mercury was found down to the end of the core at respectively 3.2 and 2.2 meters. However the lack of mercury from 1.0 to 3.1 meters in the core from station 405 indicates that the deep samples might have been polluted with mercury from the top part of the core. This could also be the case for the core from station 406, but no samples between 0.2 and 2.1 meters have been analysed. It is our guess that the potential contamination of the deep samples could have occurred during cutting of the core or by the core catcher (a metal structure inside the core liner that keeps the sediment in the core from falling out). The results are shown in table 4.

Picture D. Sediment sample with liquid mercury (photo: Sigurd Øxnevad).
